Rail Accident Report

**Near miss between a train and a track worker at
Peterborough
20 July 2018**

Report 04/2019
June 2019

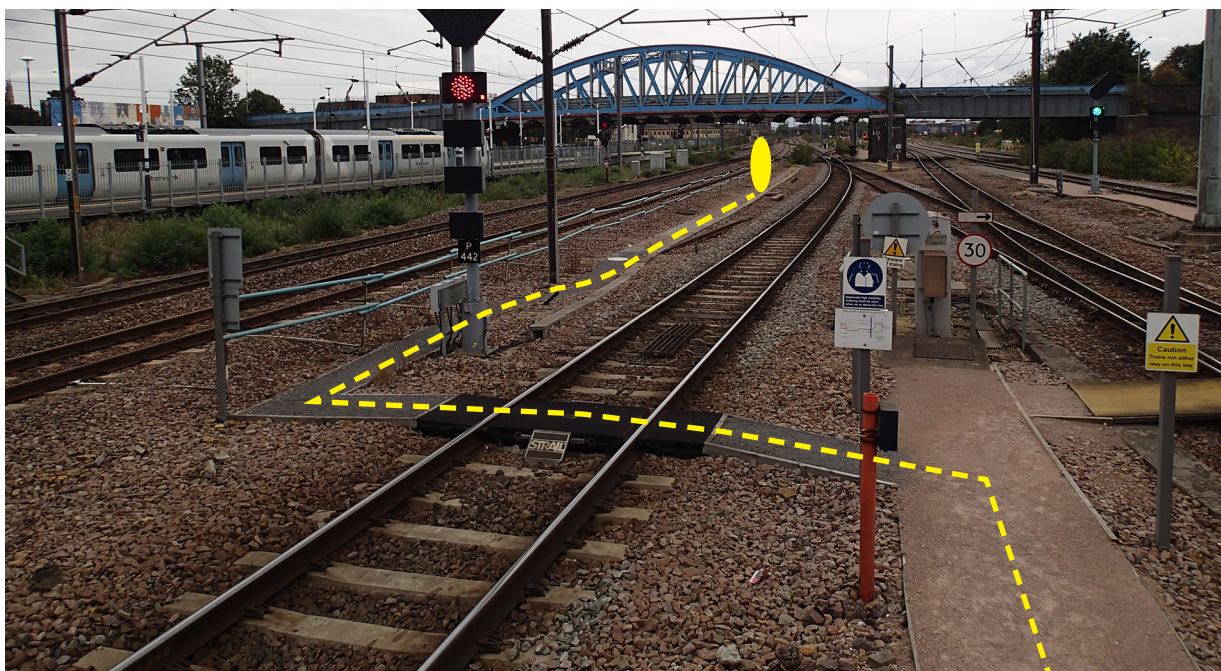
Figure 5: The authorised walkway off the end of platforms 4 and 5

- 26 When track worker B arrived at the end of platforms 4 and 5, he found another distant lookout was already standing where he planned to look out from. This was a distant lookout for a rail testing team, though he was not looking out at the time as his team had just moved to work to the north of the station. Track worker B positioned himself about 10 metres to the south of the other distant lookout (figure 6).

- 81 The walkway off the end of platforms 4 and 5 is a popular place for distant lookouts to stand (figure 5). It gives good sighting of trains approaching from the north for work taking place to the south of the station. Similarly, it gives good sighting of trains approaching from the south for work taking place to the north of the station. That morning, three maintenance teams with lookouts from Network Rail's Peterborough depot, were working around the station, and each wanted to place its distant lookout at that location.

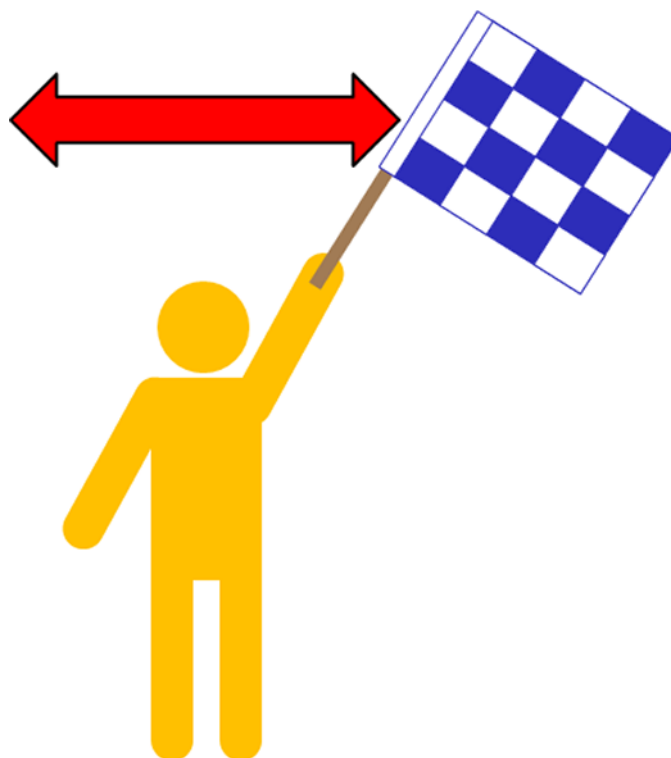
Figure 11: Lookout flag signal to give a warning

- 71 Only one lookout flag signal is described in the Rule Book (Handbook 3), to be used by the distant lookout to give a warning for an approaching train. A distant lookout waves the lookout flag from side to side above the head as shown in figure 11. When a site lookout sees this, he/she should warn the group at the site of work. Once everyone in the group has acknowledged the lookout's warning (by raising one arm above their head) and moved to a position of safety, the site lookout should return the same flag signal to acknowledge the distant lookout's warning. Both lookouts should then stop waving their lookout flags.

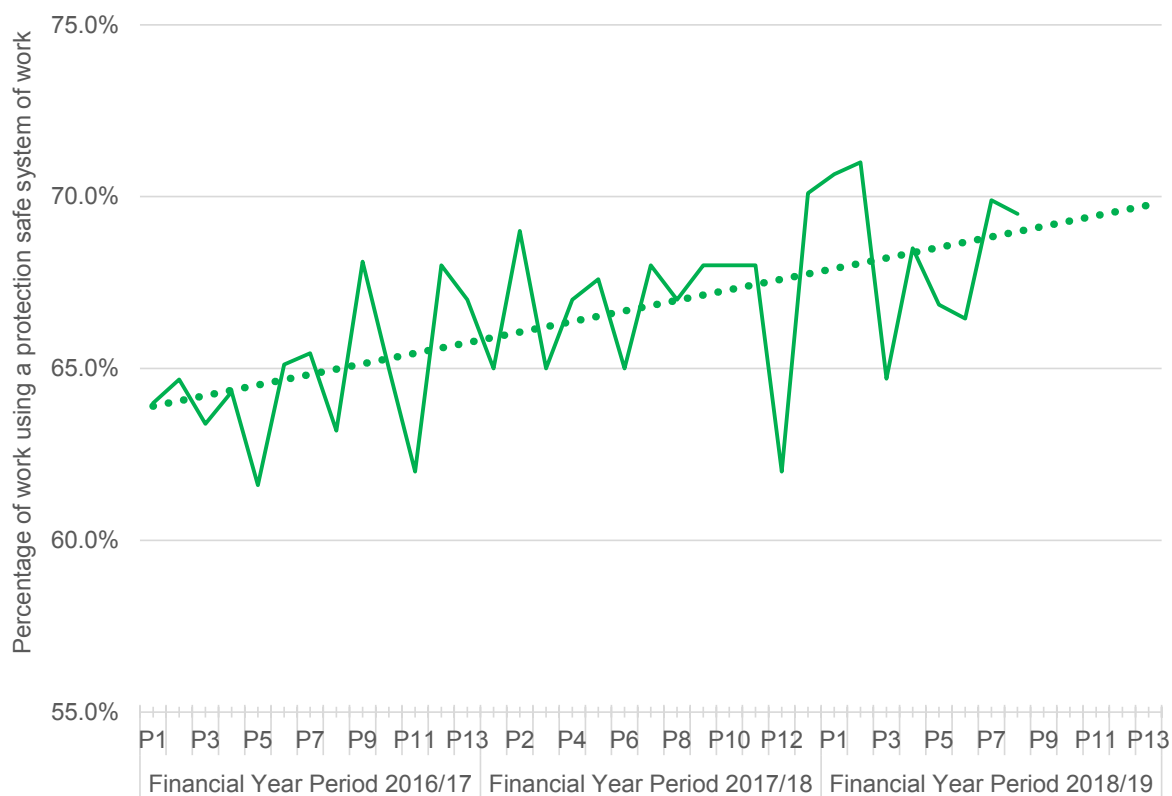
- 100 The S&EW project is monitoring the amount of work taking place using protection safe systems of work and reports it has seen a steady increase in this type of working by the four maintenance delivery units that cover the southern end of the ECML from London King's Cross to Doncaster (figure 14). Data obtained by the project also shows that the rail testing and lubrication section within the Peterborough delivery unit is the section that carries out the least proportion of work using protection safe systems of work (figure 15).

Figure 14: Graph showing the increase in the amount of work carried out using protection safe systems of work by the four maintenance delivery units that cover the southern end of the ECML from London King's Cross to Doncaster
