Rail Accident Report

Near miss with track workers at Pelaw North Junction 21 February 2018

Report 13/2018
August 2018

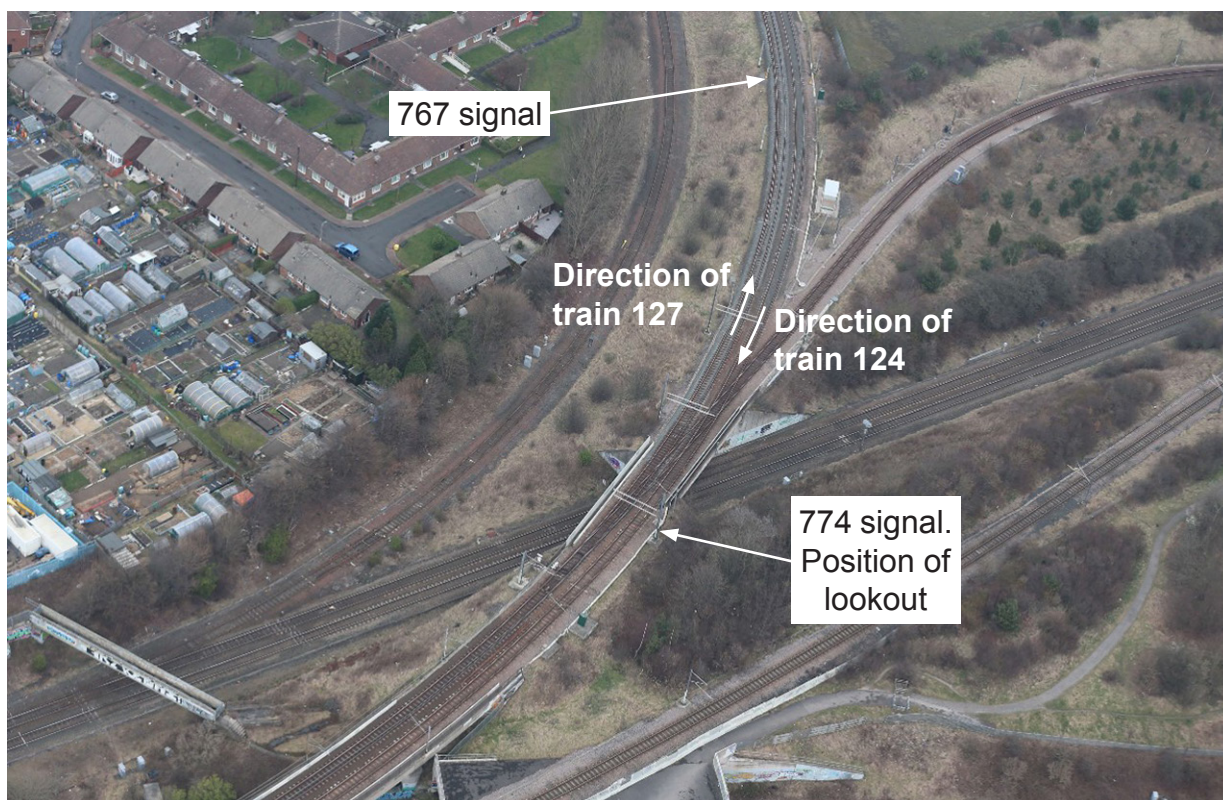
Figure 5: Image from the Network Rail Routeview system of Pelaw North Junction (courtesy of Network Rail)

- 33 Because of the curvature of the track (figures 5 and 6), the presence of train 127 obscured the lookout's view towards South Shields. The lookout and the WSC were therefore unaware of the approach of outbound train 124, which was approaching from that direction. Train 124 was travelling at, or close to, 65 km/h, its maximum permitted speed at Pelaw North Junction.
