Rail Accident Report

**Near miss involving track workers near Hest
Bank, Lancashire
22 September 2014**

Report 08/2015
July 2015

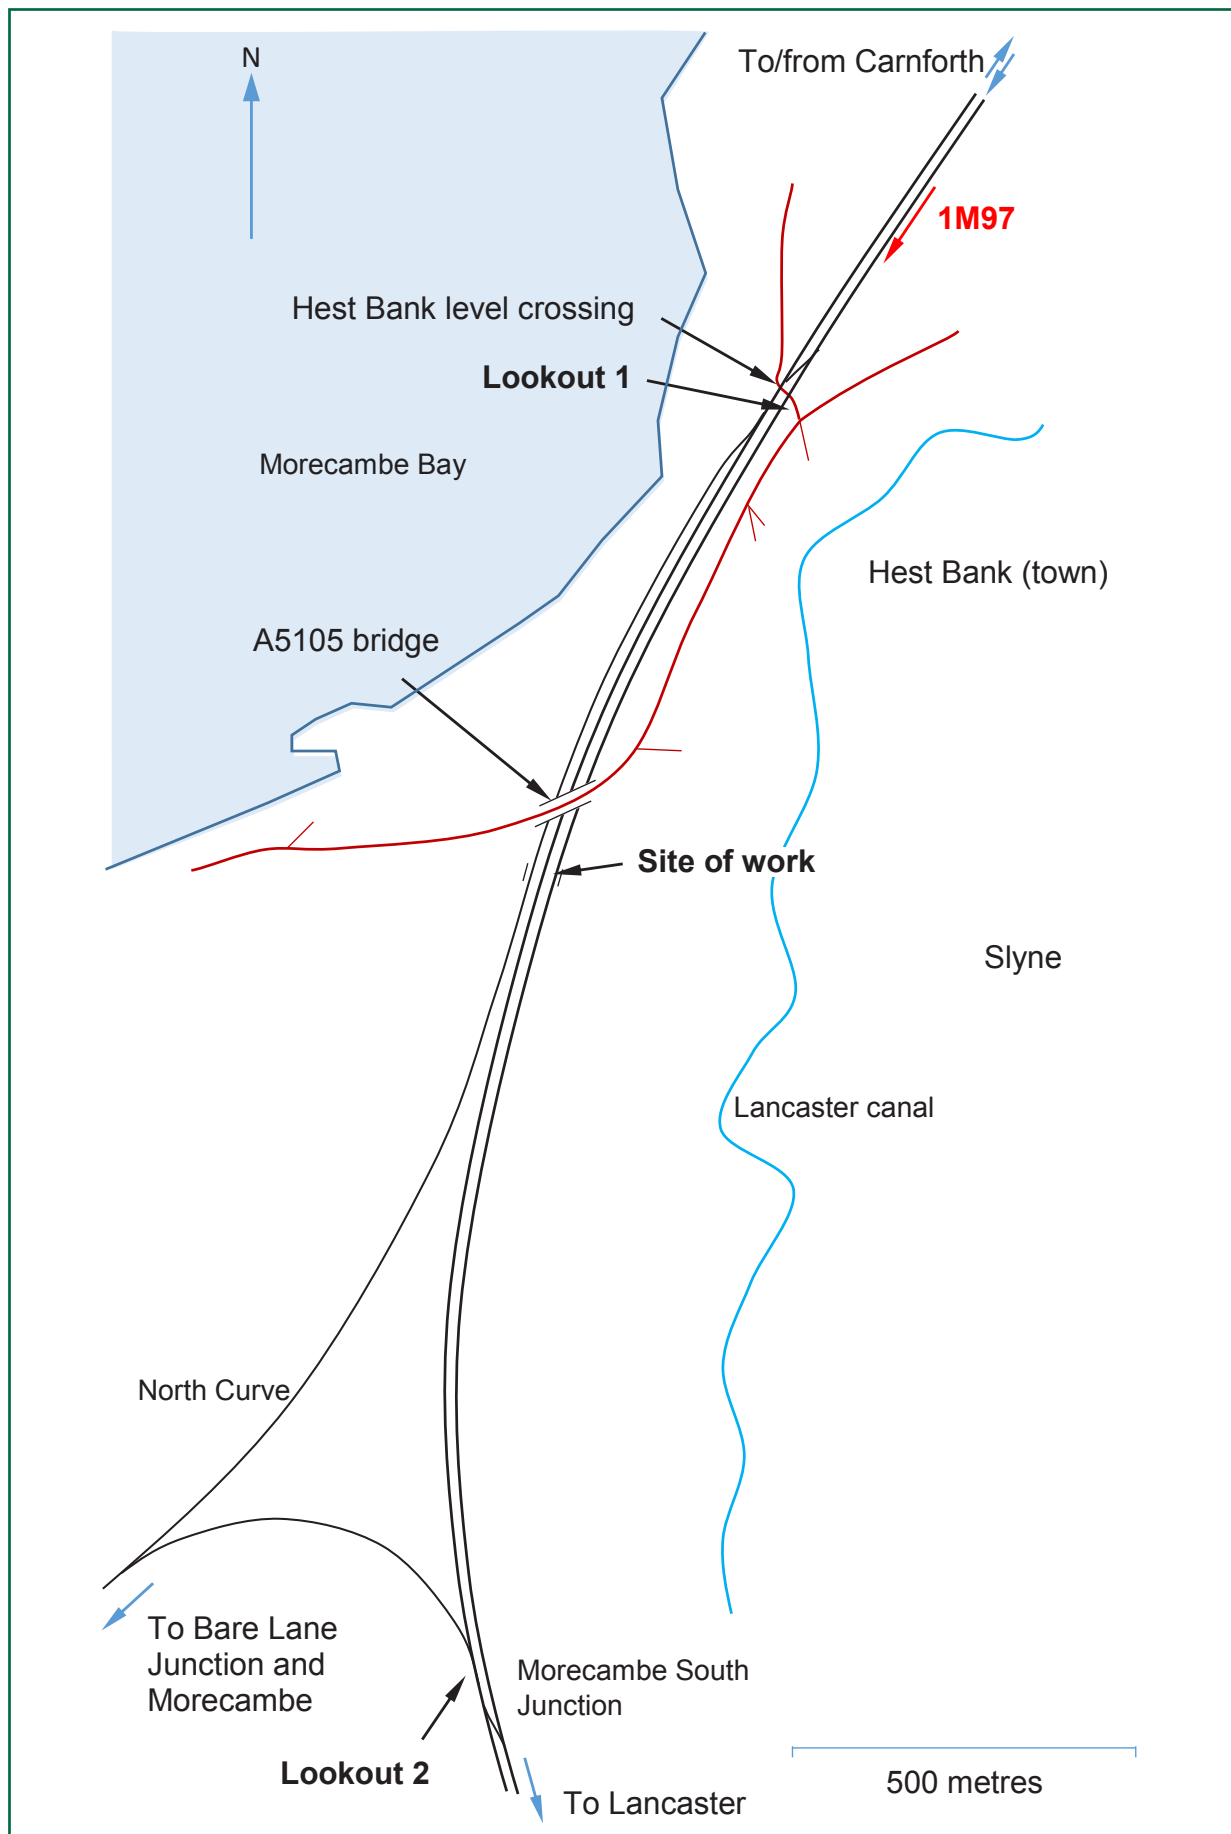
Figure 3: map showing track layout and location of staff

- 7 The site of work was located at 2 miles 52 chains² on the West Coast Main Line, 780 metres (853 yards) south of Hest Bank level crossing (Engineer's Line Reference CGJ7). At this location, the up and down main lines run parallel to the single line Down & Up Morecambe (North Curve) leading to Bare Lane Junction. The main lines, on which trains can travel at up to 125 mph (201 km/h), are electrified with 25 kV overhead equipment. An overhead neutral section is located 280 metres south of the site of work. The North Curve, on which trains can travel at up to 45 mph (72 km/h) in either direction, is not electrified (figure 3).

- 8 Travelling south from Carnforth, the up and down main lines approach Hest Bank level crossing on a straight section of track over 4 km long. Immediately after the level crossing, the North Curve branches off the down main line and the three lines curve to the left, passing under a bridge carrying the A5105 road over the railway about 110 metres before the site of work. The abutment of this bridge restricted the train driver's view and meant that he could not see the track workers until the train was about 150 metres from them. About 1200 metres beyond the site of work, the railway from Morecambe joins the main line at Morecambe South Junction.

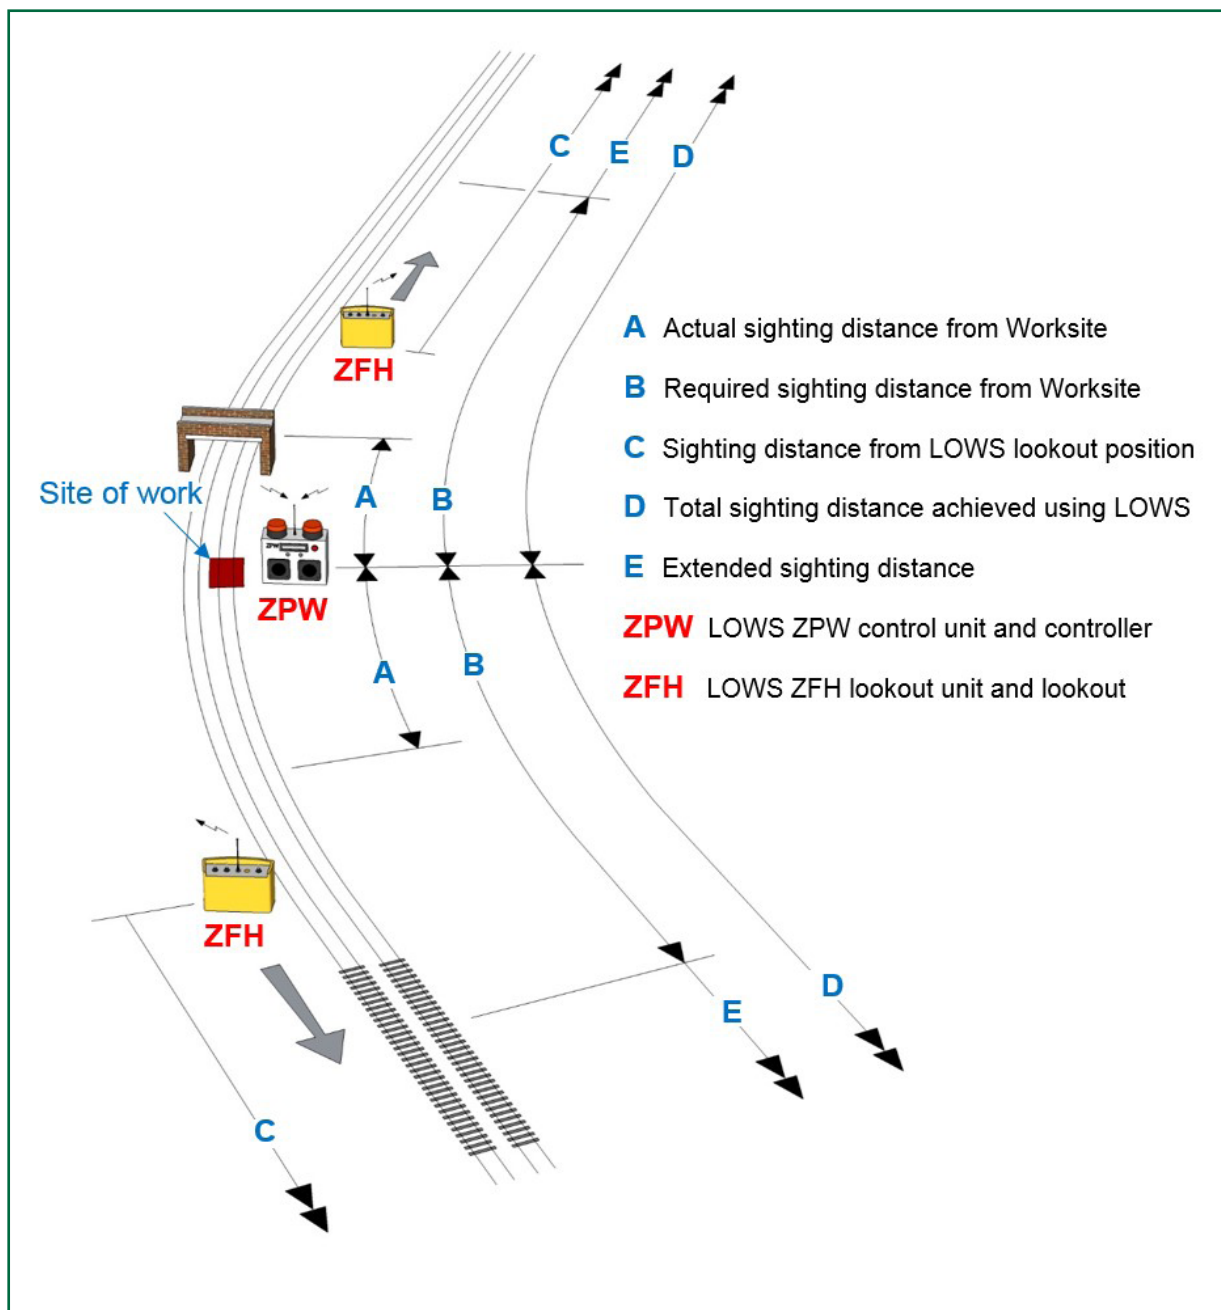
Figure 4: Schematic diagram of LOWS equipment in use

- the Lookout mistakenly operated the operator vigilance switch instead of the warning activation switches (paragraph 58); and/or
 - the Lookout forgot about the need to send a warning after delaying his response because of the extended sighting distance available (paragraph 65 and figure 4).

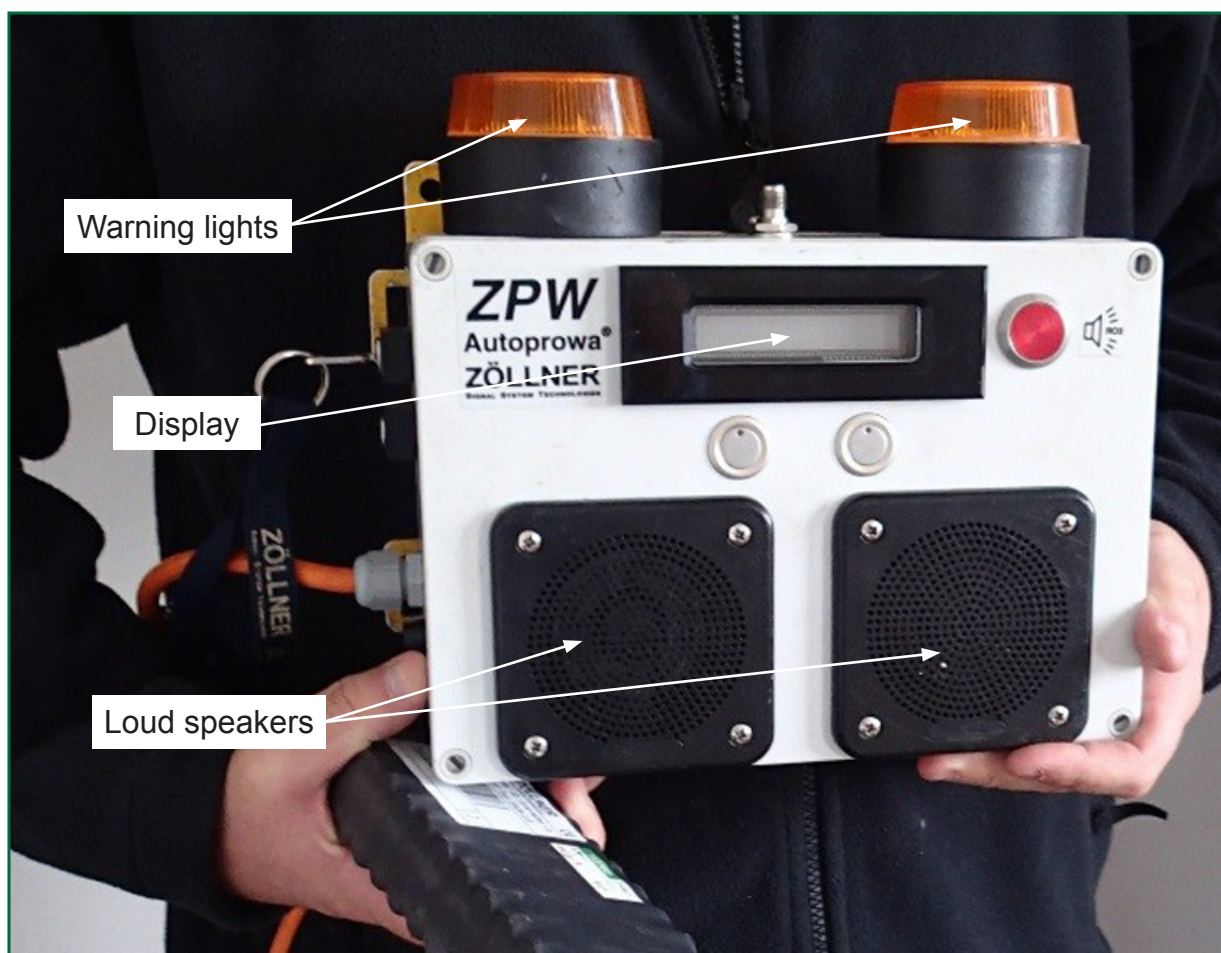
Figure 5: ZPW control unit with external battery

- 17 Each Zöllner ZPW-LOWS set comprised a ZPW control unit incorporating a radio receiver (figure 5) and up to four ZFH lookout operated transmitters (figure 6) equipped with booster aerials, spare batteries and harnesses. The set included a paper log book to record usage, routine testing and faults. The radio system fitted to ZPW-LOWS version 1 equipment is uni-directional, so cannot transmit messages from the ZPW control unit to the lookout's ZFH transmitter. Each set of Zöllner equipment is therefore supplied with dedicated mobile phones which allows communication between the site of work and the lookouts³. The ZPW control unit has an internal data logger which records incoming warnings and system error messages. The ZFH transmitter units do not contain a data logger.
