# Rail Accident Report

**Fatal accident involving a track worker near  
Newark North Gate station  
22 January 2014**

Report 01/2015  
February 2015

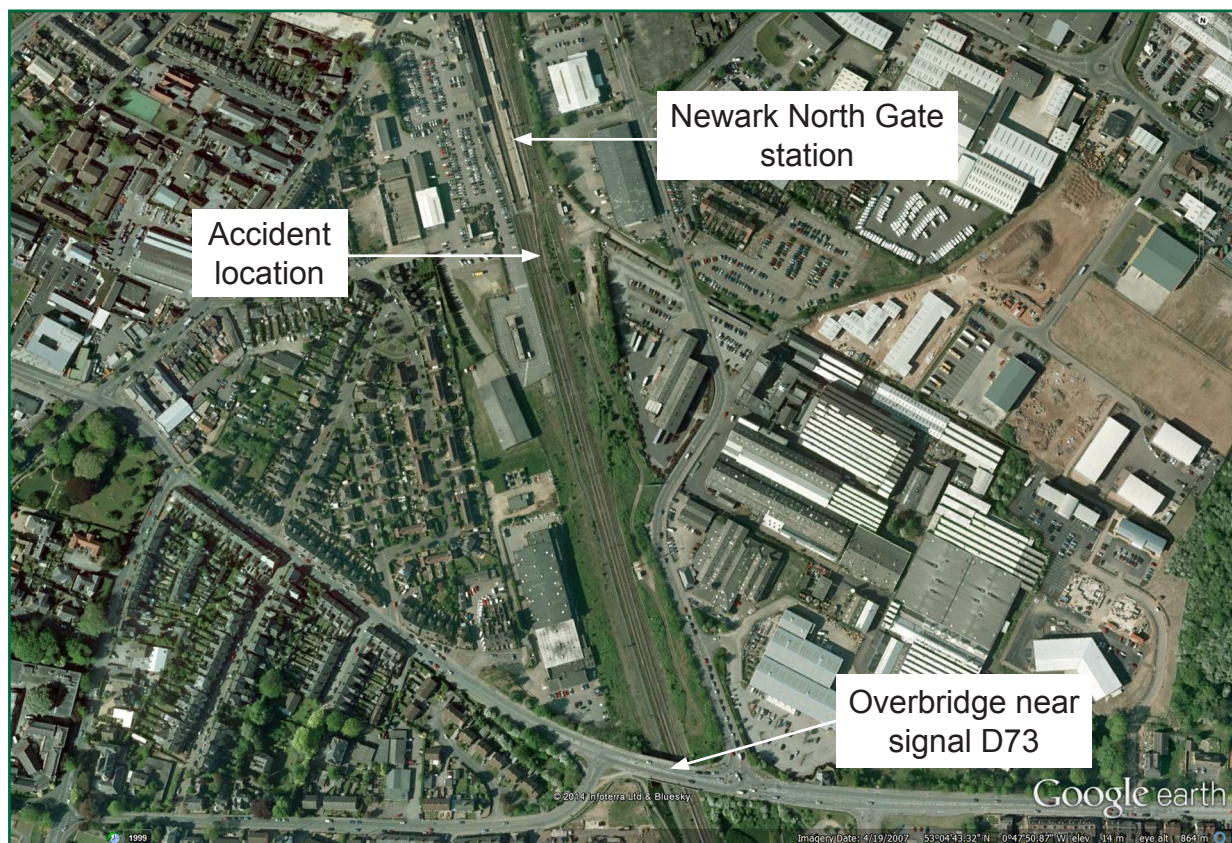
Figure 2: Google earth image of the accident site

- 31 At 11:33:45 hrs (around 28 seconds before the collision), train 1B82 drew up to the *overbridge* at the southern end of the site (figure 2). The driver had reduced the train's speed to 26 mph (42 km/h) in preparation for running over the two crossovers on the approach into platform 3.
