Rail Accident Report

Derailment at Washwood Heath West Junction, Birmingham 23 March 2015

Report 01/2016
January 2016

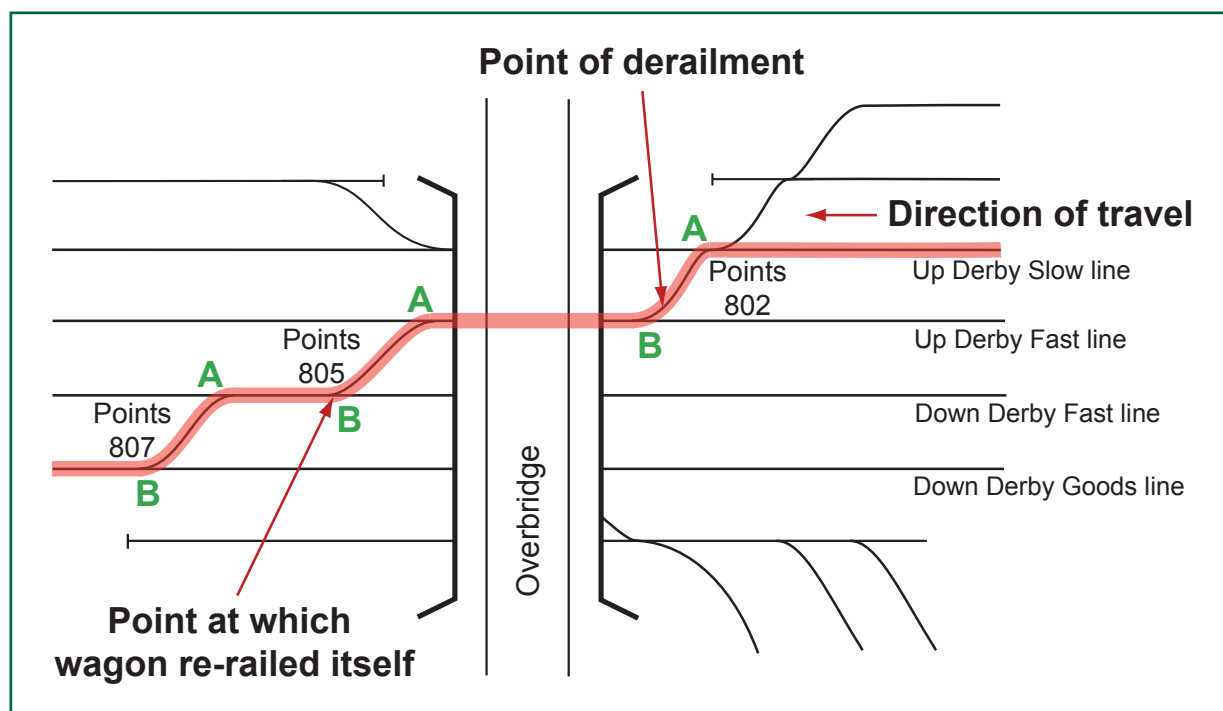
Figure 3: Track layout at Washwood Heath West

- 9 The train was crossing to the Down Derby Goods line via a series of crossovers, made up of points 802, 805 and 807, when the derailment occurred. Each of these crossovers consists of two points which operate together and have a suffix A or B to distinguish each end (figure 3). The derailment occurred as the wagon was running through 802B points.

- 11 As is normal for a crossover between two parallel tracks, crossover 802 included a *reverse curve*. The manufacturer's drawing showed that the minimum radius was 227 metres on the left-hand curve through 802A points and 286 metres on the right-hand curve through 802B points.

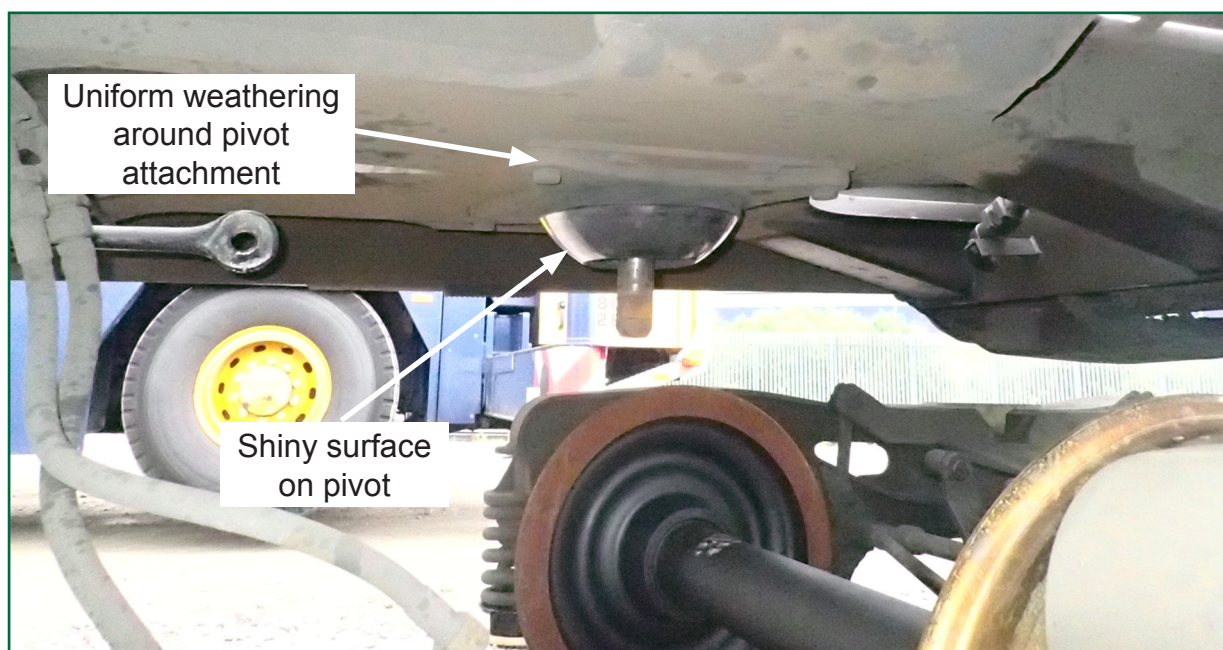
Figure 10: Centre pivot of another Megafret wagon

68 The wagon body was lifted from its bogies under RAIB supervision at Lawley Street Freightliner terminal. The centre pivot liners of all four bogies of the wagon were found to be worn to the extent that the steel centre pivot on the wagon body was in contact with the steel casting on the bogie. These plastic centre pivot liners are intended to prevent direct contact between the centre pivot on the body and the casting on the bogie. This is because the friction involved in direct steel to steel contact is much higher than the intended level of friction between the polished steel surface and the plastic liner. This increased frictional resistance would have prevented the bogies from rotating freely in curves. Figure 10 shows the centre pivot of another Megafret wagon whose liners had not worn so as to cause steel to steel contact. Figure 11 shows the centre pivot of the bogie which derailed.

69 The AAE TSO specified that the wear of the liner be assessed by measuring its thickness using a special gauge placed across the centre pivot bowl. AAE stated, however, that other methods of checking the wear were acceptable provided that the liner projected above the steel bowl by a minimum of 2 mm at the bottom of the bowl and 1 mm at the top.

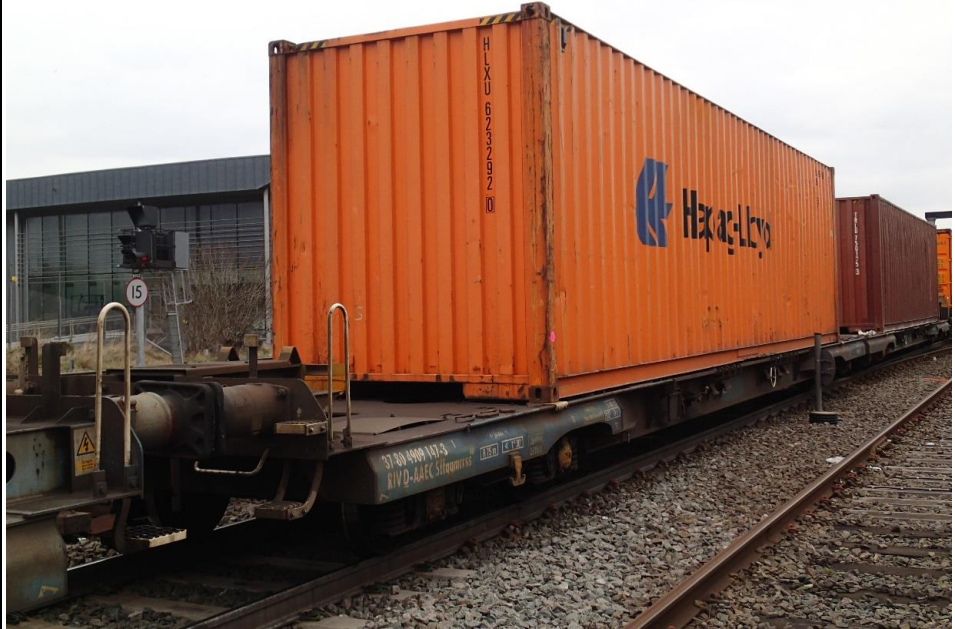
1. INCIDENT DESCRIPTION			
LEAD / INSPECTOR		CONTACT TEL. No.	
INCIDENT REPORT No	0776	DATE OF INCIDENT	23 March 2015
INCIDENT NAME	Derailment at Washwood Heath West		
TYPE OF INCIDENT	Freight train derailment		
INCIDENT DESCRIPTION	<p>At 08:03 hrs on 23 March 2015, the failure of signalling equipment in the vicinity of Washwood Heath West Junction, Birmingham, following the passage of train 4O14, alerted the Network Rail signaller to a possible problem with that train. It was subsequently discovered that the train had derailed and then re-railed when crossing from the Up Derby Slow line to the Down Derby Fast line. The train was brought to a stand at Landor Street Junction at 08:10 hrs and the driver was asked to examine the train. He found evidence that the 10th wagon on the train had run derailed.</p> <p>Train 4O14 was the 05:58 hrs Basford Hall (Crewe) to Southampton container service. It consisted of a Class 66 locomotive pulling a mix of 24 container wagons and had been travelling at 15 mph while negotiating a series of crossovers. The wagon that derailed was an IKA 'Megafret' wagon (8049091473), consisting of two flat wagons permanently coupled together. Examination of the track confirmed that the train had run derailed for a distance of 121 metres, before re-railing at a set of trailing points. The derailment caused significant damage to track and signalling equipment. No-one was injured.</p>

<p>Figure 1: The wagon involved.</p>
