Rail Accident Report

Collision at Frognal Farm User Worked Crossing 23 October 2017

Report 12/2018
August 2018

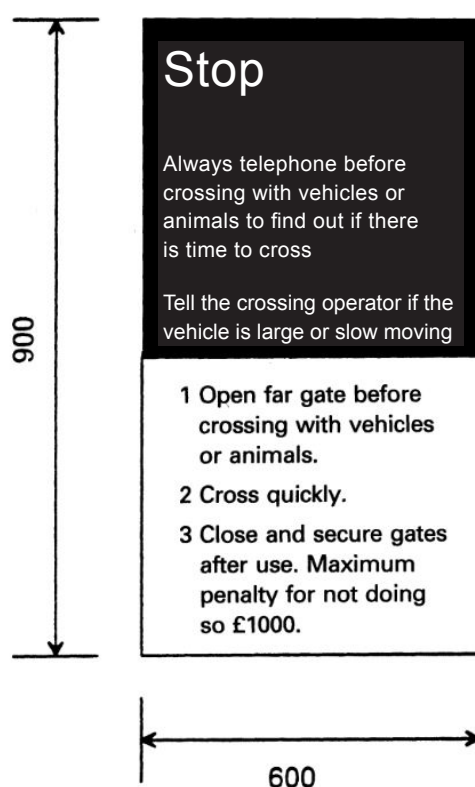
92 **The signage was not clear, contained conflicting information and did not convey the most important action required to the crossing user.**

93 The Private Crossings (Signs and Barriers) Regulations 1996⁶ prescribe the signs to be used at a user worked crossing with and without telephones. POGO equipment had not been invented when these regulations were made, and so the sign that should be used at a crossing with telephones, shown at diagram 103 in the regulations (figure 6) does not explain how to use a POGO crossing. There are currently no appropriate signs in the regulations for crossings with new technology such as POGO equipment, and the signs used at Frognal Farm and other POGO crossings were designed by Network Rail for use in conjunction with other, legally specified, signs.
