# Rail Accident Report

**Freight train derailment at Lewisham,  
south-east London  
24 January 2017**

Report 04/2018  
February 2018

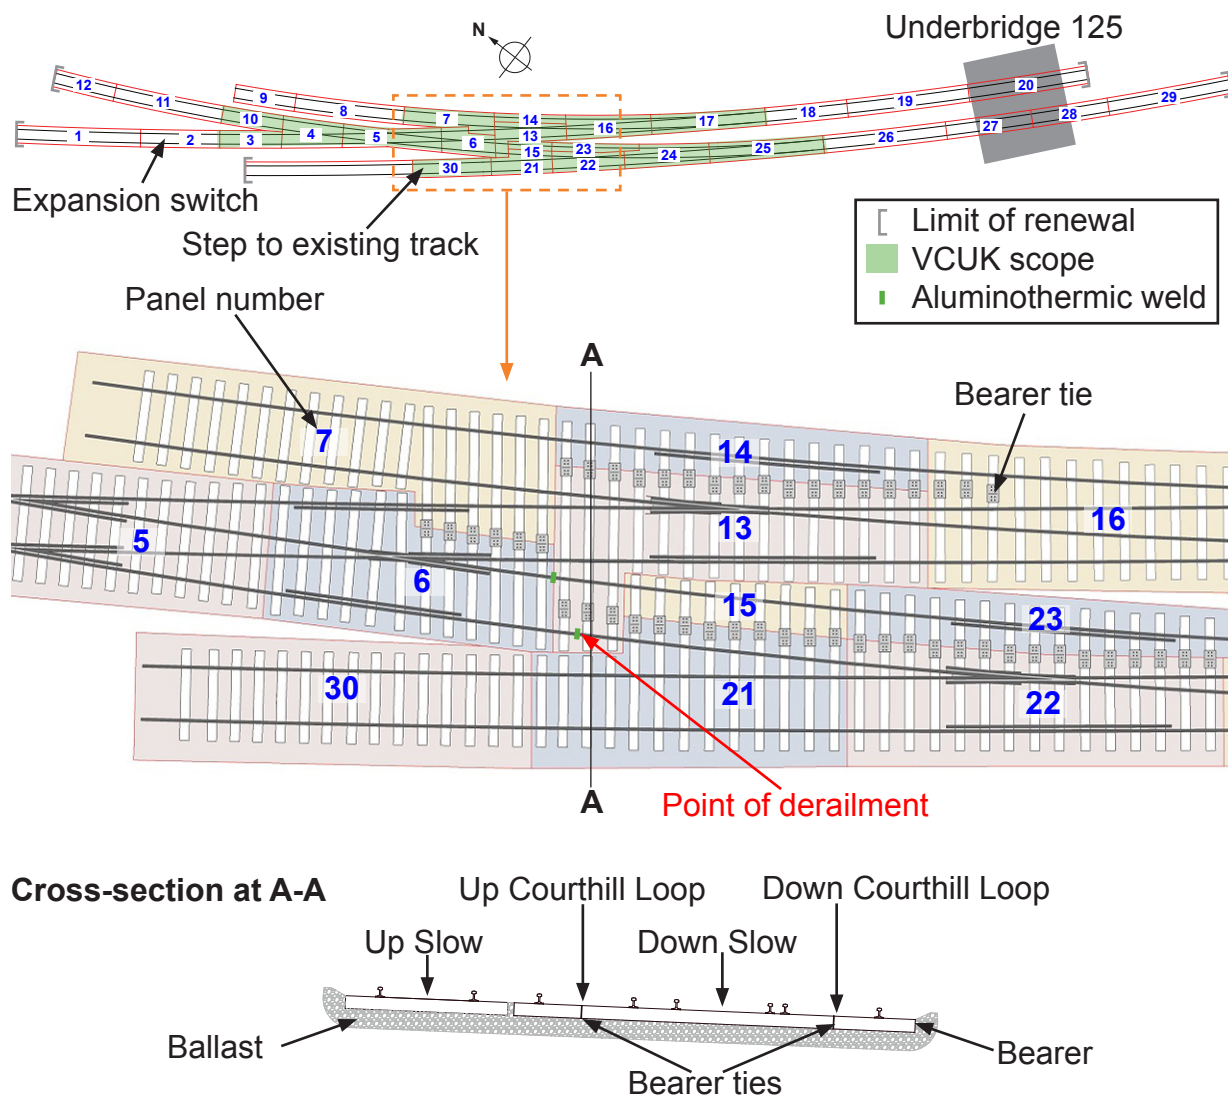
Figure 6: The new track layout at Courthill Loop South Junction

- 24 Figure 6 is a diagram of the new track layout showing the limits of the renewal, the way it was subdivided into (modular) S&C panels and the main elements that VCUK supplied. It includes a cross-section through the layout close to where the derailment occurred showing the common concrete bearer that supported the rails on the Up Courthill Loop, the Down Slow and the Down Courthill Loop lines and the concrete bearer that supported the rails on the Up Slow line.

- 106 The bearer closest to the point of derailment supports three lines. It has a bearer tie in the four-foot of the Up Courthill Loop line as well as in the four-foot of the Down Courthill Loop line. The bearer section supporting the Down Slow line is continuous in between (figure 6). The RAIB analysed the track measurement trolley recordings made during the follow-up work (paragraph 35) and the void measurements and track measurement trolley recordings made after the derailment (paragraph 47). With reference to figure 19, it found that, at the time of the follow-up work, the cant on the individual lines on the bearer varied: the static cant on the Up Courthill Loop line was less than that on the Down Slow line (in the middle of the bearer), and the static cant on the Down Courthill Loop line was more. The different amount of cant on each line is explained by the fact that the bearer ties were acting as hinges, which allowed the bearer sections to rotate relative to one another. By the time of the derailment, the static cant on the Up Courthill Loop line had reduced considerably further. The dynamic cant was even less, evidencing how vulnerable the short bearer section under the left-hand rail was to inadequate track bed support.
