Rail Accident Report

**Near miss between a train and a track worker at
Shawford
24 June 2016**

Report 05/2017
March 2017

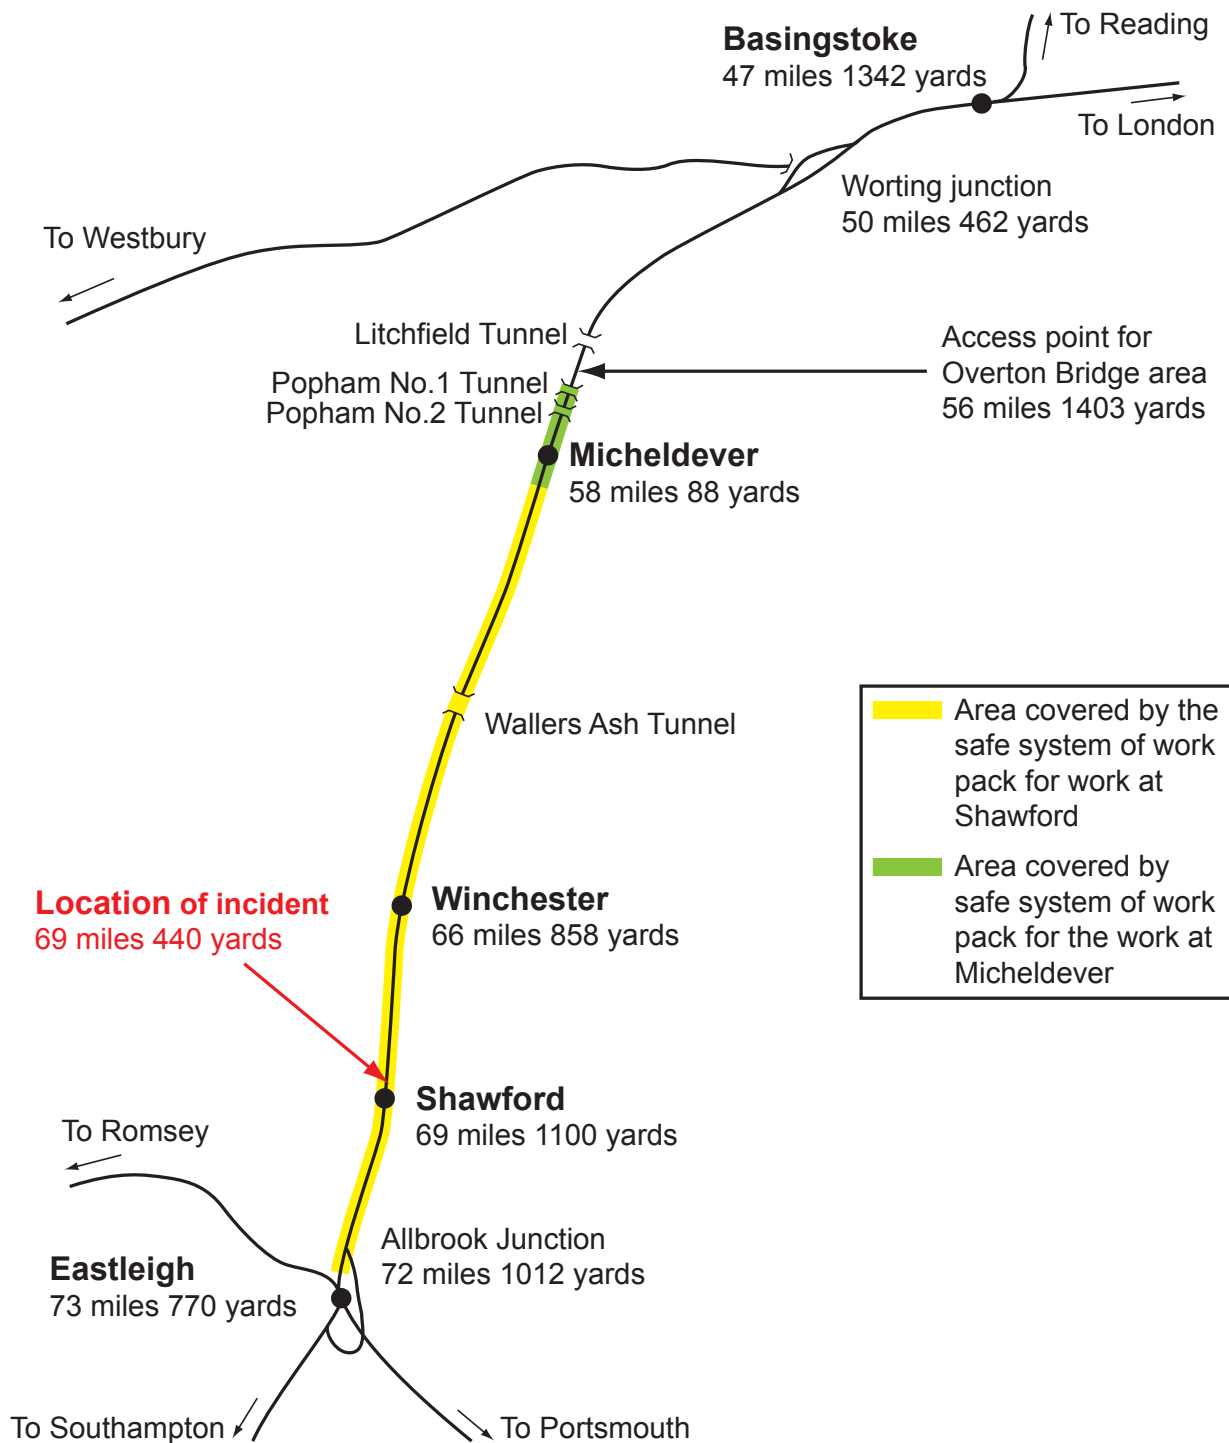
Figure 2: Overview of the key locations

- 5 The incident occurred to the north of Shawford station on the *down fast* line between Winchester and Eastleigh (figure 2), at about 69 miles 440 yards (from a zero datum at London Waterloo station). The line is part of Network Rail's *Wessex Route* and at this location the railway comprises three tracks: the *up main*, down fast and down slow lines (figure 3).

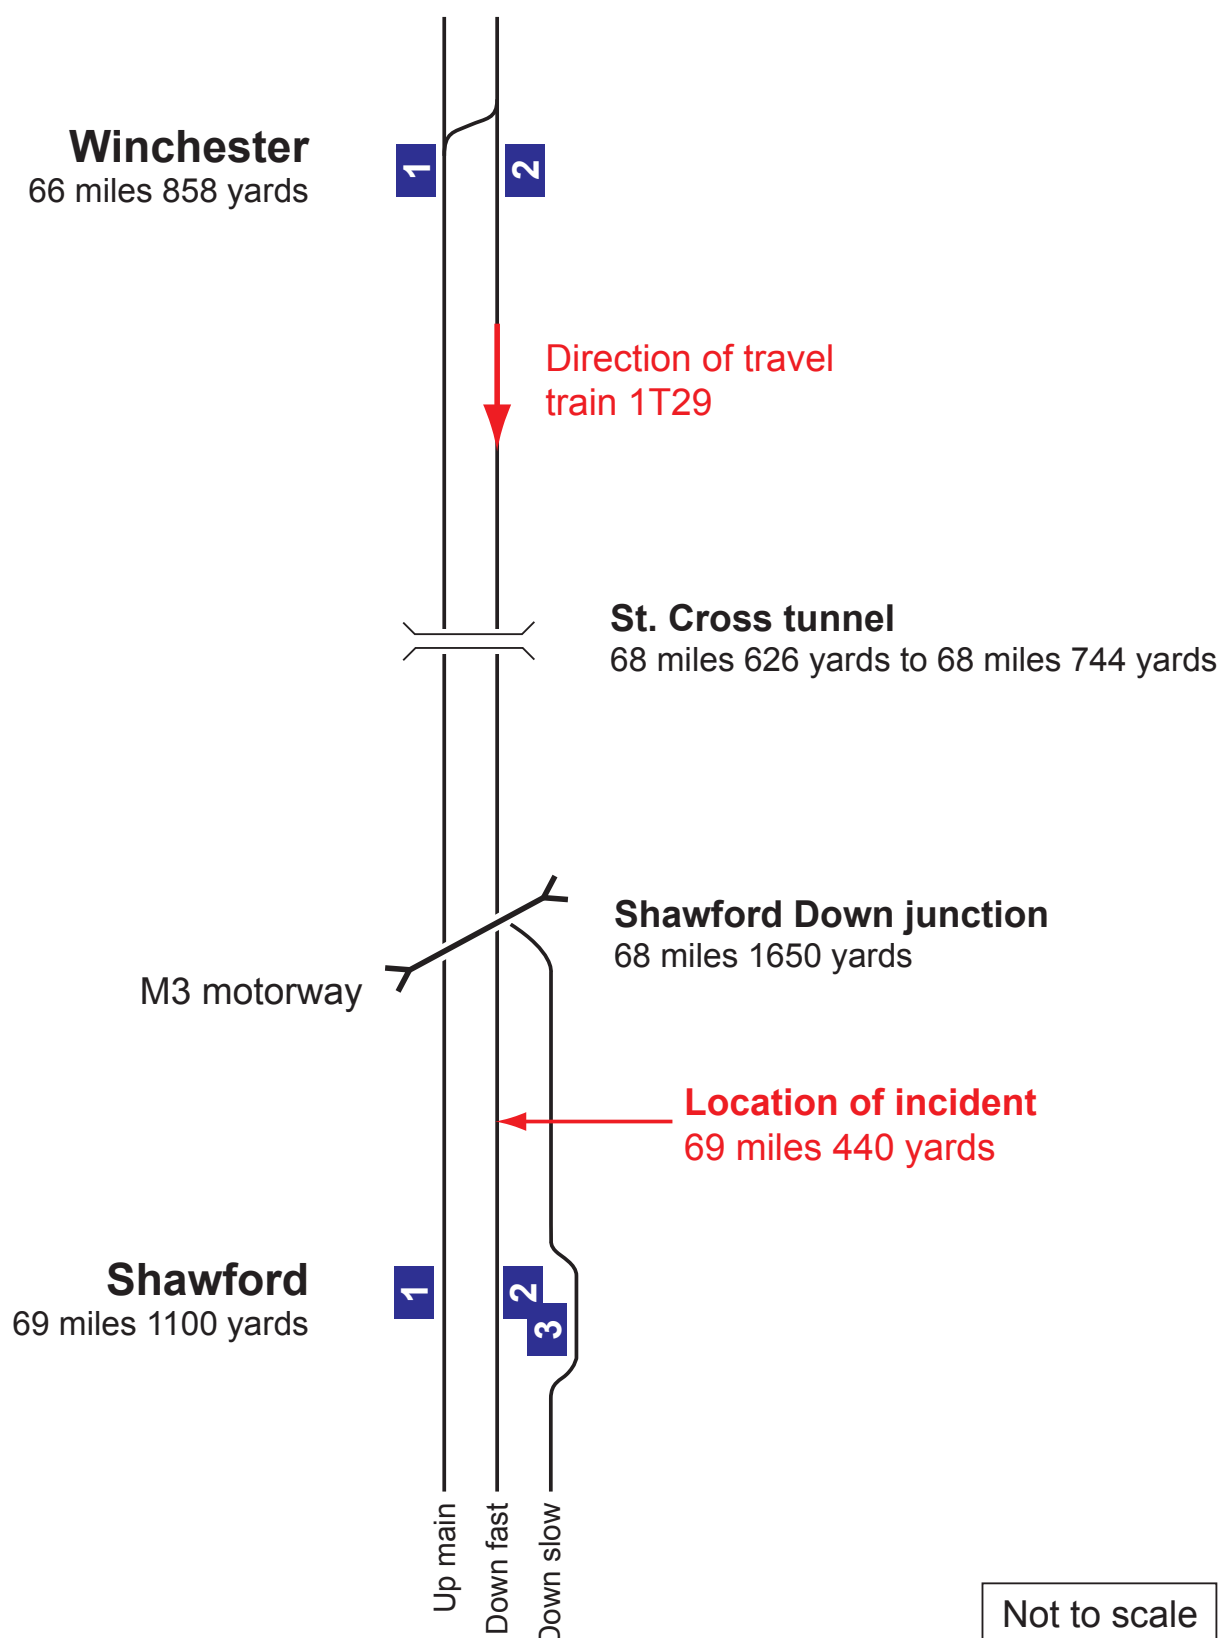
Figure 3: The track layout at Shawford

- 25 Just as the track worker stepped into the down fast line, the handheld GPS unit beeped. The track worker stopped to look at it. At this time train 1T29 was approaching on the down fast line at about 85 mph (137 km/h). As the train passed Shawford Down junction (figure 3), the driver saw the track worker and sounded the train's horn. The track worker did not acknowledge the warning (normally done by raising an arm) or begin to move, so the driver used the train's horn to give an urgent warning (a series of short, sharp blasts) and made an *emergency brake application*.

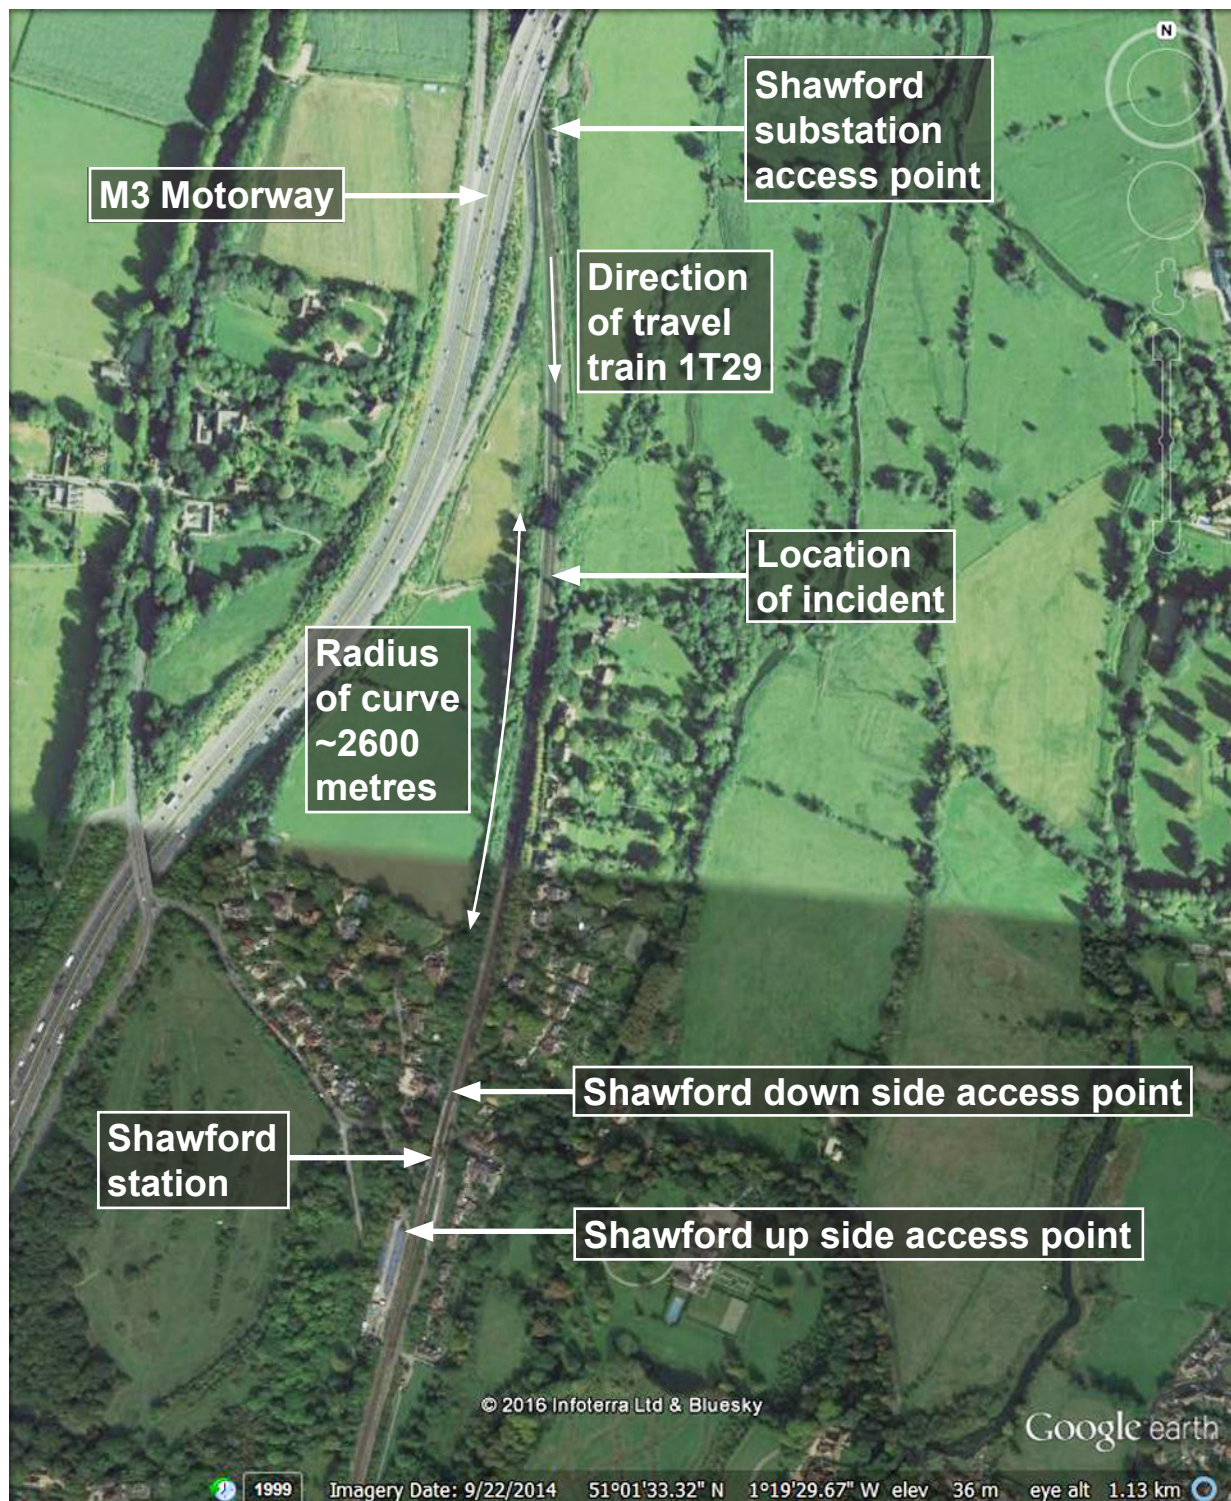
Figure 4: Google Earth view of incident site

- 7 The incident occurred on a right-hand curve (in the train's direction of travel) of about 2600 metres radius (figure 4) and on a falling gradient of 1 in 258 (0.39%). Signalling in the area is controlled from the Eastleigh Area signalling centre. *Third rail electrification* is present throughout.

- 77 Just after passing over Shawford Down junction, the driver saw the track worker and sounded the train's horn. At this point the driver was not sure exactly which line the track worker was standing on due to the track's curvature (figure 4). As the train got closer, the driver realised the track worker was standing on his line so he gave an urgent warning on the train's horn (paragraph 25) and made an emergency brake application. It was this urgent warning that caught the track worker's attention (paragraph 26) and gave the track worker just enough time to move clear.
