## **Derailment of an empty passenger train at Paddington station 25 May 2014**

Report 03/2015  
April 2015

# **Derailment of an empty passenger train at Paddington station, 25 May 2014**

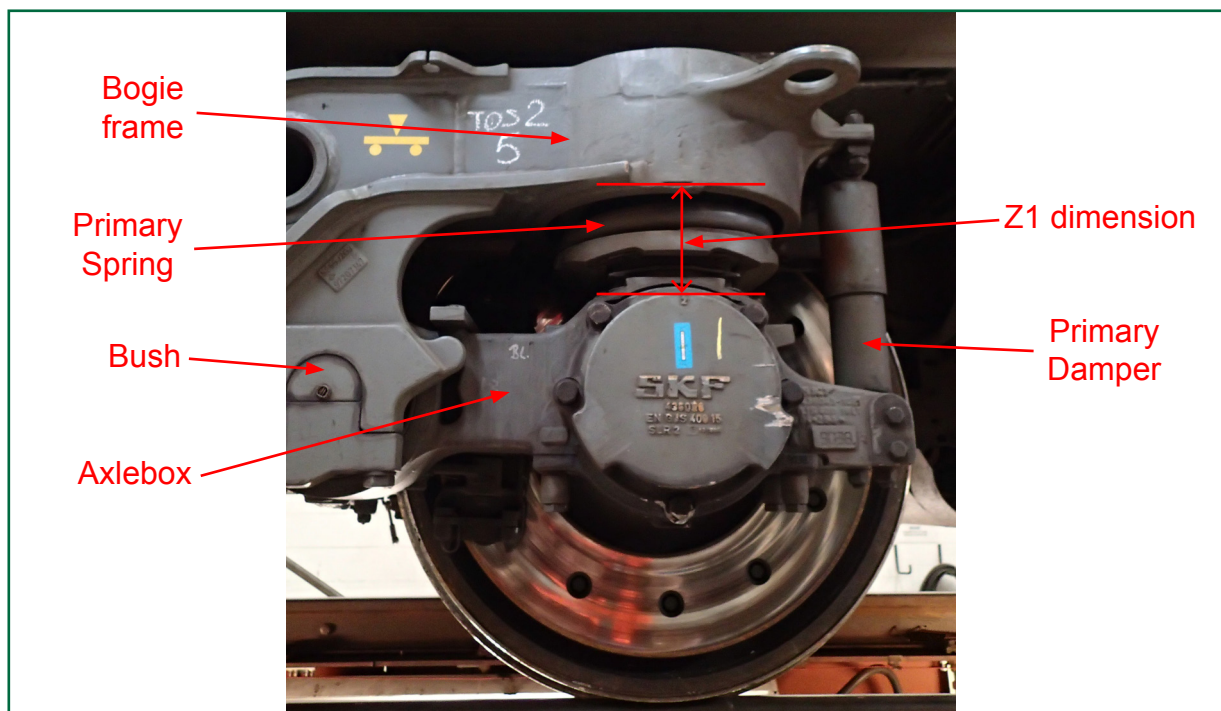
Figure 6: Primary suspension (SF5000 bogie)

- the Z1 dimensions (figure 6) were high on the left-hand side (150 mm instead of the nominal 141 mm) and low on the right-hand side (130 mm instead of 141 mm) of the leading bogie and the opposite way round on the trailing bogie.

- 85 The investigation established that there is a strong link between uneven wheel loads and the distance between the axleboxes and the bogie frame (the Z1 dimension, see figure 6). This was confirmed on the TOS2 vehicle when these dimensions were measured after the derailment. The measurements showed that on one side of the bogies, the Z1 dimensions were significantly lower than the expected value (130 mm instead of 141 mm) whereas the measurements were significantly higher on the other side (150 mm instead of 141 mm). In comparison, the carbody was only showing an apparent twist of 2-3 mm at the same time which was probably lost in the inaccuracy of the measuring technique of the ride heights.

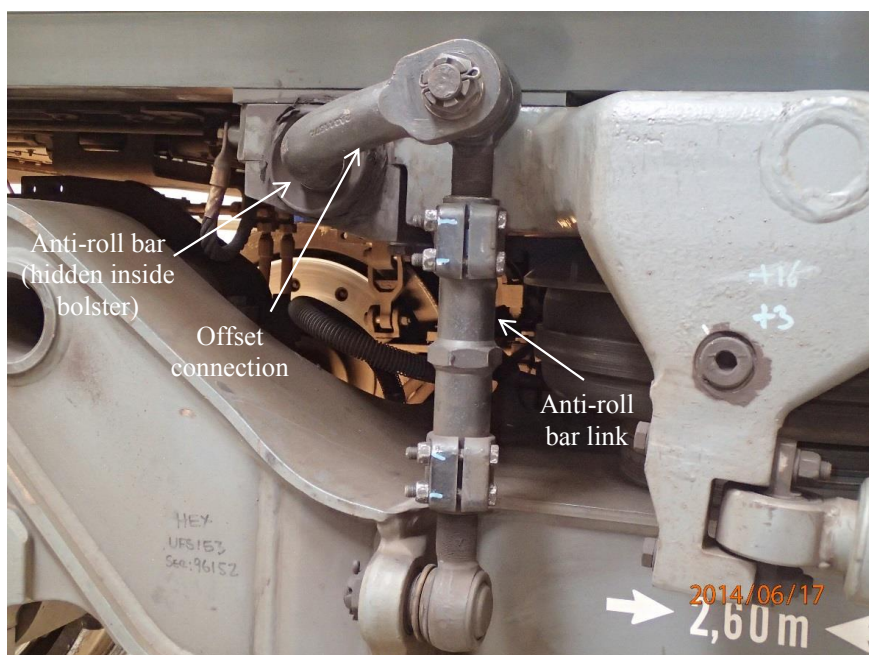
Figure 2 Anti-roll bar system

2. URGENT SAFETY ADVICE	
USA DATE:	18/06/2014
TITLE:	Setup of SF5000 bogies and other bogies with similar suspension arrangements
SYSTEM / EQUIPMENT:	Bogie, anti-roll bar
SAFETY ISSUE DESCRIPTION:	<p>Class 360/2 trains are fitted with SF5000 bogies. These bogies have anti-roll bars to react any dynamic roll in the body as a vehicle travels along the track. On each bogie, the anti-roll bar sits inside the bolster and is fitted with an offset connection at both ends (see figure 2). As the body rolls, the offset connection loads the bar inside the bolster in torsion which transfers loads from the body to the bogie frame.</p> <p>On flat and level track, the anti-roll bars should be set so as not to carry any load. This is checked by the maintainer post-tyre turning or after wheelset replacement as part of Siemens' procedure for setting the vehicle ride height (Maintenance Procedure No. UOP001). The procedure describes the actions needed if the anti-roll bars are found to be under load after setting the correct body height following tyre turning or wheelset replacement. This involves adjusting the length of the links connecting the anti-roll bar to the bogie frame. The procedure also states that the operator should ensure that the links are set to the same length on either side of the bogie.</p> <p>If the links have been set incorrectly and are of different length, it is possible for the anti-roll bars to permanently carry a load even on flat and level track. This load in the anti-roll bar system will result in the vehicle body loading the bogie frame in a manner which will lead to an uneven wheel load distribution.</p>
