Rail Accident Report

Derailment at Godmersham, Kent 26 July 2015

Report 05/2016
April 2016

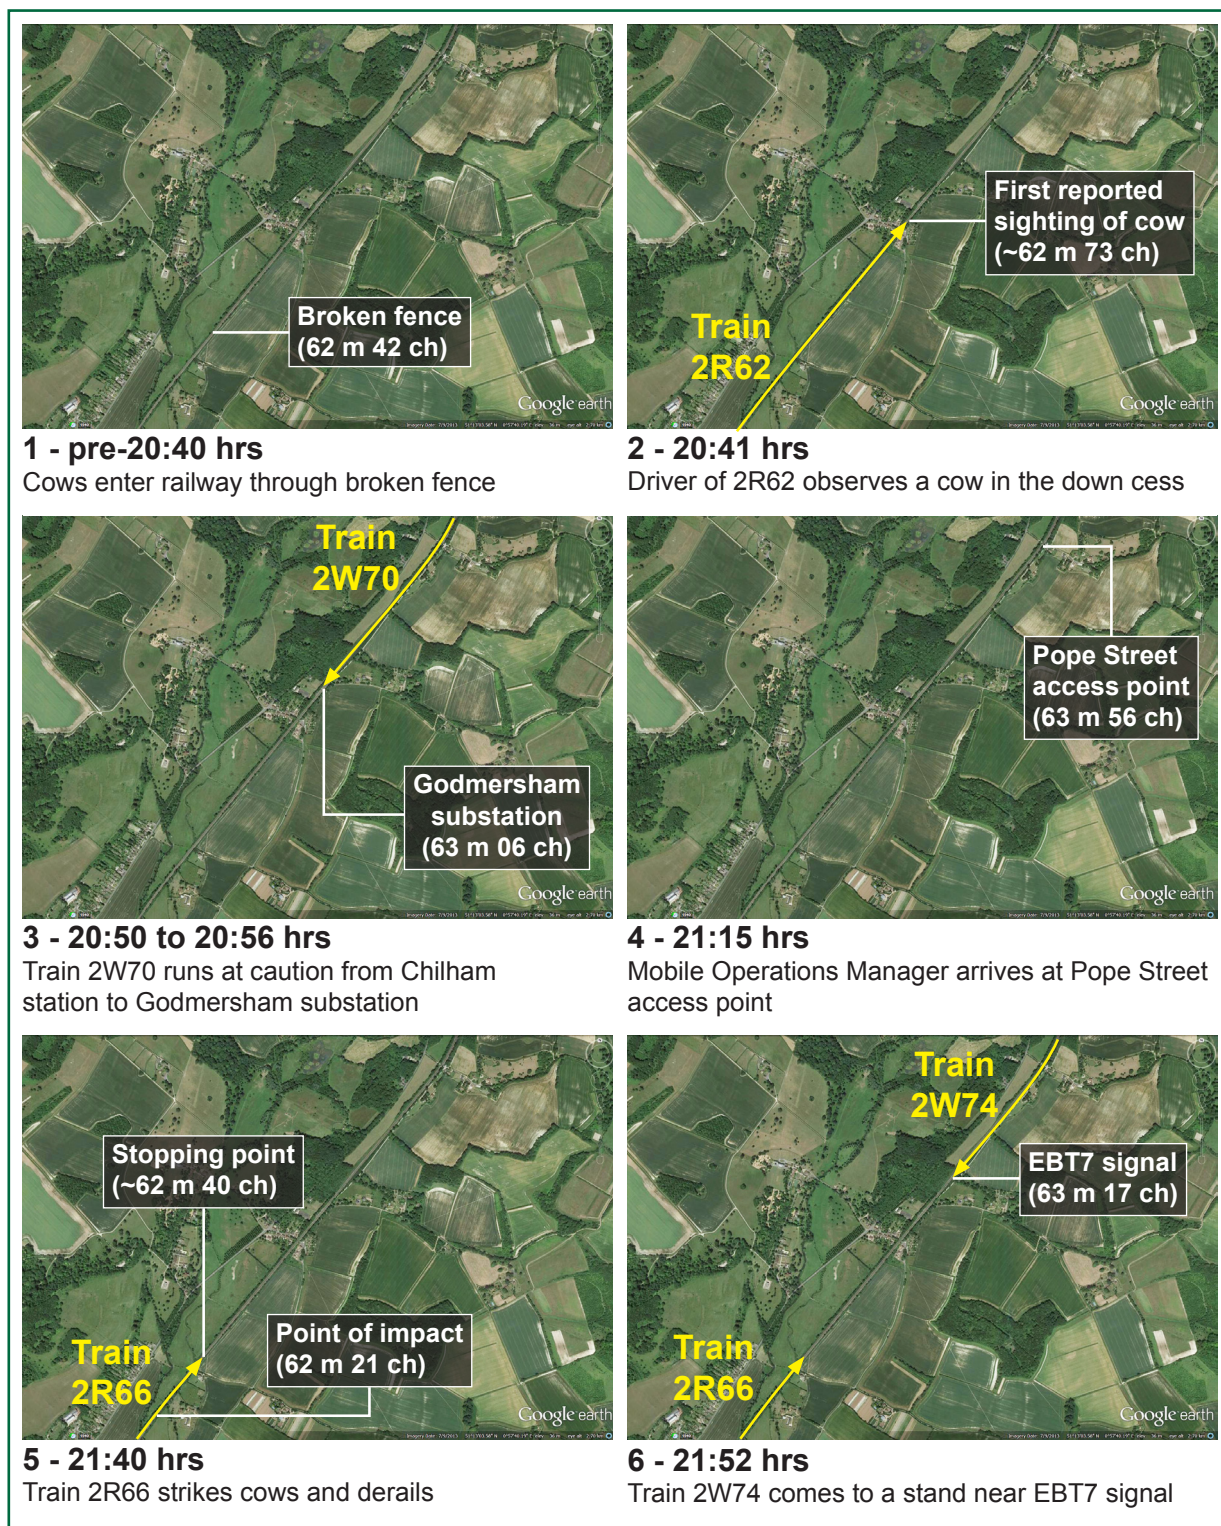
Figure 4: Google Earth view of the accident vicinity showing key locations referred to in this report (with track locations in miles and chains where relevant)

- 8 The point of first impact was approximately 28 metres past the 62¼ milepost and the train came to a stand around seven metres before reaching the 62½ milepost. The first evidence of derailment was found about 29 metres after the impact point. The cows had breached the boundary fence about 40 metres beyond the train's stopping point, some 400 metres from the point of impact, and there was evidence that they had wandered up and down the cess for some distance. These, and other key locations referred to in this report, are represented in figure 4.

- 20 At 20:41 hrs, the driver of train 2R62 (the 19:10 hrs service from London Charing Cross to Ramsgate) reported to the CWACC signaller that he had seen a cow in the down cess approximately 500 yards on the approach to EBT7 signal (figure 4, image 2). He reported this using the train's *GSM-R* radio system while on the move, soon after seeing the cow.

- 24 Around 21:15 hrs, the MOM stated that he had arrived at Pope Street access point (figure 4, image 4) and started walking towards Godmersham substation using the down cess. He spent around half an hour in the area searching for cows and inspecting the fence line for evidence of any breach, but did not find anything.
