# Rail Accident Report

## **Derailment of a freight train at Stoke Lane Level Crossing, near Nottingham 27 August 2013**

Report 02/2015  
April 2015

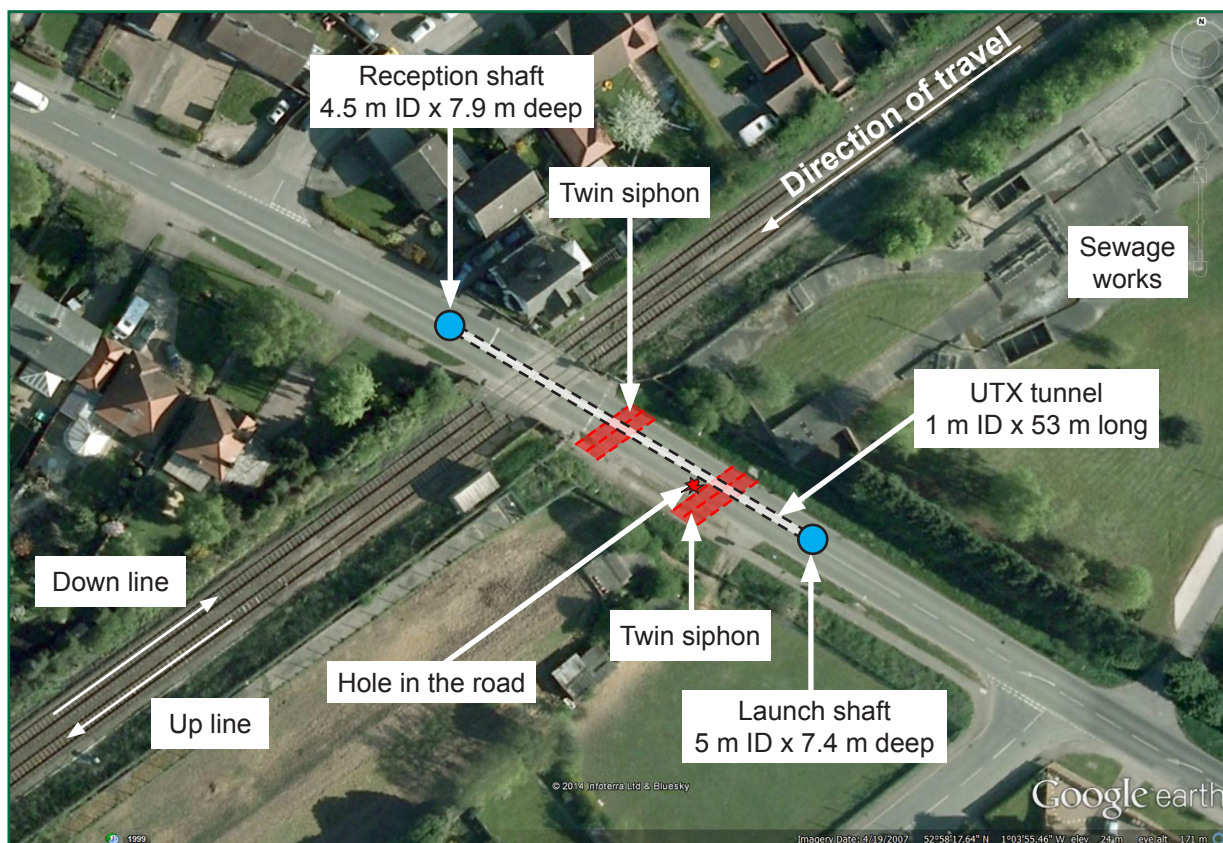
- 11 At this location there is an *under track crossing* (UTX) which had been built under the road and railway, seven weeks prior to the derailment (figure 5). The UTX was built to carry six 132 kV electrical cables along Stoke Lane as part of a larger project to build and connect a new substation on the east side of Nottingham at Stoke Bardolph. The UTX comprises a *microtunnel* around 53 metres long with an internal diameter of 1 metre and an external diameter of 1.2 metres. The crown of the tunnel lies at a depth of around 5.7 metres below ground level.

Figure 5: Google image of the level crossing, with microtunnel and construction shafts marked

- 37 On 8 August, Bridgeway Consulting staff found a hole in the road located at one end of the trial excavation (paragraph 29) over the twin siphon closest to the launch shaft (figure 8). The position of the hole in relation to the siphons is shown in figure 5. On closer examination, the Bridgeway Consulting staff found the hole had loose material inside it which appeared to come from the reinstated road sub-base material and that there was a void below the surface which sloped downwards and toward the centre line of the road. Bridgeway Consulting called a site meeting the same day with representatives from Morgan Sindall Utilities and Nottinghamshire County Council, to examine the hole and determine the likely cause of the defect. The opinion of the two contractors' representatives at the meeting was that the hole had originated at the trial excavation due to inadequate reinstatement of the excavation and that both the hole and the void were not linked to the tunnelling activity. Nottinghamshire County Council's representative was uncertain as to the cause of the hole and subsequently sought further views from the involved parties. However no party accepted responsibility and the matter was unresolved when the derailment occurred. Severn Trent Water and F&B Tunnelling Solutions were informed of the hole. Network Rail was not informed and remained unaware of the hole until after the derailment.

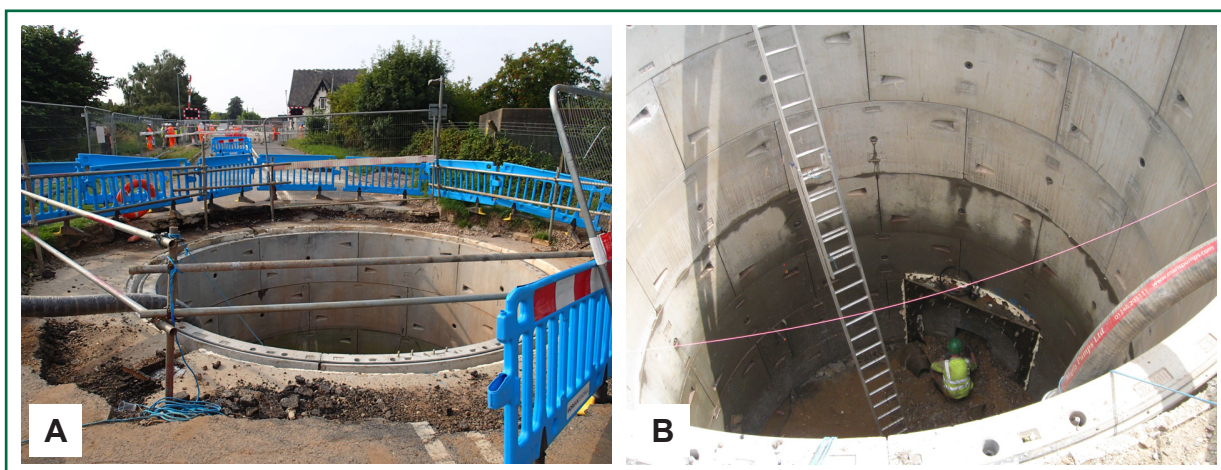
- 12 The microtunnel was bored by a *slurry shield tunnel boring machine* (TBM) (appendix D) and lined with 2.5 metre long concrete pipes (called *jacking pipes*), locked together end to end. In order to bore the microtunnel, two vertical shafts had to be built first. The launch shaft was built at the south eastern end of the tunnel and used to insert the TBM into position and then drive it and the jacking pipes forwards, along the path of the tunnel. At the north western end, the reception shaft was used to retrieve the TBM. These shafts (figure 6) are also the entry and exit points for the 132 kV electrical cables. A cross section along the centre line of the road showing the position of the microtunnel and shafts in relation to the railway is shown in figure 7.

Figure 6: Launch shaft (a) and reception shaft (b) during the works (image courtesy of Morgan Sindall)

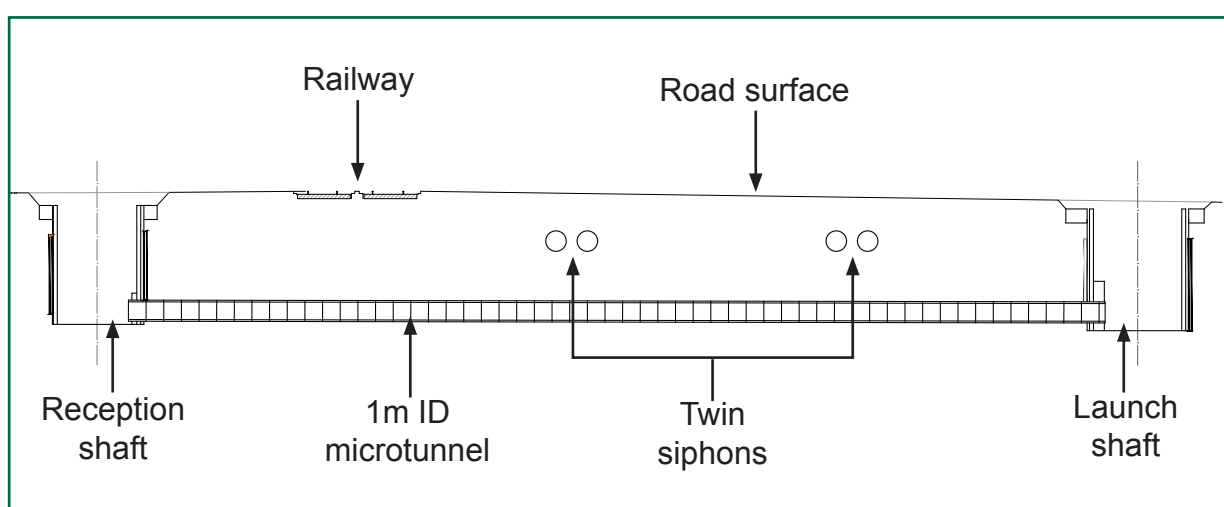
Figure 7: Schematic cross-section through microtunnel and construction shafts

- 13 Between the launch shaft and railway, two twin sewer siphons (figures 5 and 7) run across the road and parallel to the railway and carry sewerage from Nottingham into the Stoke Bardolph sewage works (figure 5). The twin siphons nearest the railway comprise two 1.2 metre diameter cast iron pipes located around 3 metres below ground level and date back to circa 1880. The twin siphons nearest the launch shaft are believed to be cast iron pipes of about 1.3 metres diameter each and encased in concrete. The two twin siphons have a combined flow capacity of around 6 m<sup>3</sup>/sec and their location was a factor in deciding the depth of the microtunnel.

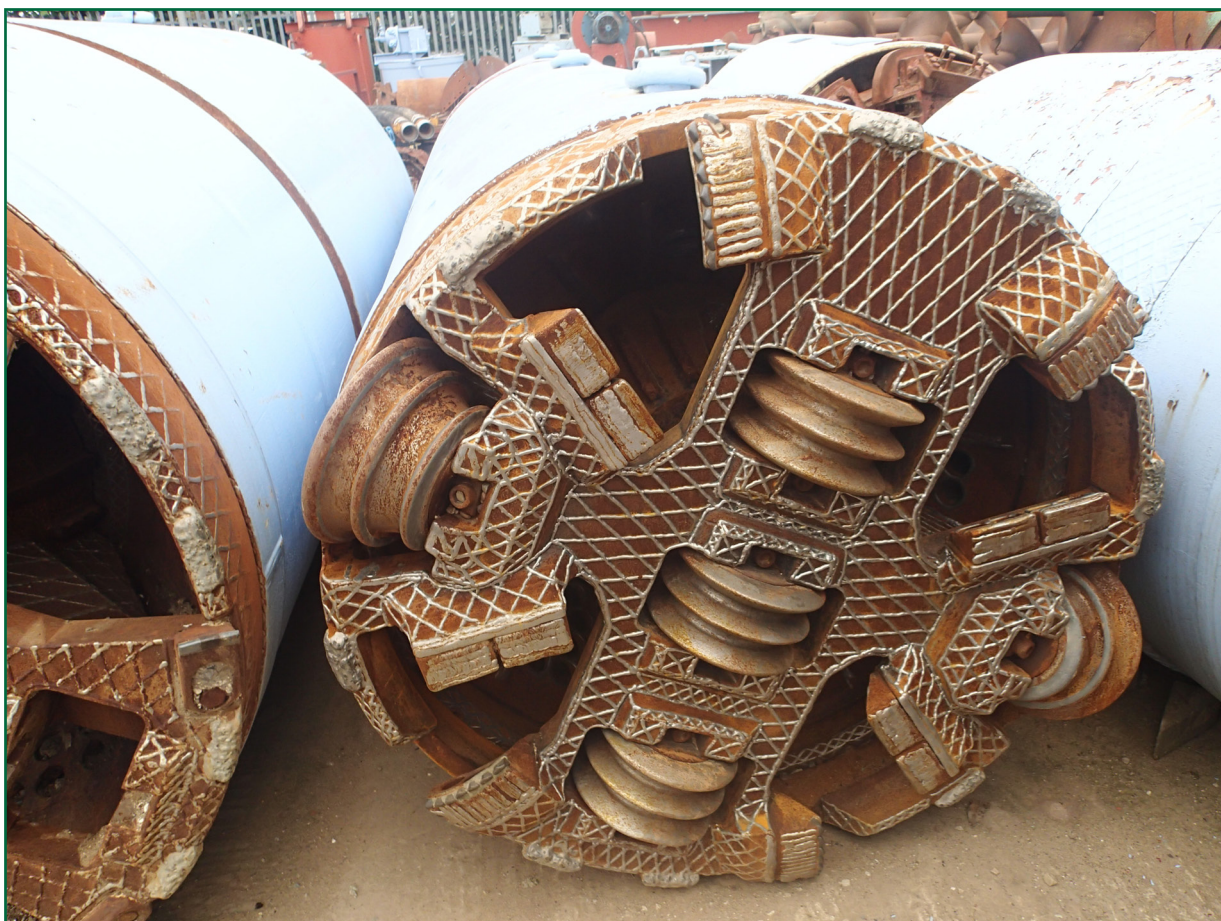
- 54 The UTX at Stoke Lane was bored using a slurry shield tunnel boring machine (TBM), described in appendix D. The minimum amount of material that must have been removed by the 1.25 metre diameter TBM cutter head (figure 10) to bore out a 53 metre long tunnel, is around 65 m<sup>3</sup>. The combined volume of the near surface and deep voids (shown in red and green in figure 9) was around 54 m<sup>3</sup>, which indicates there had been additional ground loss<sup>4</sup> of around 80%. The RAIB was advised by its consultant that a typical upper bound value of ground loss for a tunnel of this type and size would be around 5%.

Figure 10: TBM cutter head

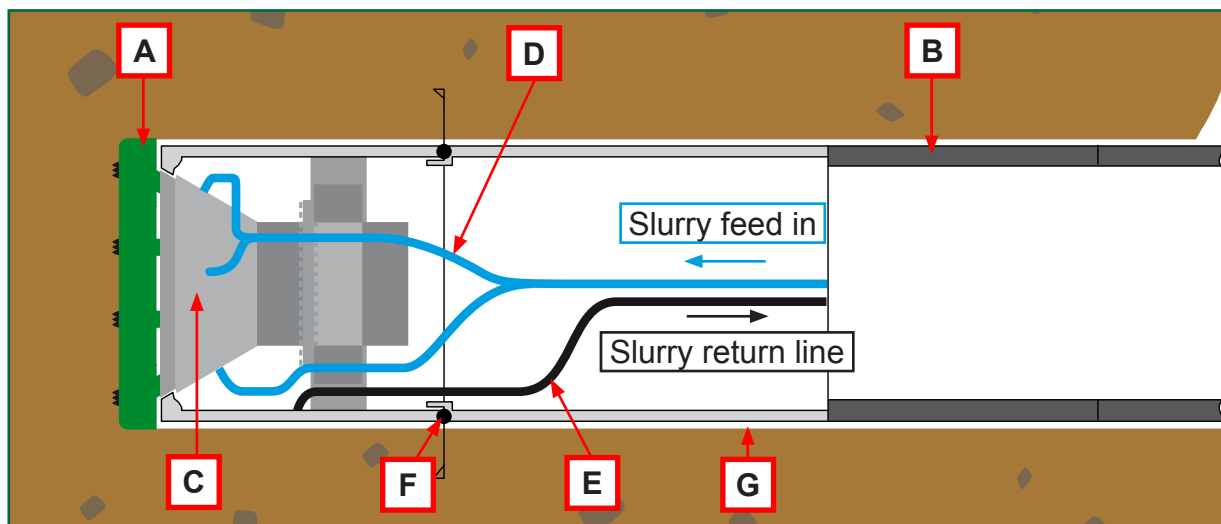
Figure D1: Schematic of a slurry shield TBM

The machine is remotely operated from a control cubicle at the surface. It works by cutting the ground with a rotating cutter head (A), which has rollers, scrapers and teeth, and which is pushed from behind by a series of concrete pipe sections (B). The pipes are pushed along the microtunnel by hydraulic jacks installed in the launch shaft. The process has to be paused periodically to insert a new pipe; at Stoke Lane this was every 2.5 metres. The cut ground falls into the excavation chamber (C) of the TBM. A crushing device (called a 'cone crusher') in the excavation chamber breaks up any large lumps as the cutter head rotates.

If the machine is being used in unstable ground such as wet sands and gravel below the water table, the excavated face must be supported while the TBM is operating, to prevent uncontrolled collapse of the ground into the excavation chamber, potentially leading to overmining. According to industry best practice this is achieved by feeding in a pressurised slurry (D), comprising water mixed with bentonite (or a polymer), into the excavation chamber. The pressure in the excavation chamber (called the face pressure) forces the slurry into the tunnel face in front of the cutter head, where it permeates into the ground, leaving a thin layer of bentonite (called a filter cake) on the surface of the ground. This layer of bentonite impregnated ground supports the areas of the tunnel face which are exposed as the cutter head (figure 10) rotates, while the slurry pressure counterbalances the ground water pressure. For excavation in some types of soil, such as clays, bentonite may not be required. In such cases the slurry may simply comprise water and a proportion of suspended clay material from the excavation face.

The cutter head diameter is slightly larger than the diameter of the main body of the TBM and the pipes and this results in an annular void space around the pipes (G) which, in accordance with industry best practice, should be filled with bentonite to prevent the ground closing in on the pipes.
