# Rail Accident Report

## **Trains struck platform at Moston, Manchester 28 January 2015**

Report 17/2015  
October 2015

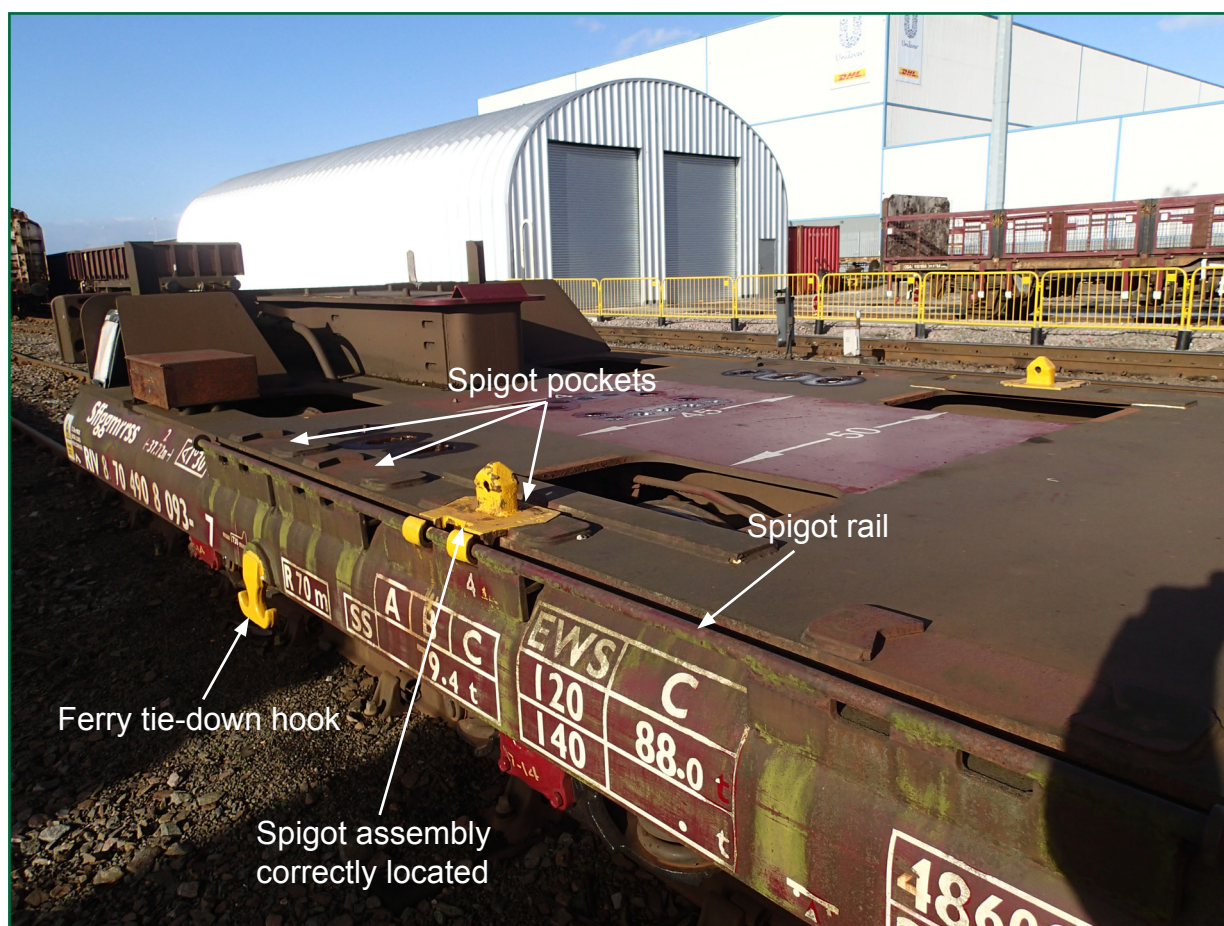
Figure 6: FKA wagon

- 15 **Spigots, left out of their pockets on the FKA wagon that formed part of train 6E33, struck platform supports and dislodged coping stones from the Down platform at Moston.**
- 16 FKA wagons comprise two semi-permanently coupled elements, each intended to carry one container secured by four spigots on the wagon which engage with sockets located at the bottom corners of the container. Each vehicle is therefore provided with four spigots, including two which slide along rods to accommodate containers of varying length. The spigots hinge about the rod allowing them to be rotated into, and out of, pockets on the top surface of the wagon. They can also be rotated outwards so that they rest against the outer side of the wagon in a position where they project outwards, and extend further from the centre of the track than any other part of the wagon (figures 6 and 7).

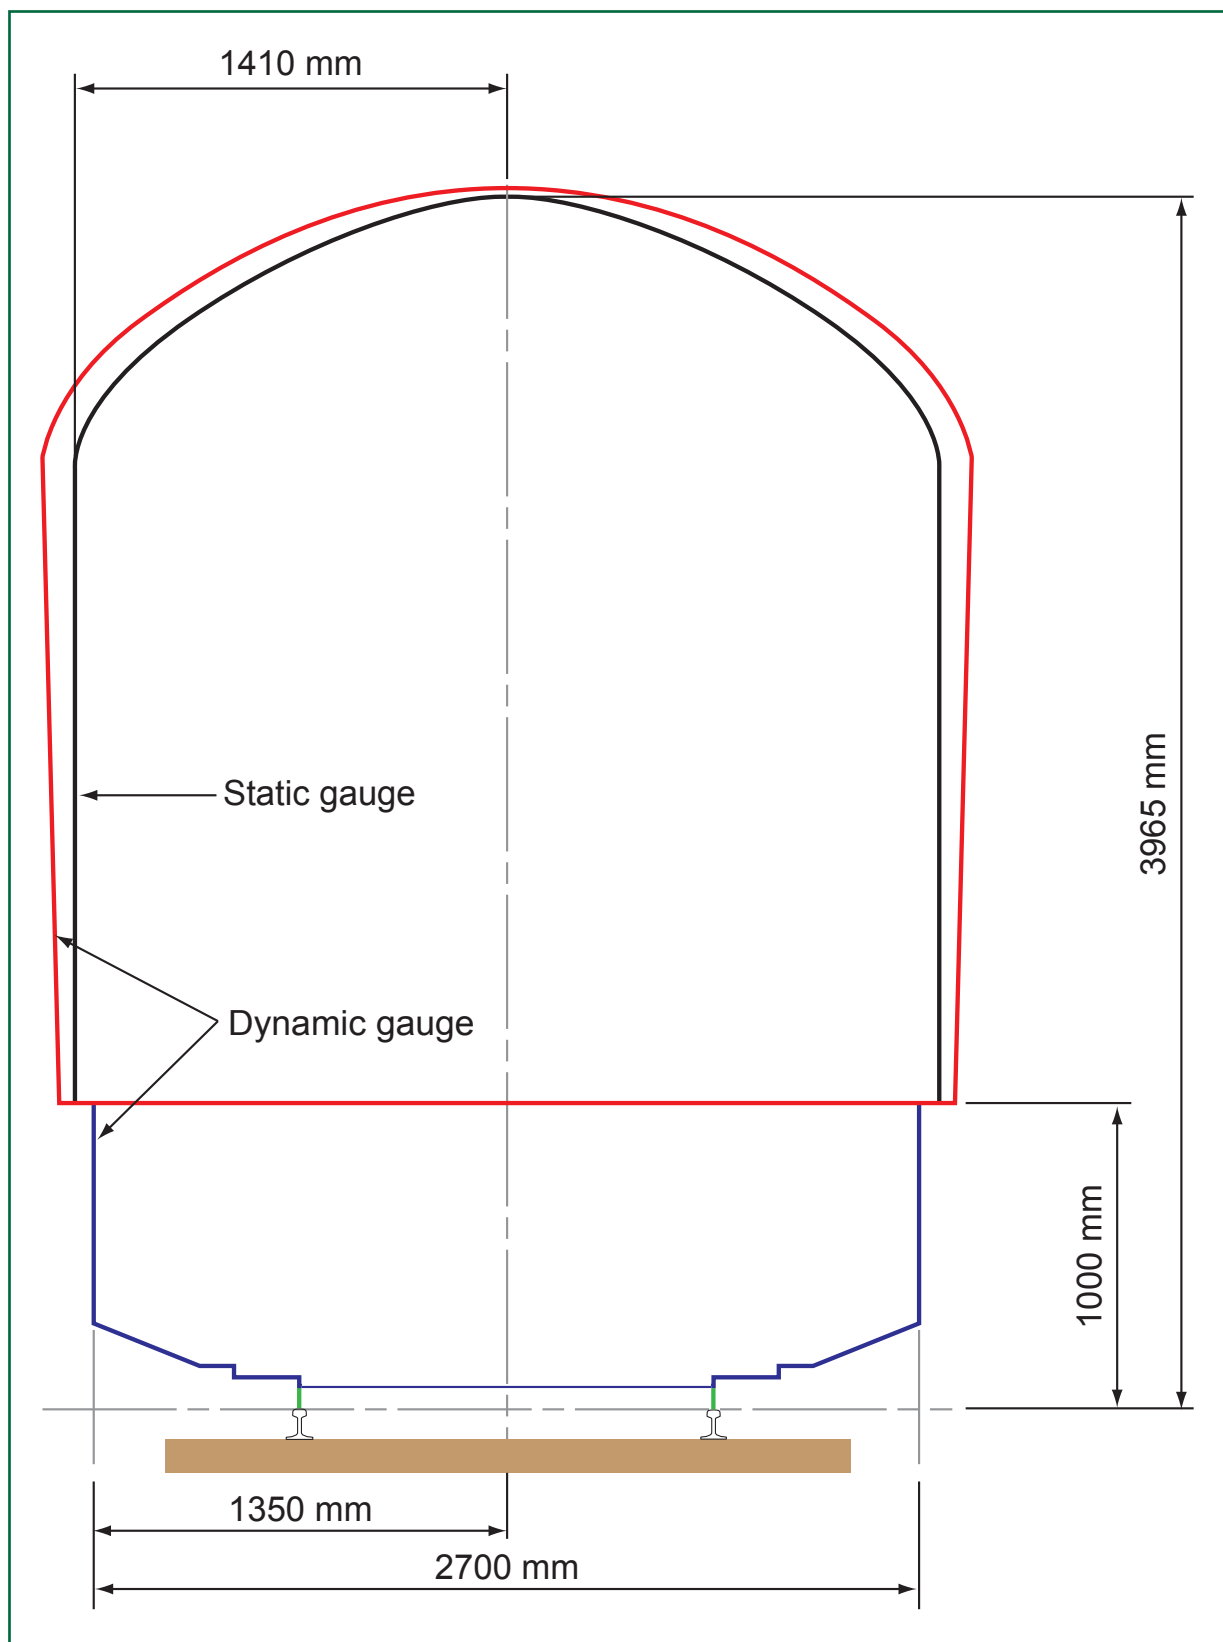
Figure 12: W6a wagon gauge (courtesy RSSB)

21 Freight wagons on the line which passes through Moston station were required to comply with the *W6a wagon gauge* which defines the maximum extent to which wagons may project beyond the track centre-line. Moston platform was about 850 mm above rail level and so the gauge dimensions applying to wagon components within a vertical<sup>3</sup> distance of 1000 mm from the top of the rails, and known as the *lower sector gauge*, are relevant to the accident. Within this vertical distance, W6a is a *dynamic gauge* requiring all parts of a wagon to remain within 1350 mm of the track centre-line when subject to effects, such as sway, which result in lateral movement of the wagon (figure 12). The dynamic gauge excludes some effects, such as lateral movement of wheels between the rails, and these must be considered separately when assessing clearances to adjacent structures (paragraph 40).

- 22 Gauging data provided by the FKA wagon manufacturer shows that these wagons comply with W6a gauge when empty. A larger gauge is required when carrying containers because these project beyond the upper parts of W6a gauge (FKA wagons loaded with containers are therefore not permitted on this route).

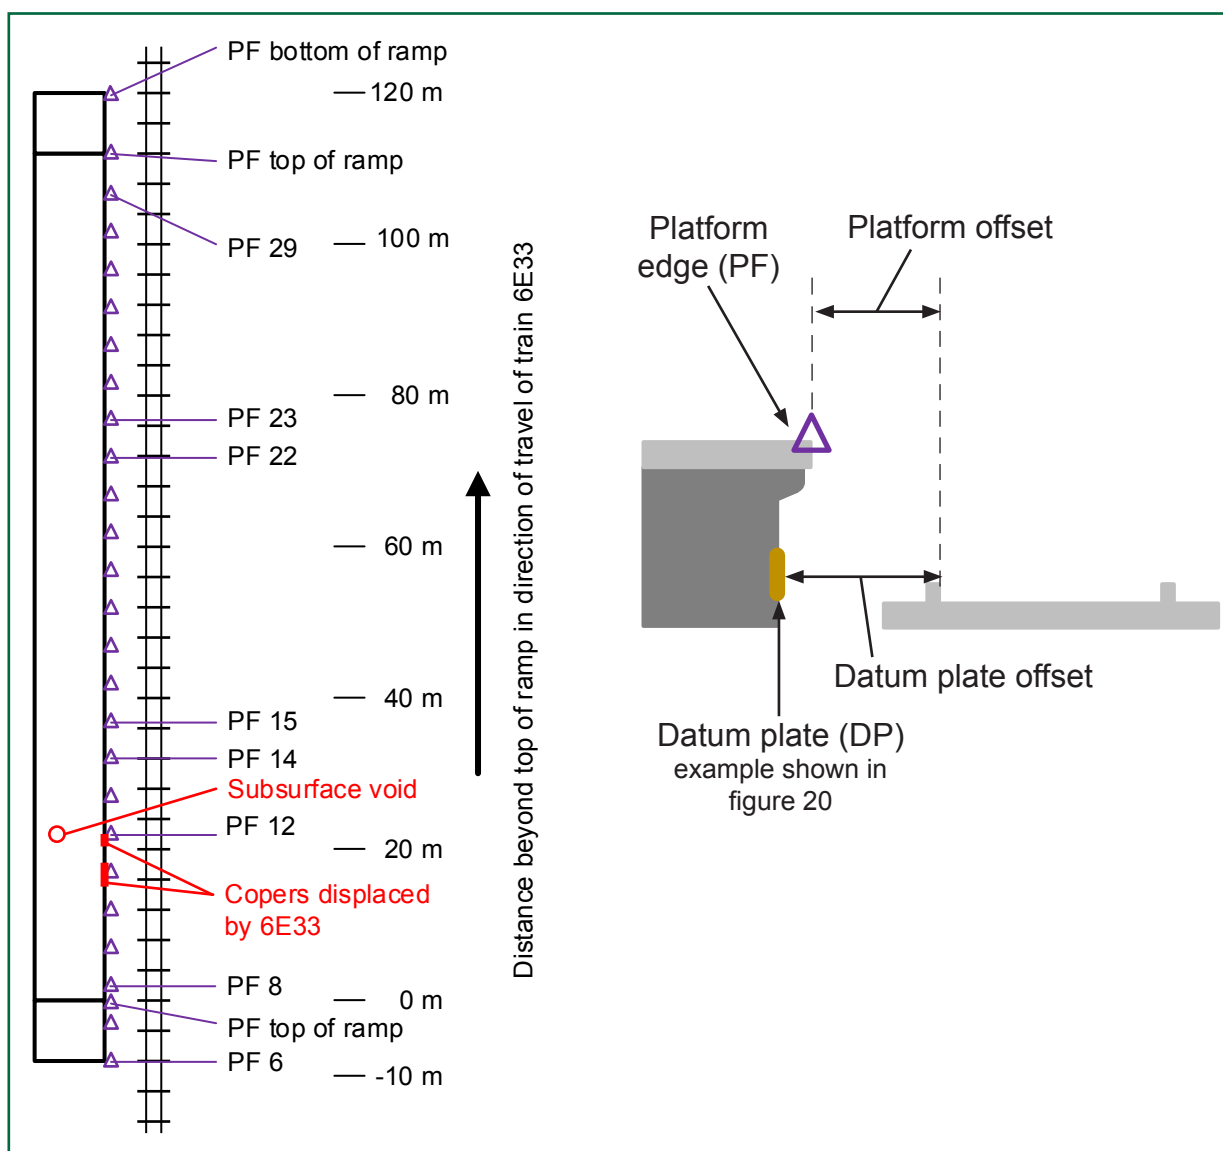
Figure 14: Moston survey locations

- a *datum plate survey* which records the distance between the track and datum plates fixed to the lower part of the platform structure at intervals of typically 10 metres (figure 14).

- 39 The most recent full survey at Moston before the accident was in July 2014 and recorded the horizontal distance between the platform edge and the nearest rail. This was also approximately the horizontal distance to the front face of the platform supports because a visual inspection shows the supports extend to approximately the outer edge of the coping stones (localised variations to this statement are discussed at paragraph 62). This data is compared in figure 15 with the offset of the outward projecting FKA spigots, W6a gauge, and the offset required to meet modern design standards.

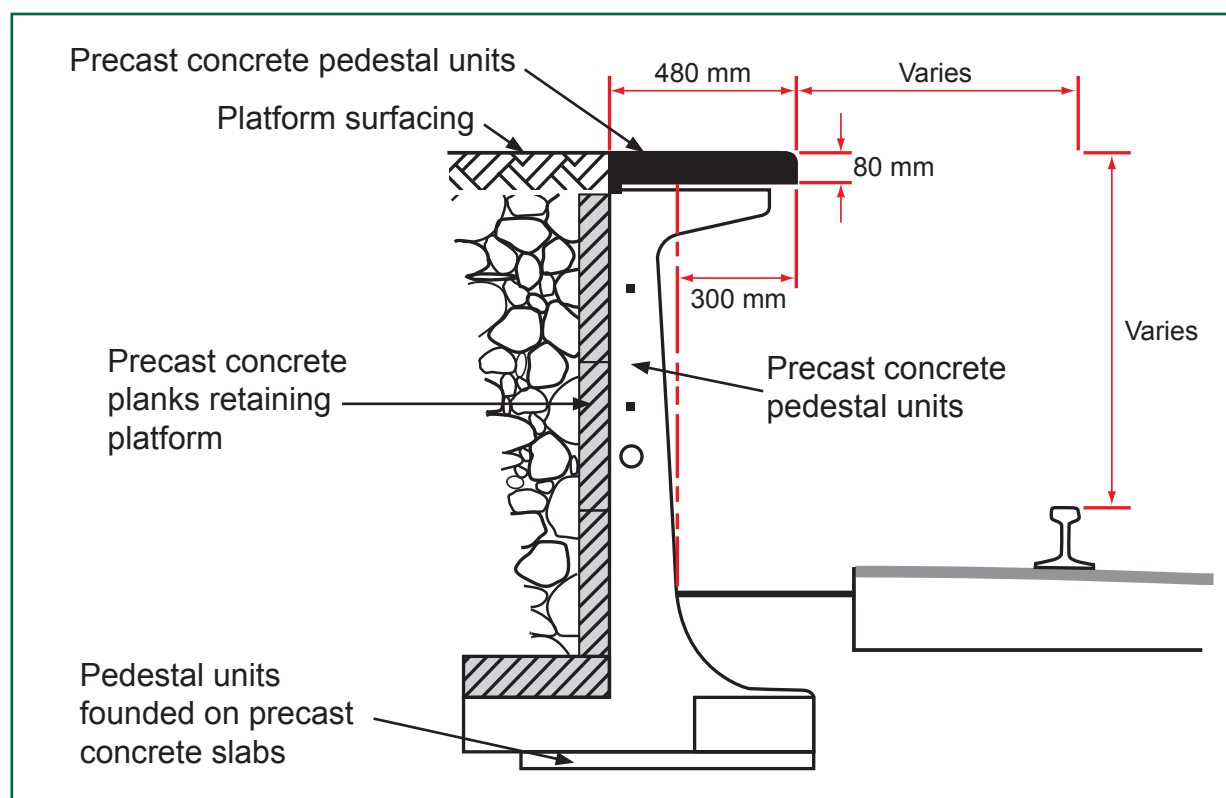
Figure 18: Platform support as-designed (detail provided by Network Rail)

- 52 Evidence of historic and recent movement of the down platform at Moston includes the following:
- Pre-accident inspections by Network Rail showing that concrete supports along the front edge of the platform had moved towards the track so that they projected beyond the coping stones, rather than the coping stones projecting beyond the supports (figures 18 and 19).
