# Rail Accident Report

**Partial collapse of a wall onto open railway  
lines, Liverpool  
28 February 2017**

# Partial collapse of a wall onto open railway lines, Liverpool, 28 February 2017

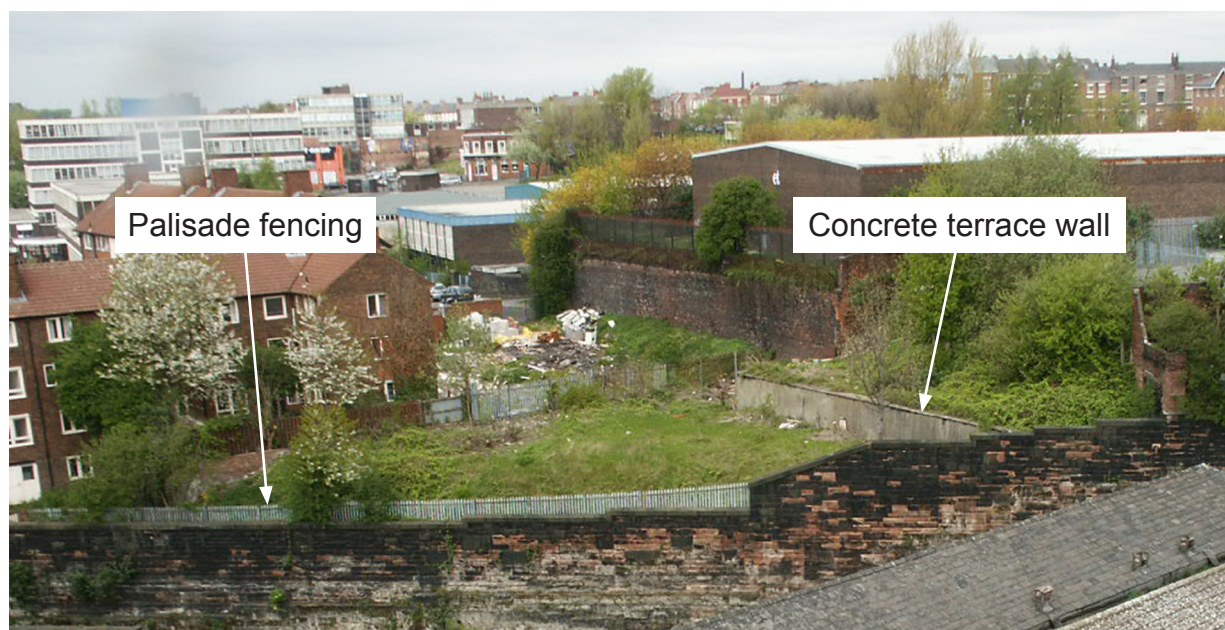
- 25 The sandstone block wall has two purposes: firstly to retain the ground adjacent to it and prevent it falling into the cutting, and secondly to prevent access onto the railway. The upper part of the wall was around 1.5 metres higher than the land immediately behind it before the land was developed by the lease holder. This upper part acted as a parapet wall to prevent ingress into the cutting and to protect users on the adjacent land. When it was originally built there was no additional fencing above the wall. Photographic evidence shows that the metal palisade fencing had been erected on the western section of the wall by 2004 (figure 5). The lease holder believes that the fencing was erected before 2000. During subsequent developments on the land, the lease holder erected palisade fencing on the eastern section of the wall.

Figure 5: The land adjacent to the wall prior to development in 2004 (photograph courtesy of Williamson Tunnels Heritage Centre)

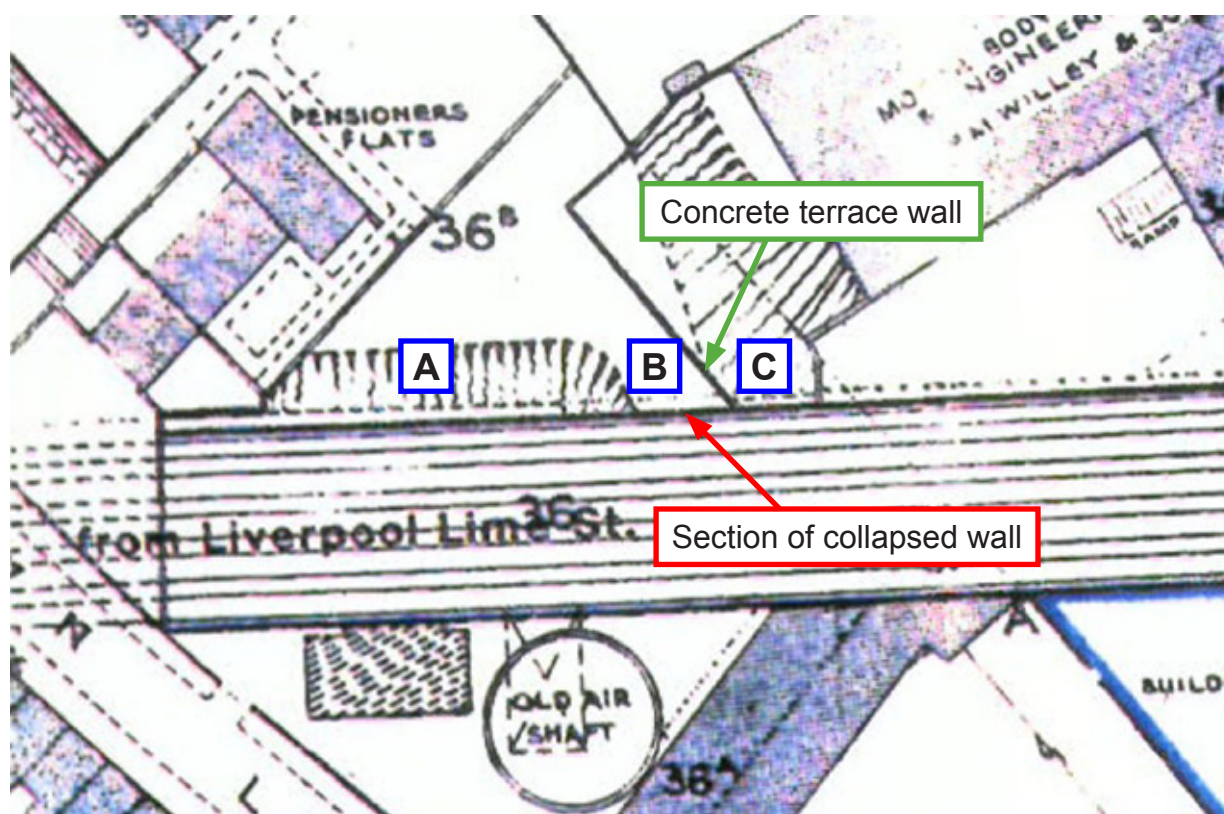
- 26 Figure 6 shows an extract of a plan of the area dating back to 1959. The approximate position of the portion of wall that collapsed is indicated. The area marked 'A' shows a shallow slope rising from the wall up to the ground level of the surrounding land. This slope ensured that the upper part of the wall was not loaded by any ground behind it. The plan indicates that there was no such slope in the area marked 'B'. At 'C', the ground reaches a concrete terrace wall which meets the railway wall at an angle of approximately 45 degrees and which retains ground along its eastern side. It is not clear from the available evidence whether the ground between 'B' and 'C' was level, as indicated by the plan in figure 6, or rises towards 'C' as suggested by the increasing height of the wall (to maintain its parapet function relative to the rising ground level) in figure 5.

Figure 6: Plan of the land adjacent to the wall in 1959 (image courtesy of Network Rail)

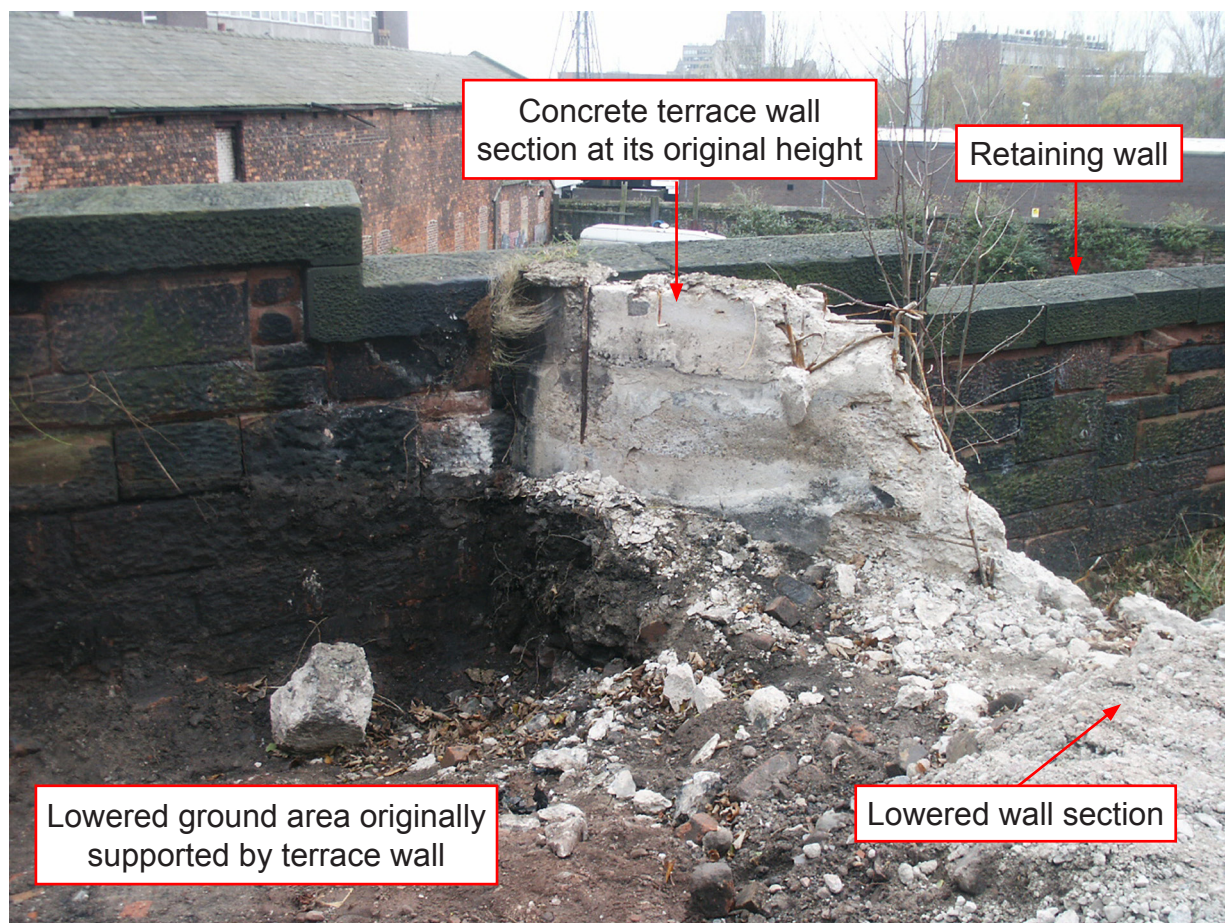
- 27 In 2004 the land was as shown by figure 5 and the concrete terrace wall was visible. Around this time the upper part of the terrace wall was demolished, and the terrace levelled. This reduced the height of the terrace wall by approximately 1 metre. However, a short length of this wall, immediately adjacent to the retaining wall, was left at its original height (figure 7). The RAIB has estimated from photographs and measurements, that the level of the ground to the west of the concrete terrace wall was then around 1.6 metres lower than the top of the original terrace wall.

Figure 7: The short section of the concrete terrace wall adjacent to the railway wall which remained at its original height (photograph courtesy of Williamson Tunnels Heritage Centre)

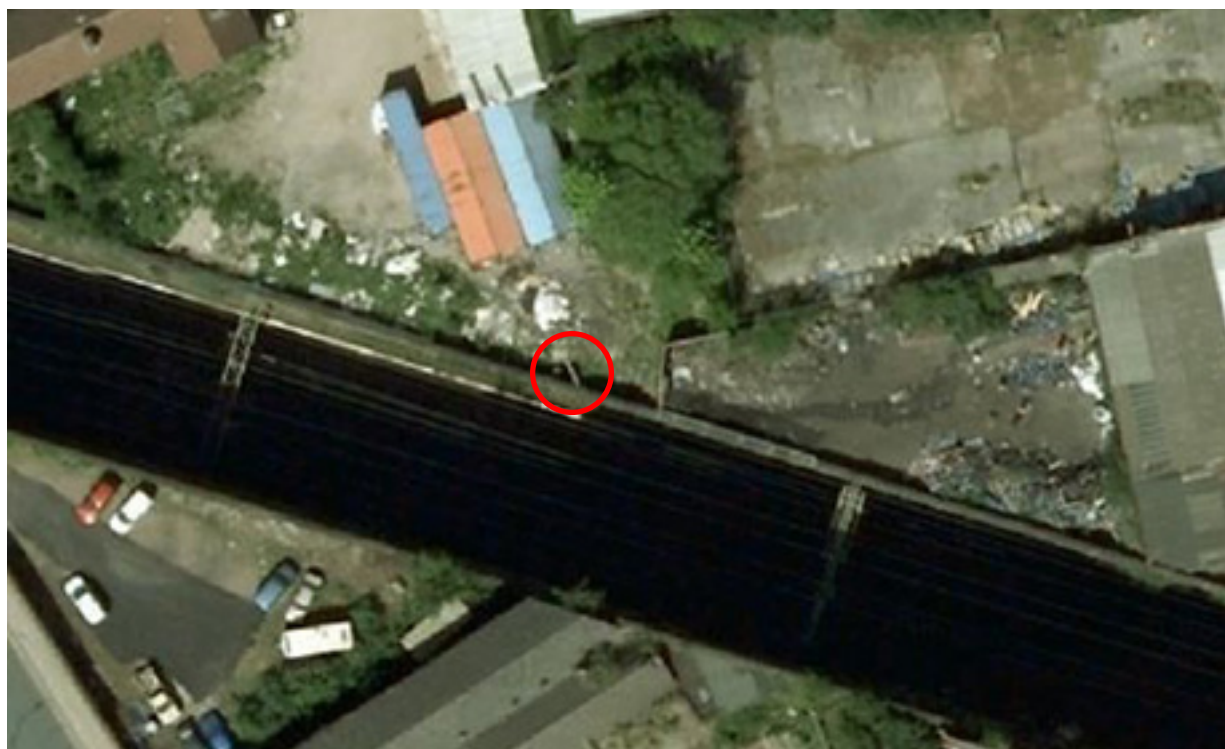
- 28 By September 2005 a metal storage shelter and five 40 foot shipping containers had been brought onto the property (figure 8). The ground immediately behind the retaining wall, and to the west of the terrace wall, was likely to still have been at its original level, as photographs indicate that this area was undeveloped and there was no concrete slab present.

Figure 8: Aerial image of the site taken on 2 September 2005 showing metal storage shelter and shipping containers. The red circle indicates the short section of remaining full height section of the concrete terrace wall (courtesy of Getmapping PLC).

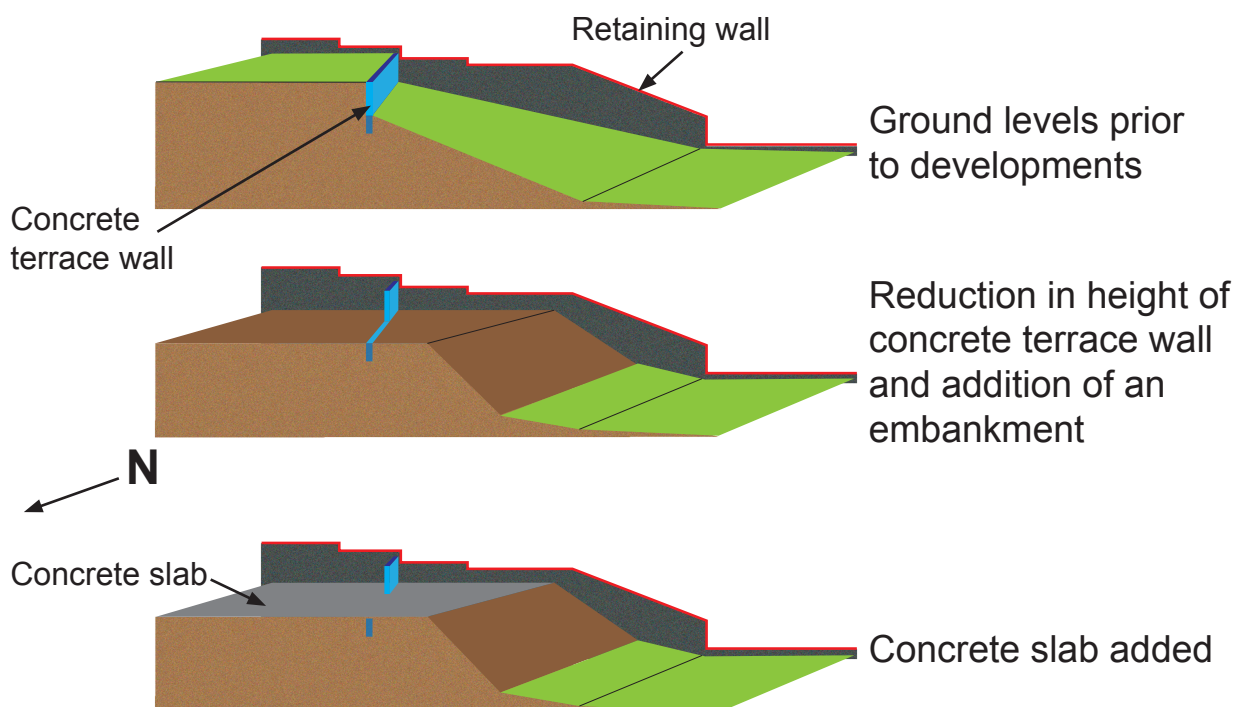
- 29 By June 2009 there were six containers on the property, rearranged and double stacked (figure 9). The containers had been placed on a concrete slab approximately 100 mm thick which was supported by an earthwork that had been built out from the terrace wall towards the west of the property (figure 10). The concrete slab also extended beyond the footprint of the containers to meet the railway retaining wall (figure 11) which by this time was additionally surcharged. Also by this time, the lease holder had erected additional palisade fencing against this eastern section of the wall.

Figure 10: Diagram showing the changes on the property behind the retaining wall (not to scale)
