Rail Accident Report

**Trailer runaway near Hope, Derbyshire
28 May 2017**

Report 03/2018
February 2018

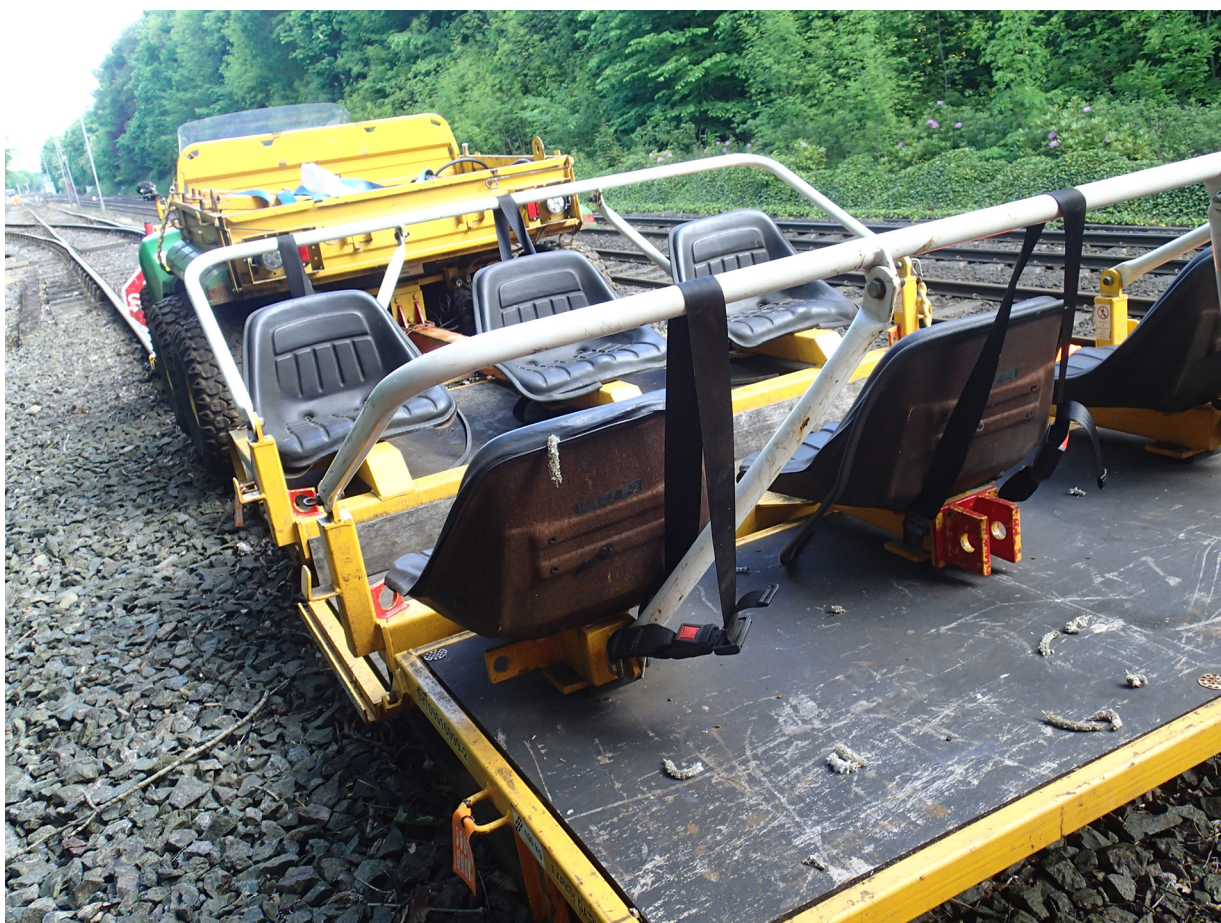
Figure 3: Personnel carrier trailer

- 15 The trailer that ran away was a Permaquip Personnel Carrier (figure 3). This is a four-wheeled trailer designed to carry six seated persons. Two of the four rail wheels, on one side of the trailer, are braked. These brakes are spring applied and are released by hydraulic oil pressure applied by a hose connection from the vehicle being used to tow the trailer. There is also a manual release for each of the braked wheels (figure 4), which is operated by attaching and pulling a handle at each end of the trailer.

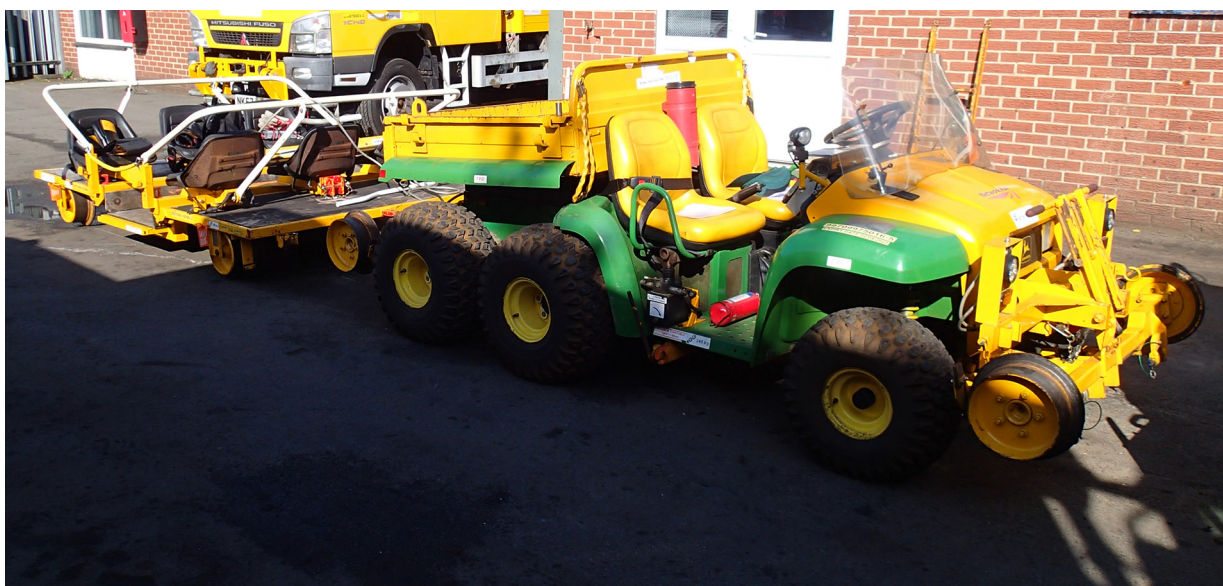
Figure 5: Gator with personnel carrier trailer

- 16 The tractor unit was a Permaquip Gator 6x4 (figure 5). This was a six-wheeled all-terrain vehicle that had been converted for use on the UK rail network by Permaquip. When on the track, the rail wheels are lowered to provide guidance. The rear four road wheels remain in contact with the rail and provide traction and braking. The front two road wheels are lifted clear of the rail, and the rail wheels take the weight.

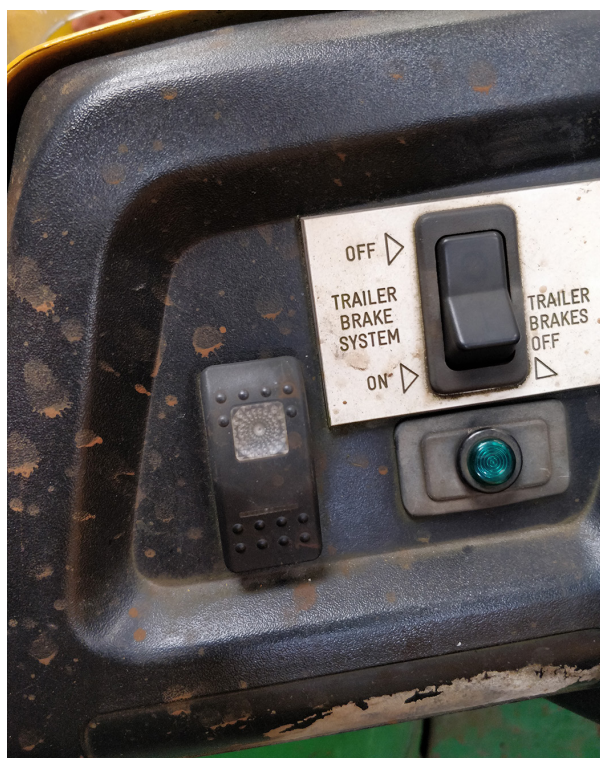
Figure 7: Hydraulic brake system control and indication

- 41 The hydraulic pump is switched on by the operator, using a switch on the gator's dashboard. When service pressure is reached (normally in a second or two) a pressure switch stops the pump, a light is lit on the dashboard, labelled 'trailer brakes off', and the trailer brakes are fully released (figure 7).

- 44 If the trailer's hose is not connected, the hydraulic system on the gator can still be switched on and pressurised because the valve in the coupling remains closed. The pressurised indication lamp on the dashboard is also illuminated (figure 7). The hydraulic system also acts to release and recharge pressure as the gator brakes are applied and released. However, in this situation the pressure is not transmitted to the trailer and therefore it has no effect on the trailer brakes.

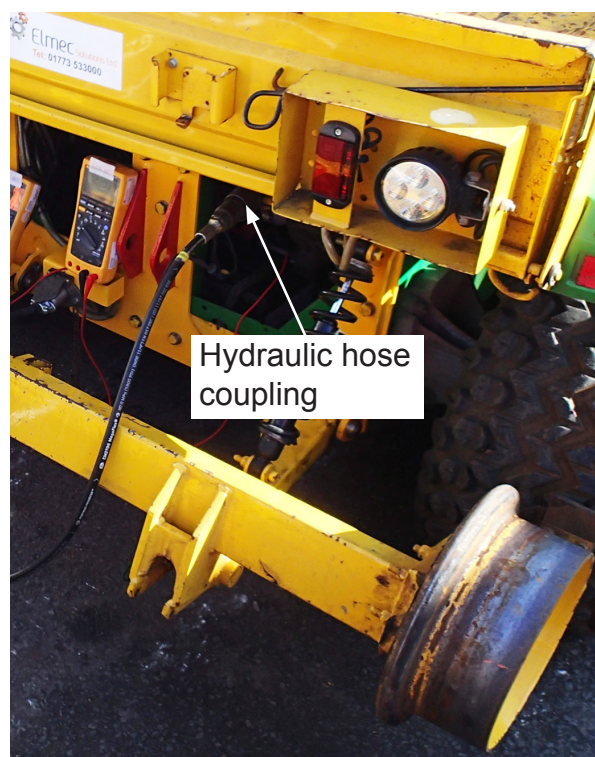
Figure 8: Hydraulic hose coupling

- 43 A hose connects the hydraulic system on the gator to the brake release cylinders on the trailer. The hose is permanently coupled to the trailer and attaches to the gator using a sealed bayonet coupling (figure 8). This coupling snaps into place and requires a locking collar to be manually retracted to allow it to be released. The hydraulic connection between the gator and the trailer is not made until the coupling is snapped into place. When this is done, the coupling is secured and a valve in the coupling is opened to allow pressure to be transmitted.

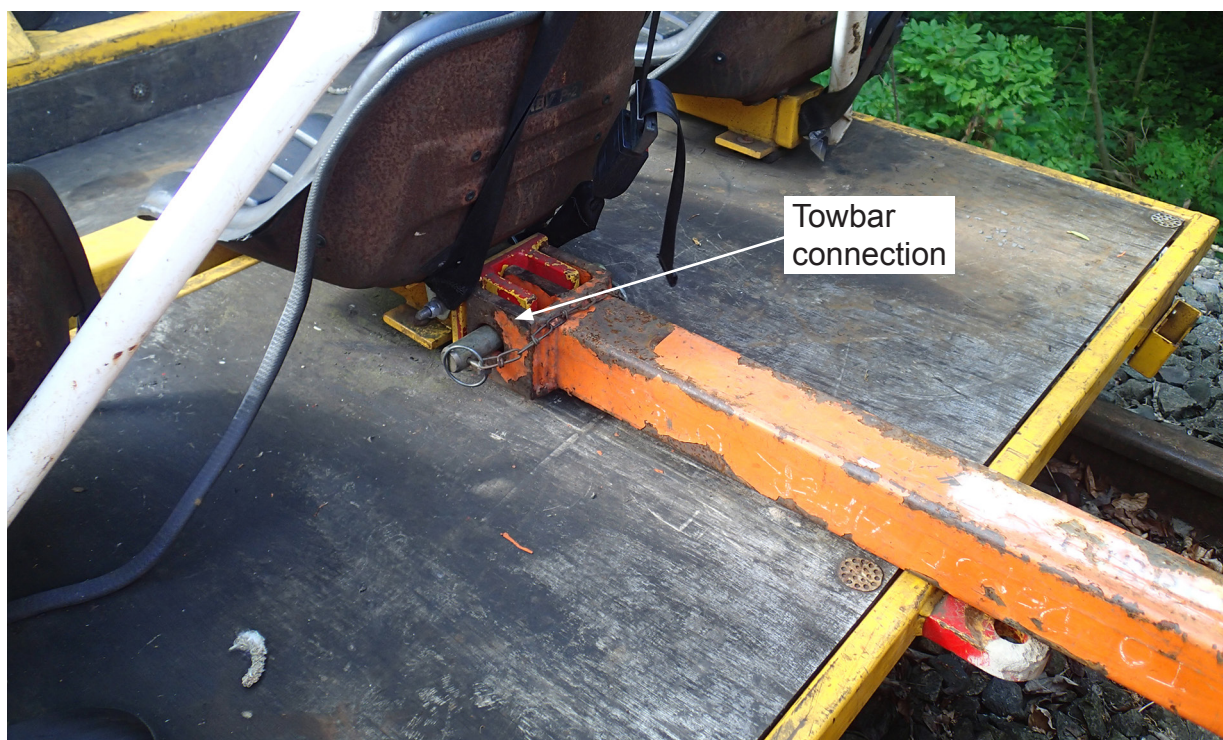
Figure 10: Towbar connected to trailer

- 57 The coupling pin at the trailer end of the towbar had fallen out.**
- 58 The towbar consists of a horizontal steel bar which is connected between coupling points on the gator and on the trailer. Each end of the towbar has three vertical fins, which interleave with two vertical fins that are mounted on the vehicle's coupling point (figure 10). A towbar pin is inserted horizontally through holes in the five vertical fins, securing the towbar to the vehicle (figure 11).

- 61 After the runaway, the towbar pin was found on the rear deck of the trailer, adjacent to the coupling. The linch pin was attached to it by a chain but was not inserted in the hole in the towbar pin. This is consistent with the towbar pin having vibrated its way out.
