Rail Accident Report

**Train ran onto a washed-out embankment near
Knockmore, Northern Ireland
28 June 2012**

Report 14/2013
September 2013

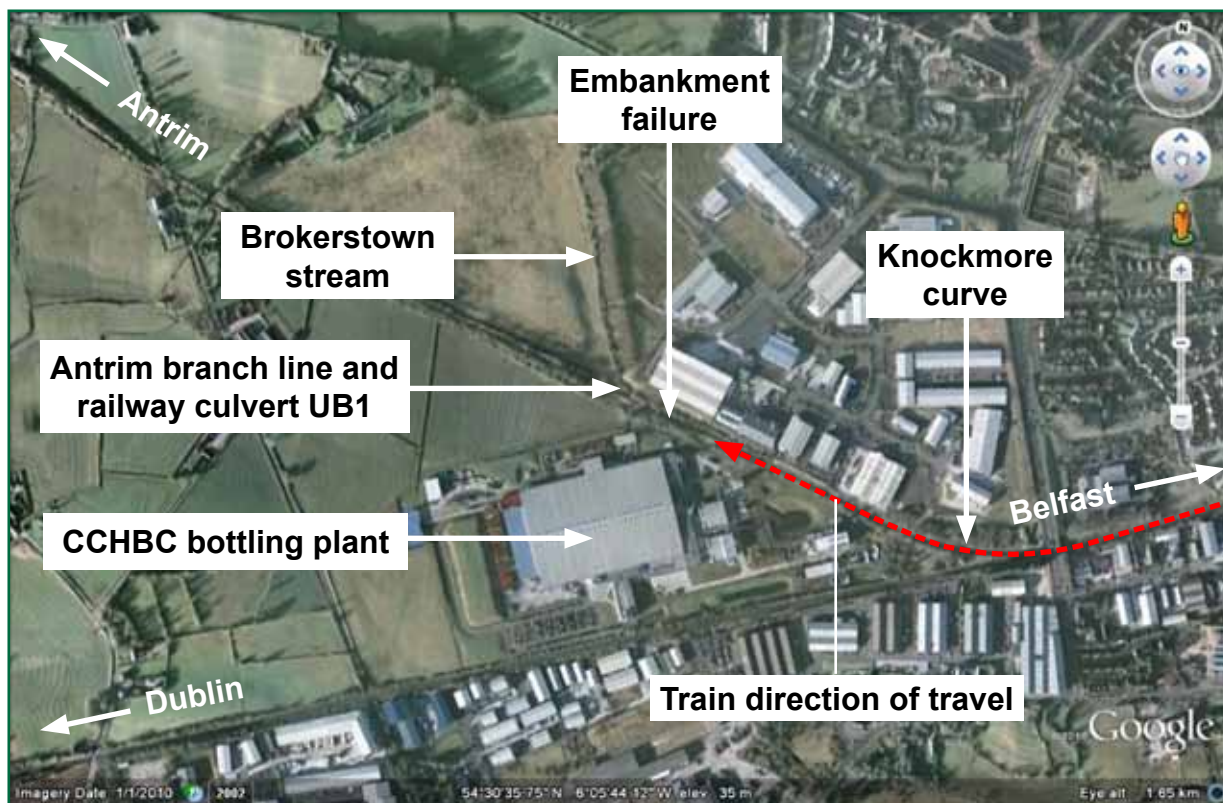
Figure 3: Google Earth image showing location of the failed embankment, UB1, and environs

- 10 The washed out embankment was located at around 0 miles 29 chains (580 metres) from a datum located just before the start of the Knockmore curve (figure 3). Its position was around 80 metres from a culvert, the NIR bridge reference of which is '*underbridge 11.001*' (hereafter referred to as 'UB1'). Adjacent to the southern boundary of the railway at the location of the washout is a soft drinks bottling plant, which covers an area of around 45 acres and was built between 2006 and 2008 on previously rural land.

- 11 The Brokerstown Road stream (hereafter referred to as the Brokerstown stream) flows under the railway through UB1, and almost perpendicular to it (figure 3). It originates in an area called the 'White Mountain', north of the site, and runs over a total distance of around 4.4 km in a southerly direction under the Antrim branch line and the Belfast to Dublin main line and discharges into the River Lagan. Its *catchment area* is around 6 km², and around 3.2 km of the watercourse lies north of the Antrim branch line. The watercourse is *culverted* along 35% of its length by 11 *culverts* of different lengths from around 1 metre to 880 metres; five culverts lie to the south and downstream of UB1 (figure 4). It is a designated watercourse which means that the Rivers Agency is responsible for its inspection and maintenance.

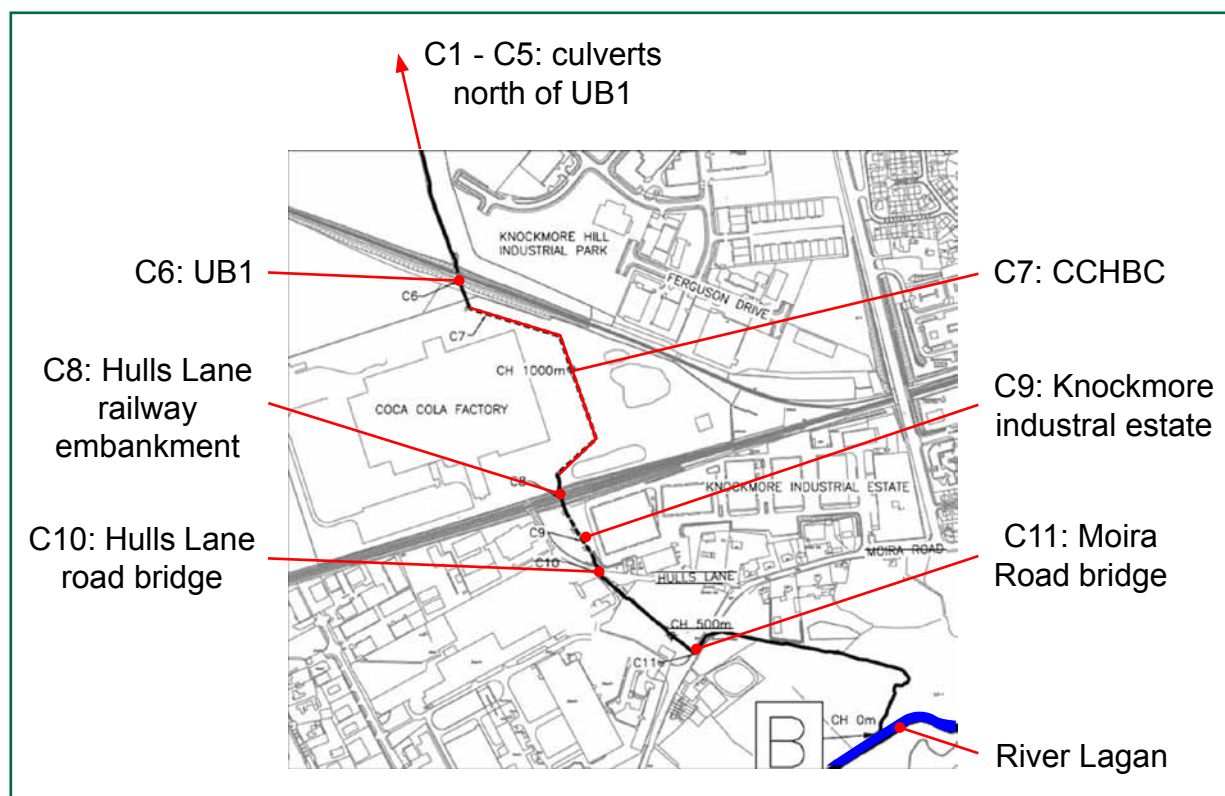
Figure 4: Culverts at and downstream of UB1 (courtesy of WDR & RT Taggart)

- 50 **The culvert system on the Brokerstown stream was unable to cope with the water flows generated by the heavy rainfall, causing water to back up behind the railway embankment.**
- 51 The brick arch culvert structure, UB1, is 38 metres long, with cross sectional dimensions, 1.8 metres high by 2.25 metres wide (figure 7). The Brokerstown stream flows from UB1 through a 40 metre long open section, to another culvert at the CCHBC plant, which is 390 metres long and has a series of bends in it (figure 4). This culvert has an inlet which is almost perpendicular to the watercourse and is protected by a *trash screen* (figure 8). Water then flows under the Belfast to Dublin main line through another culvert, (NIR bridge reference 02.278, shown as C8 in figure 4), before flowing through three other culverts and into the River Lagan.

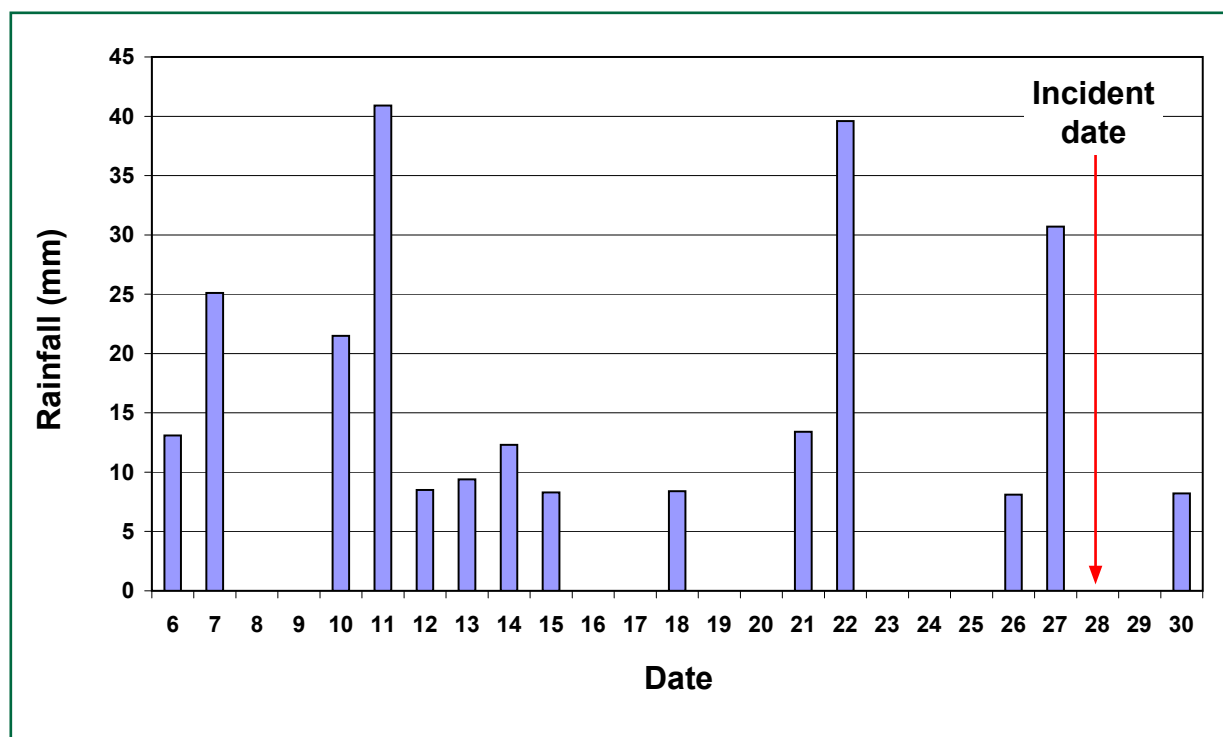
Figure 5: Daily rainfall at Tullynacross, 6 - 30 June 2012

- 47 The nearest rainfall monitoring station to the incident site is at Tullynacross, located about 5 km east north-east of the incident site and outside the catchment area of the Brokerstown stream. Daily rainfall records there, for the period 6 to 30 June 2012 (figure 5), indicate that 27 June was the third wettest day, with 31 mm rainfall. More rain fell on 11 and 22 June (around 40 mm rainfall each) than on 27 June but no flooding was reported on these two days, either at the railway embankment or the CCHBC plant. This could be because the rainfall for Tullynacross on those days did not reflect the conditions in the Brokerstown stream catchment area. Alternatively, it is also possible that the intensity of rainfall and the state of the ground water saturation on 27 June in the catchment were higher, resulting in higher water flows in the Brokerstown stream than on 11 and 22 June.

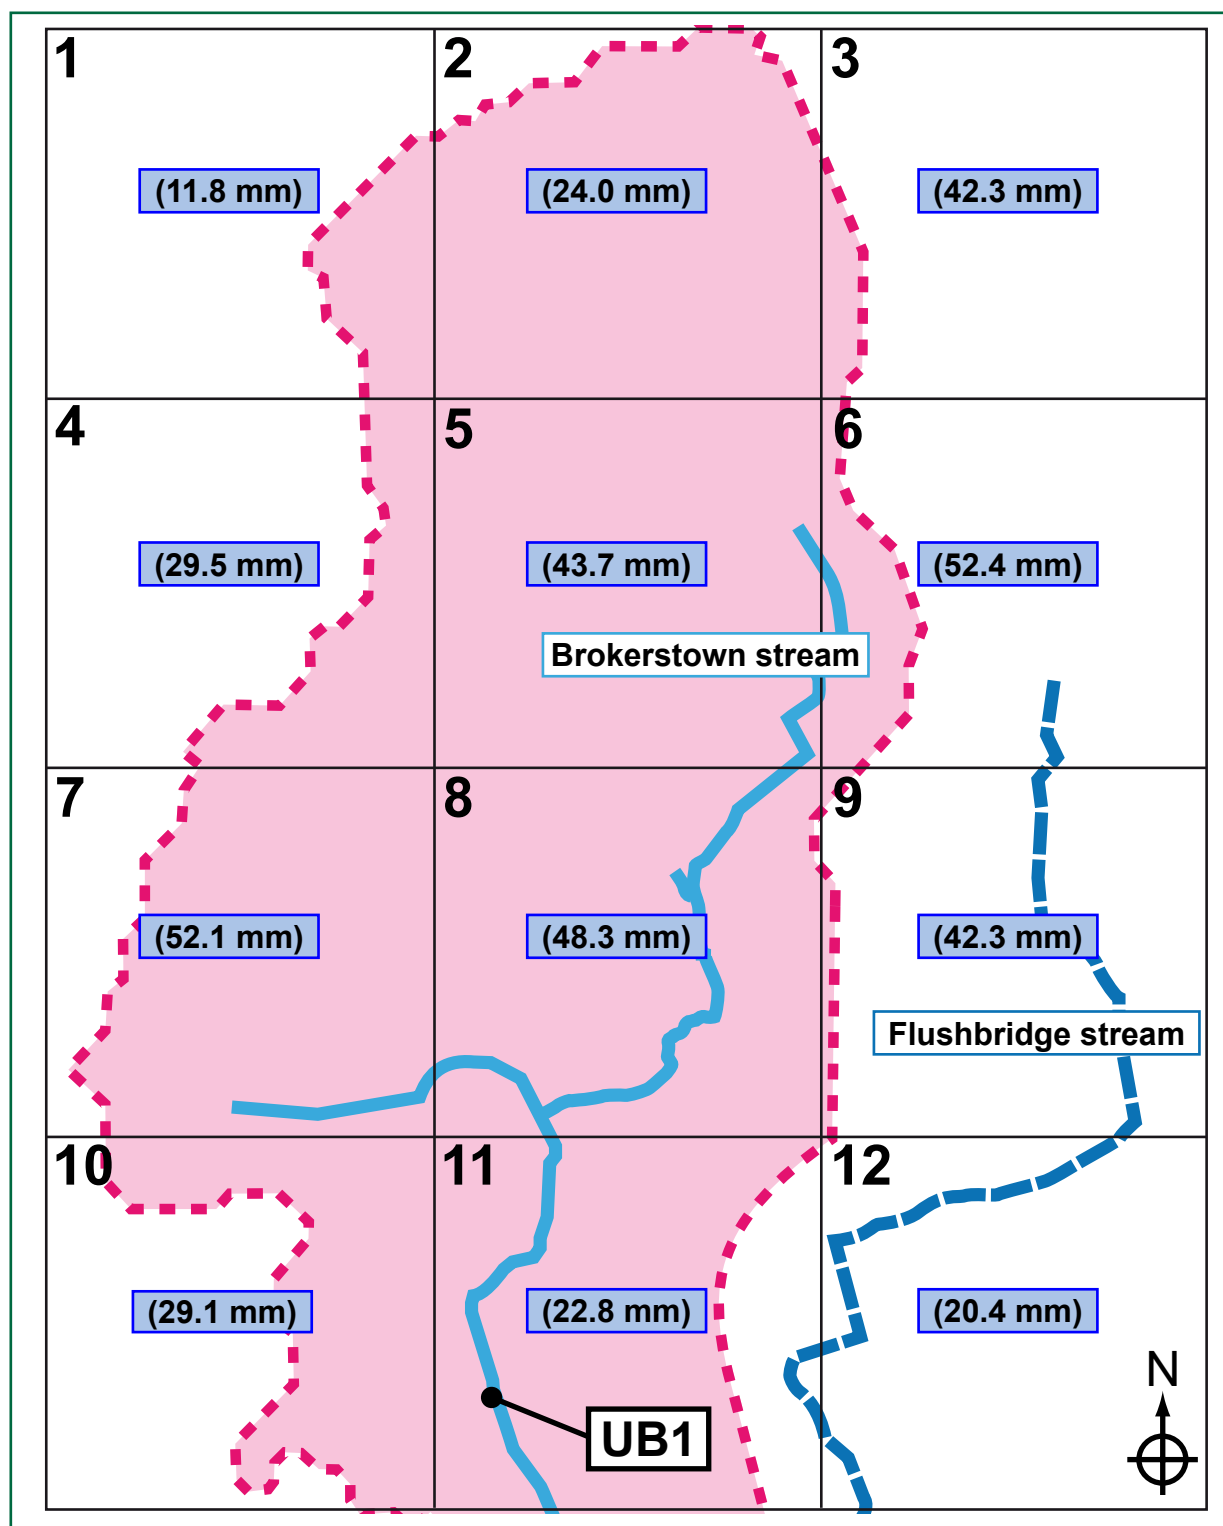
Figure 6: Rainfall in the Brokerstown stream catchment area on 27 June 17:00 - 19:00 hrs

- 49 Figure 6 shows that there was a wide variation in rainfall within the catchment area. The greatest amount of rain fell in the central part of the catchment area nearest to the watercourse (grid boxes 5 to 8), where between 43.7 and 52.4 mm fell in the two hour period, corresponding to hourly rainfall rates of around 22 - 26 mm. These rates are around five to six times greater than the four mm per hour threshold used by the Met Office to describe heavy rain. The frequency of occurrence of rainfall events is often expressed as the average interval between events of a given magnitude. For example an event with an estimated probability of occurrence of 0.1 per year is said to have a *return period* of 10 years. The rainfall rates in grid boxes 5 to 8 correspond to return periods of between 171 - 373 years. The average for the whole of the catchment has been estimated by the RAIB to have been around 1 in 100 years. The result of this intense rainfall was an abnormally large water flow in the Brokerstown stream.
