# Rail Accident Report

## **Electrical arcing and fire under a train near Windsor & Eton Riverside 30 January 2015**

Report 18/2015  
October 2015

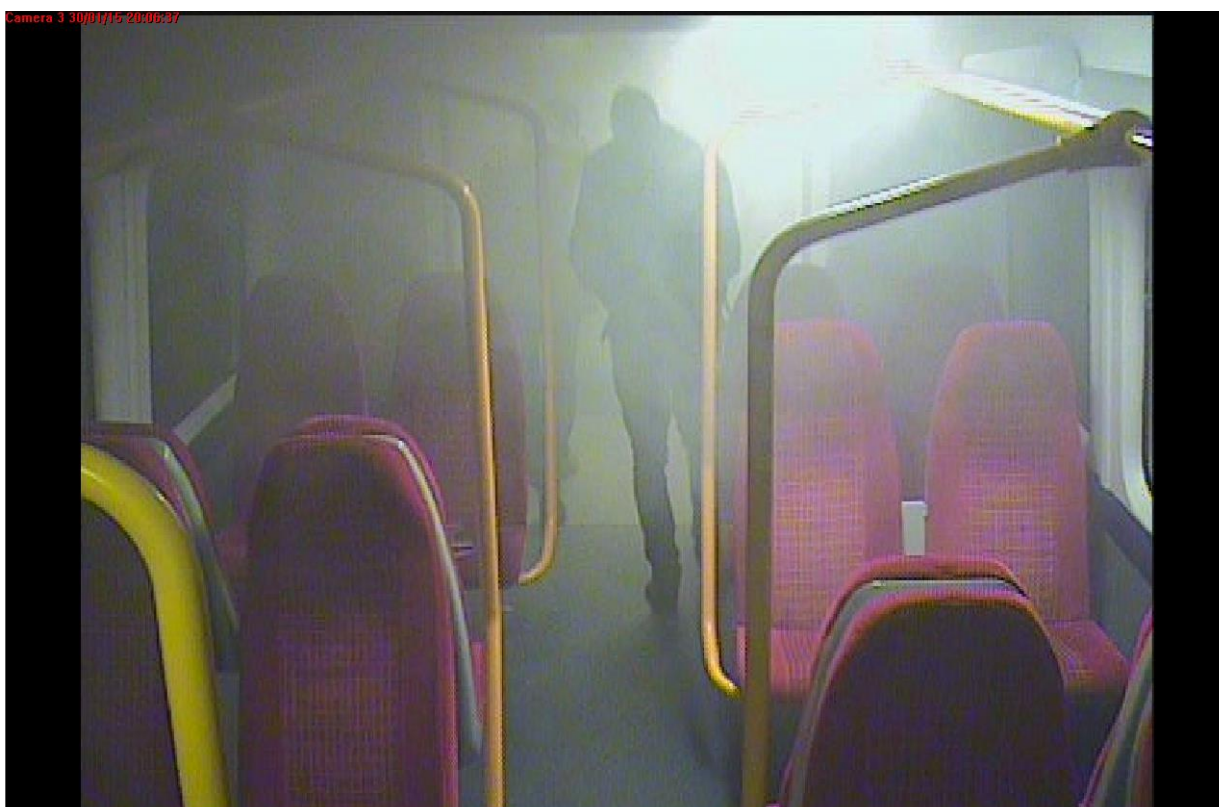
- 33 Three passengers went into the sixth carriage at about this time, and used their mobile phones to take photographs of the smoke-filled vehicle. CCTV shows that they retreated, coughing, to the seventh carriage after about one minute (figure 4).

Figure 4: Passengers taking photographs of the smoke in car 67601

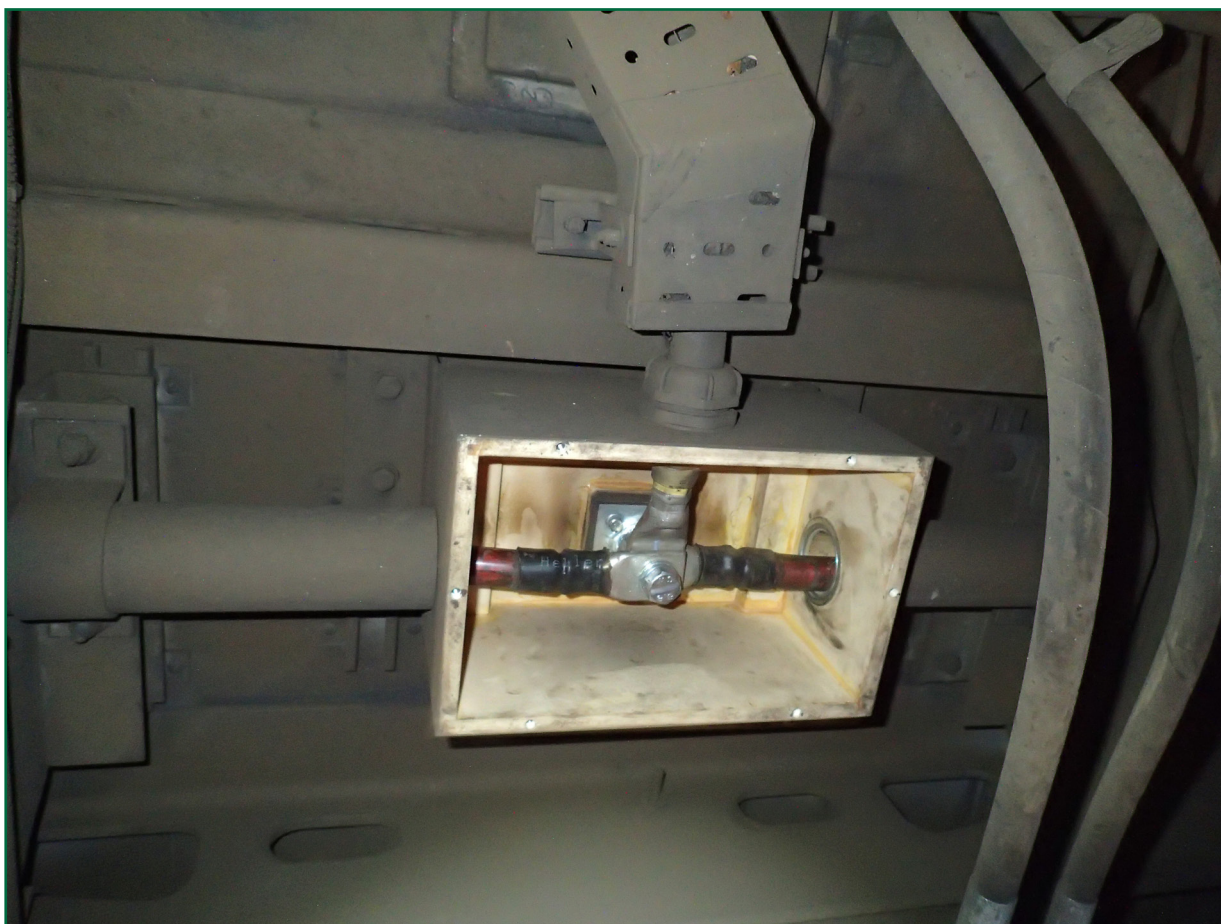
- 49 This bracket is bolted to a pillar of insulating material. The pillar is within a junction box made of the same material, MICAM EM42. This fire-resisting material is a filled epoxide resin composite with woven and non-woven glass reinforcement. The junction box is glued together, and has a lid (which is on the bottom when the junction box is mounted on the train). The lid is bolted in place with captive screws (figure 7).

Figure 7: The junction box (undamaged example: lid removed)

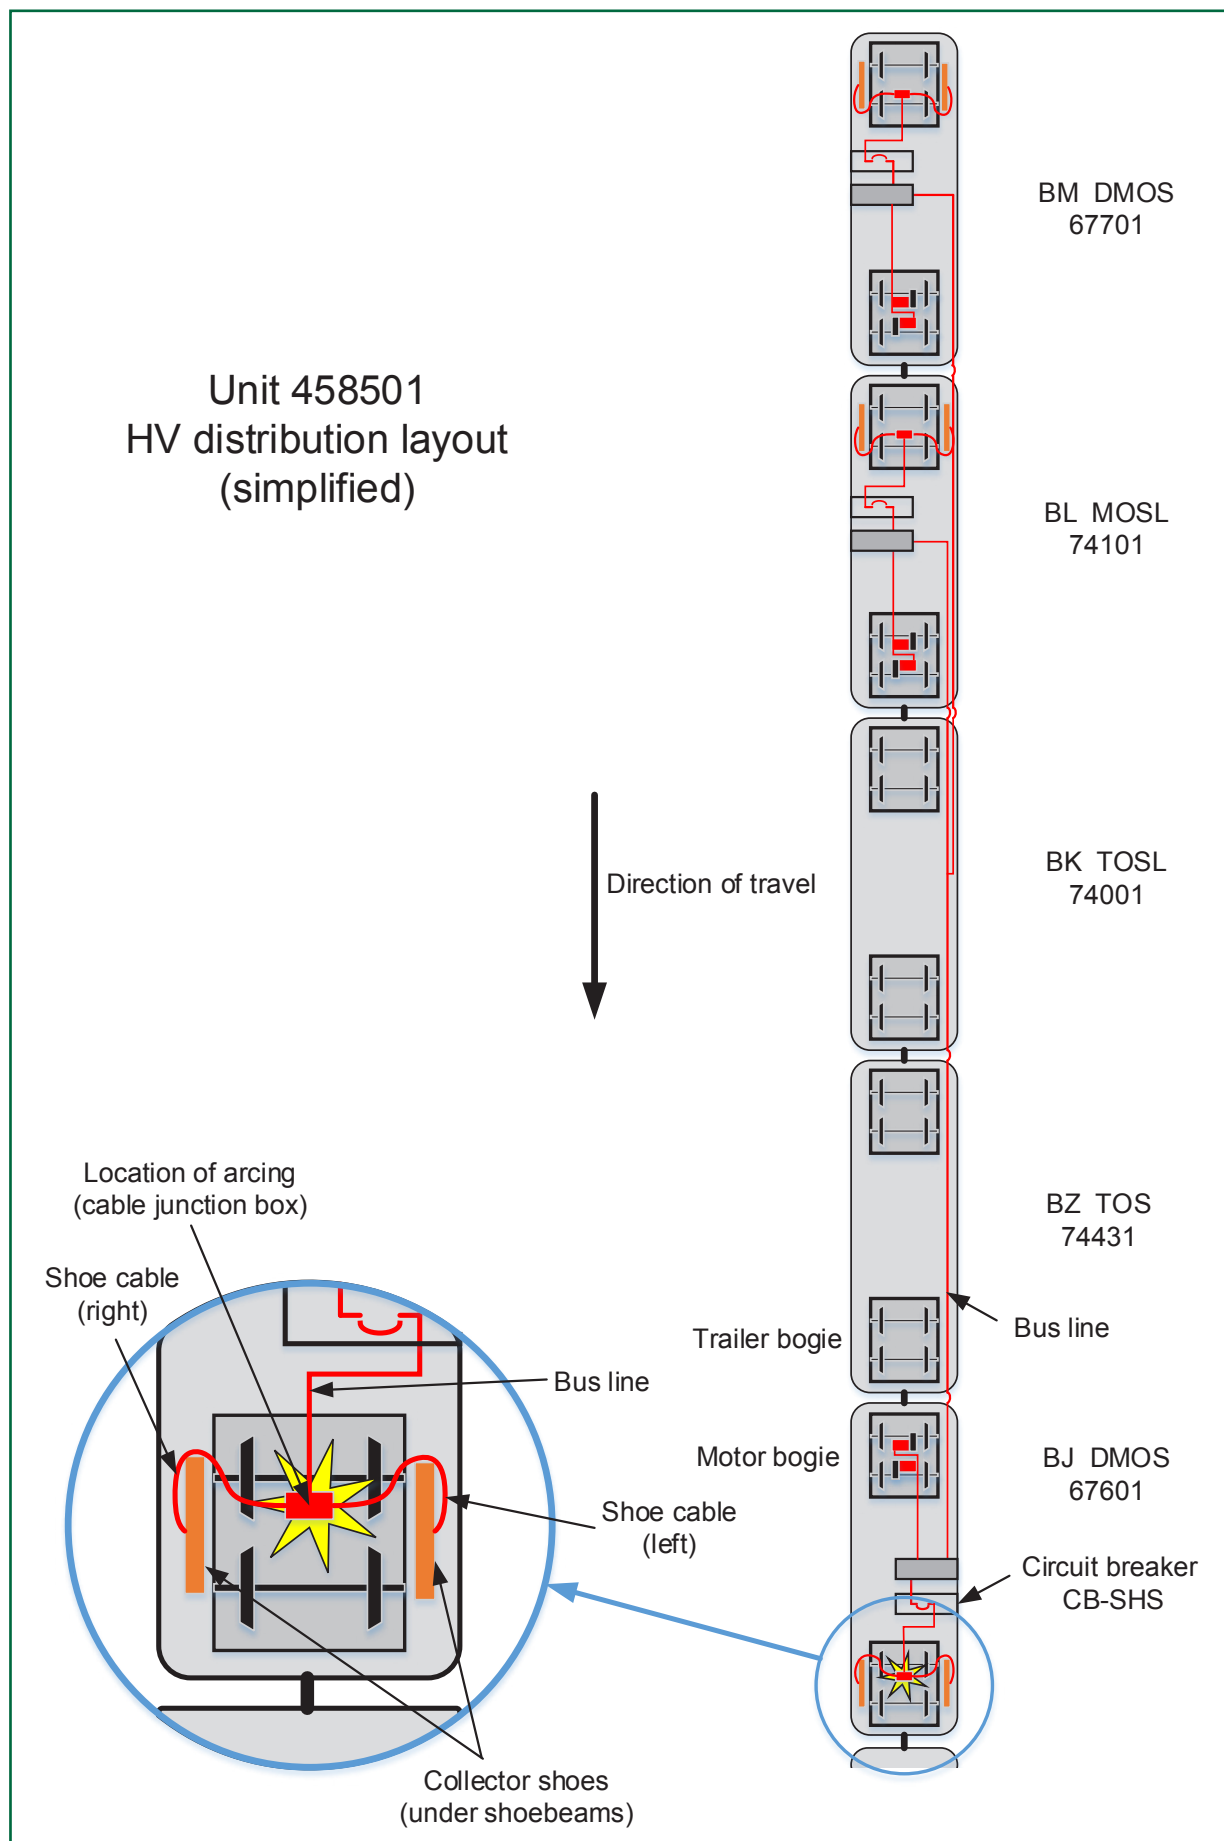
- 93 On the class 458/5 train, there are three high speed circuit breakers (HSCB), one associated with each set of collector shoes, and referred to by Alstom as 'circuit breaker – shoe gear high speed' (CB-SHS) (figure 11). These are mounted on the underside of the vehicle, and there is no protection for faults which may occur in the cable between the collector shoes and the CB-SHS. The maximum rated service current for a class 458/5 unit is 1930 amps.

Figure 11: diagram of high-voltage distribution layout on class 458/5

- 95 In the TMS of unit 458501, all three CB-SHS are recorded as having operated at the same time (to within one second) when the train was travelling at about 14 mph (23 km/h). There is no record in the TMS of any of the push buttons having been operated. The Bus Line Earth Leakage Relay circuit does not monitor the cable on the shoe gear side of the CB-SHS and could not have detected the arcing, and the CB-SHS is rated to trip on overcurrent (instantaneous trip setting of 3600 Amps). This leads to the conclusion that the CB-SHS tripped on overcurrent when it detected high current flowing from the traction supply to the vehicle body.
