Rail Accident Investigation Branch

Rail Accident Report

**Derailment of a freight train near Langworth,
Lincolnshire
30 June 2015**

Report 11/2016
June 2016

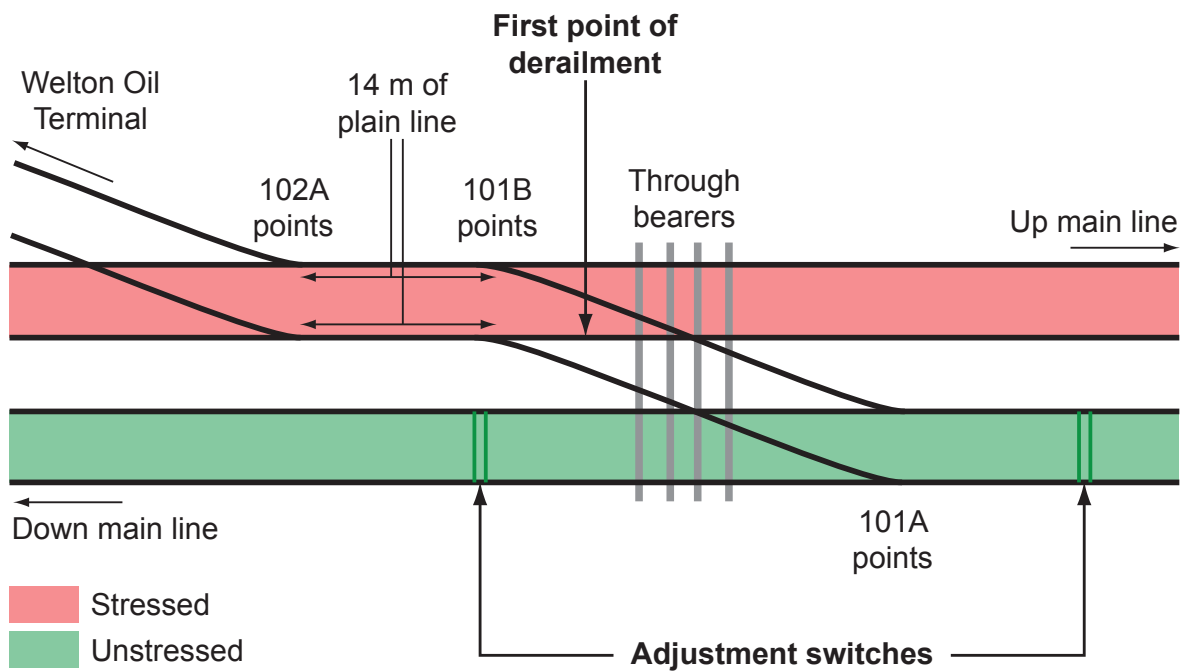
Figure 4: Layout of Welton switches and crossings (not to scale)

- 18 Beyond 102A points in the up direction there was a 14 metre section of *plain line* (figure 4) to 101B points where the derailment occurred. The two sets of points are described as 'closely abutting' because of the short distance between them. Train movements from 101B points could either go straight ahead on the up main line or be directed over the crossover to 101A points on the *down main* line. Points 101A and 101B were installed on concrete bearers and also operated by point motors controlled from the signal box at Langworth.

- 80 A track layout comprising a crossover between stressed and unstressed rails (figure 4) is unusual on Network Rail infrastructure. It is theoretically possible that, had the adjustment switches protecting 101A points on the down main line been seized or had reached the end of their travel, thermal stresses could have been transferred via the crossover to 101B points. The RAIB arranged for both sets of adjustment switches to be forensically examined and both were found to be in working order with capacity for further movement.
