# Rail Accident Report

## **Extensive track damage between Ferryside and Llangennech, Carmarthenshire 30 October 2017**

Report 17/2018  
October 2018

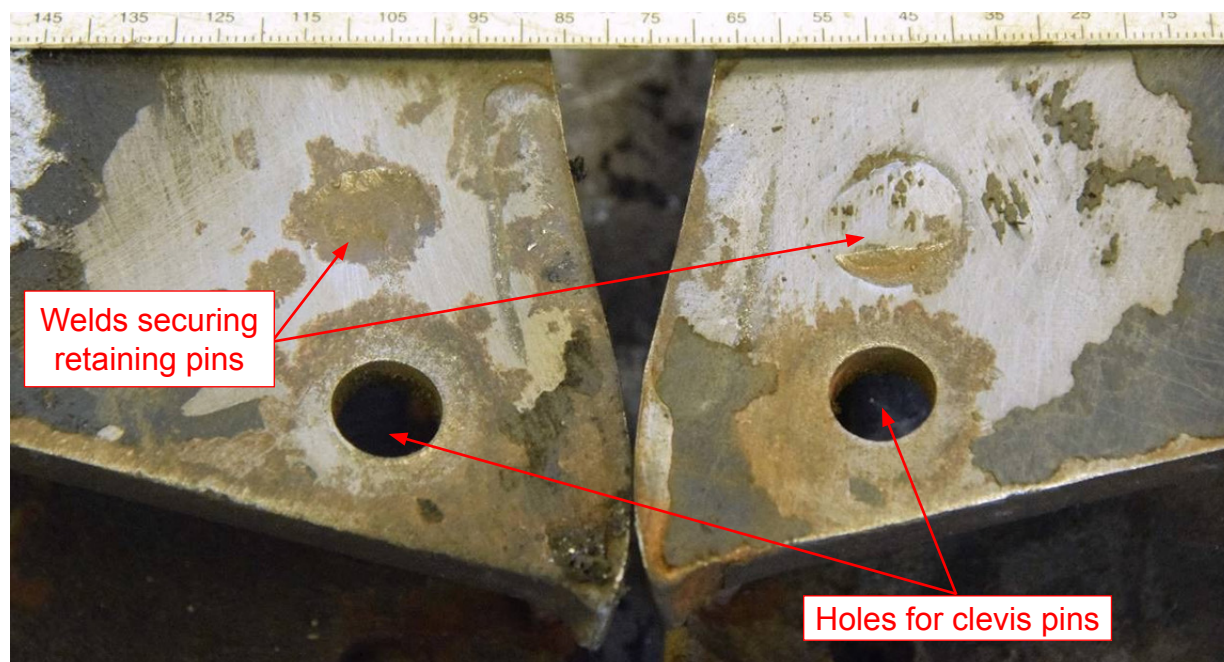
- 56 The fixed retaining pins are fitted through holes in the inner and outer plates of the block holders, and are welded to the faces of the plates (figure 14).

Figure 14: Outer faces of block holders from wheel positions 7 and 8, partially cleaned (courtesy Serco Rail Technical Services)

- 80 The fixed retaining pins that form part of the mechanism for attaching the brake blocks were missing from the block holders on the second wheelset of bogie 2741 (paragraph D9, appendix D). If one or both of these pins had fallen out, the associated key could also fall out and the brake block would no longer be restrained.
- 81 While the block holder from wheel position 6 (figure 8) was destroyed, accounting for the loss of that retaining pin, the block holder from wheel position 5 remained intact. The welds that secured the pin in position had failed (compare figure 16 with figure 14).
