# Rail Accident Report

## Passenger trapped and dragged at Notting Hill Gate station, 31 January 2018

Report 14/2018  
September 2018

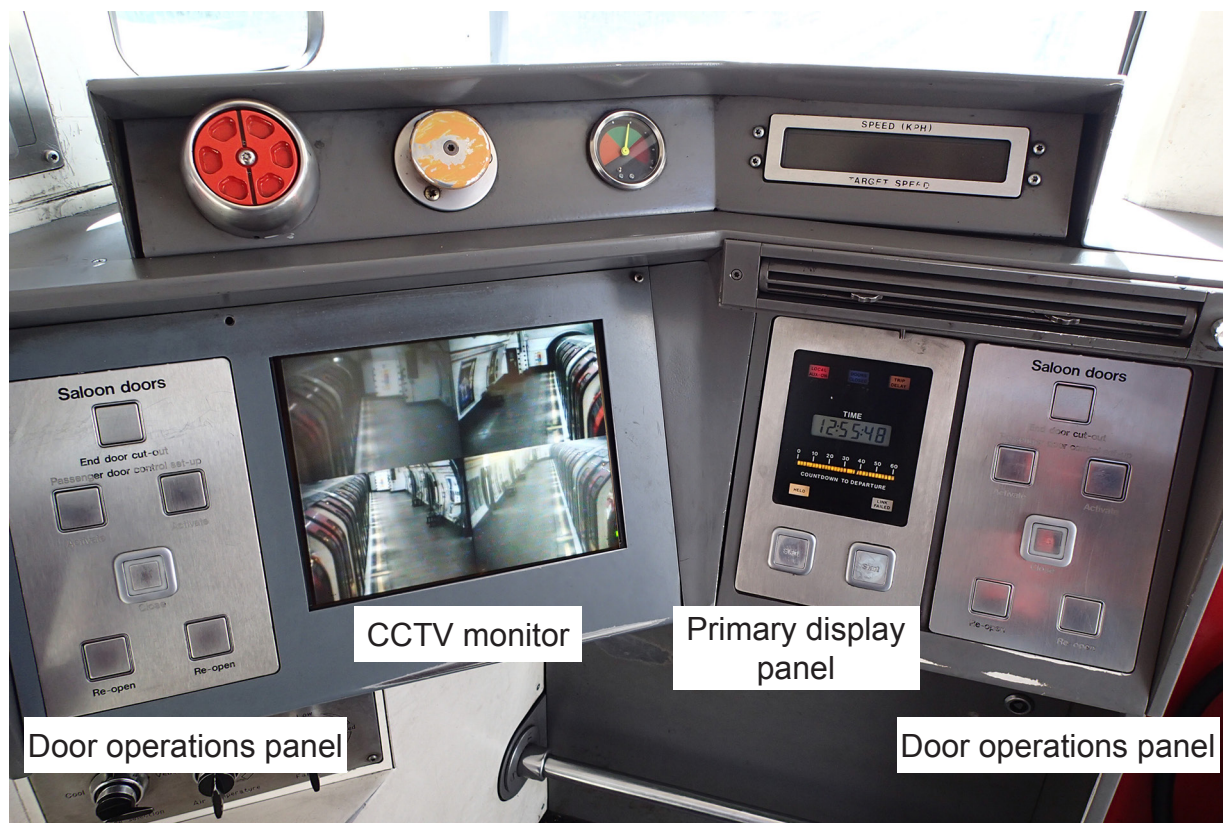
- 38 The cab display and control panels on 1992 stock (figure 3) include buttons for opening and closing the doors on each side, a pair of buttons for starting the train, and a CCTV monitor to view images of the platform-train interface.

Figure 3: 1992 stock cab display and control panels. The panels to the left and right are for door operation on each side of the train, there is a 12.1 inch LCD monitor to display platform CCTV images, and a primary display panel. NB: For illustration, RAIB has superimposed a typical platform image on the CCTV monitor display, as the original photograph showed a blank display.

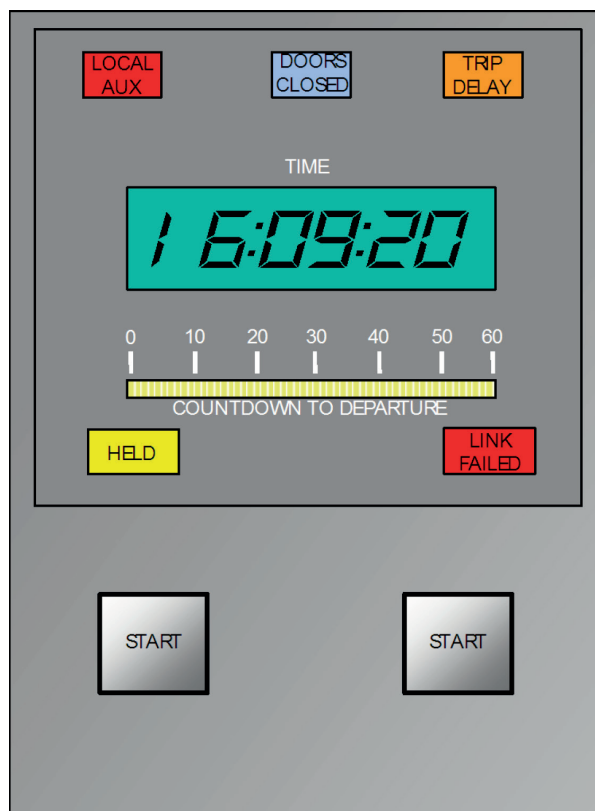
- 39 The primary display panel (figure 4) includes the following features:
  - a. a 'doors closed' visual indicator (blue light, top centre), commonly known as a 'pilot light', which shows that a door interlock circuit has detected that all the doors are closed and, therefore, that the train can be moved (see paragraph 49);

- c. a pair of start buttons which must be simultaneously pressed and held for at least two seconds to start the train.
- 40 The train operator uses images on the CCTV monitor to check the platform-train interface during train despatch. The CCTV monitor displays images from station cameras, which are transmitted to the train from around the moment it enters the station until the last carriage has left the platform. At most stations, the screen is divided into four images to cover the full length of the train and the platform edge (as shown in figure 5). However, some stations require more images due to platform curvature (for instance, Bank and Stratford stations use eight images). At platform 4 at Notting Hill Gate, there are five images arranged as shown in figure 6. The three images on the left-hand side look towards the front of the train; the two images on the right look towards the rear.

Figure 4: Schematic representation of the primary display panel (courtesy of LUL)

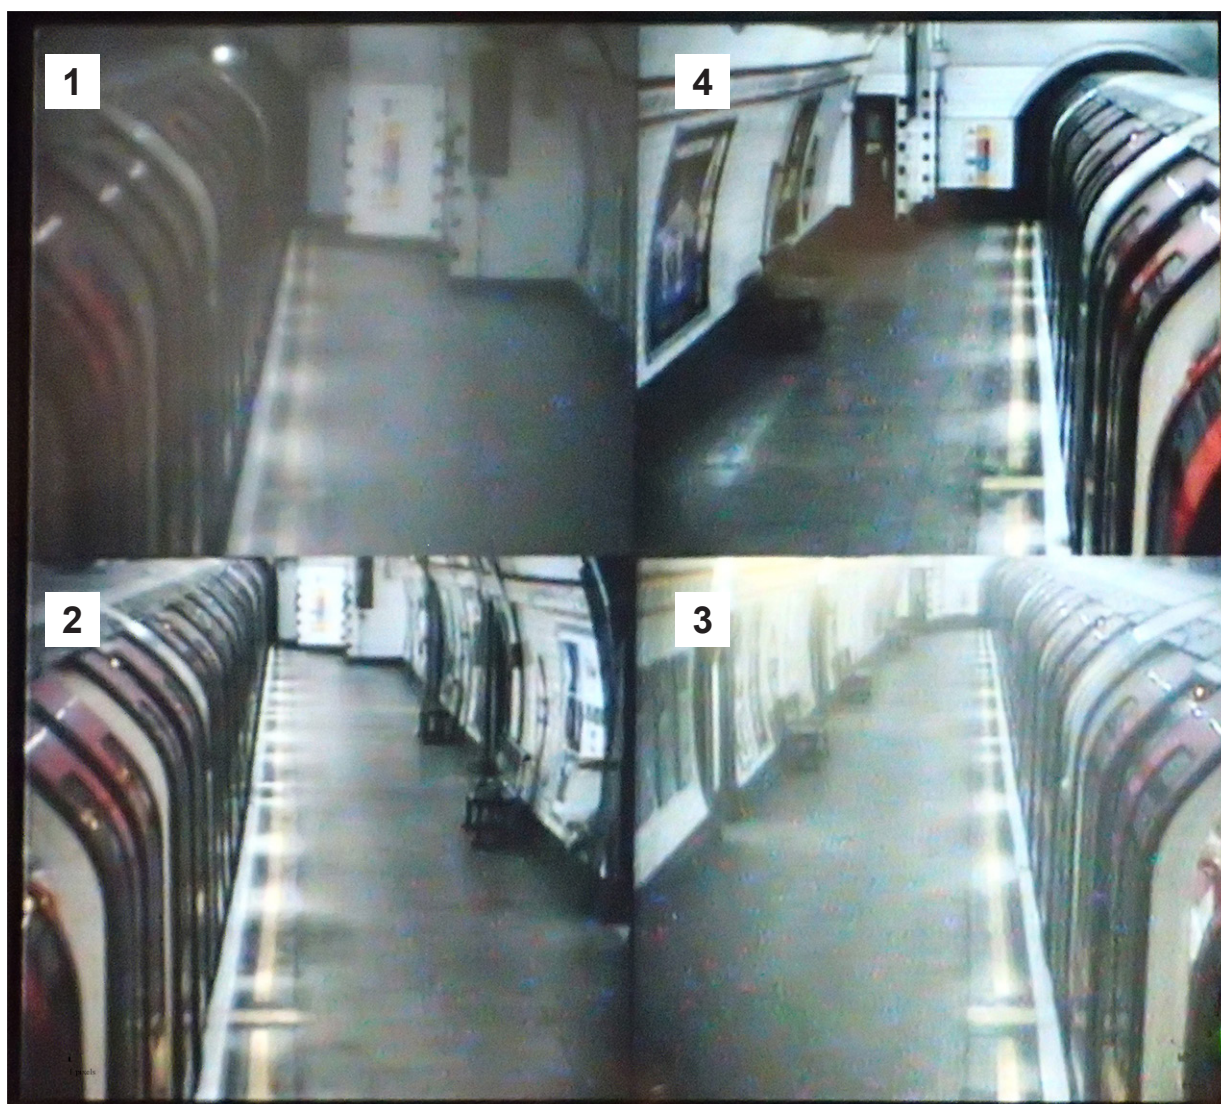
Figure 5: Typical arrangement of in-cab platform CCTV images on the Central line (numbers denote the ordering of images from front to rear of the train)

41 LUL's current standard<sup>6</sup> for in-cab, platform CCTV monitors, sets out specific requirements for a clear view of the complete critical area of the platform-train interface under all conditions at all times. This includes the configuration of cameras, the arrangement of images on the monitor (with no more than four images per display screen) and visibility requirements for the displayed image. The specified optimum viewing angle for a target object shall be at least 54 minutes of arc<sup>7</sup> at the driver's eye point, and shall never be less than 42 minutes of arc (the absolute limit of discernibility is defined in the standard as 20 minutes of arc). The same specified object should occupy at least 13.2% of the screen height for a four-way split screen. However, 1992 stock pre-dates this standard and the standard is not applicable retrospectively. LUL stated that the specification for the in-cab platform CCTV monitors on 1992 stock is no longer available.
