Rail Accident Report

Structural failure caused by scour at Lamington viaduct, South Lanarkshire 31 December 2015

Report 22/2016
November 2016

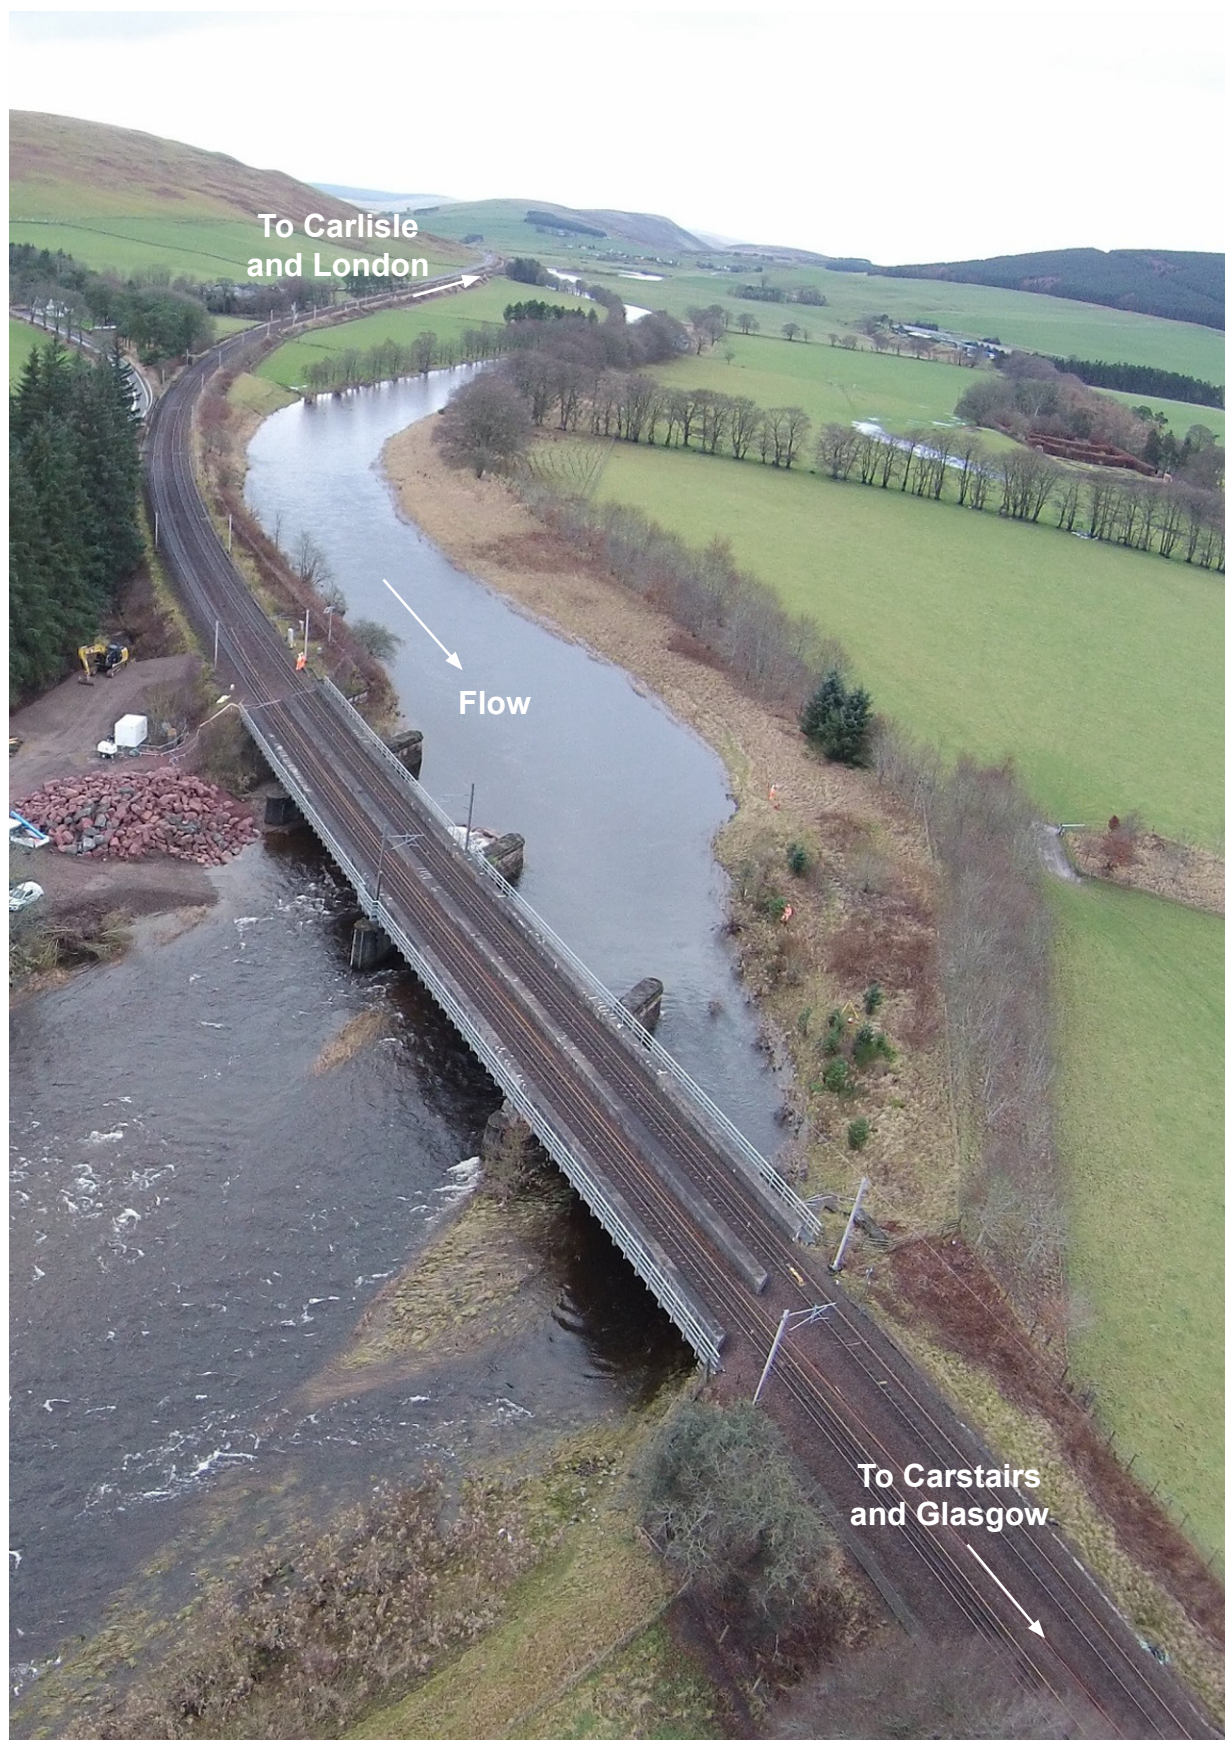
Figure 2: Aerial view of Lamington viaduct looking south-west towards Lockerbie and Carlisle on 4 January 2016 (photograph courtesy of Network Rail)

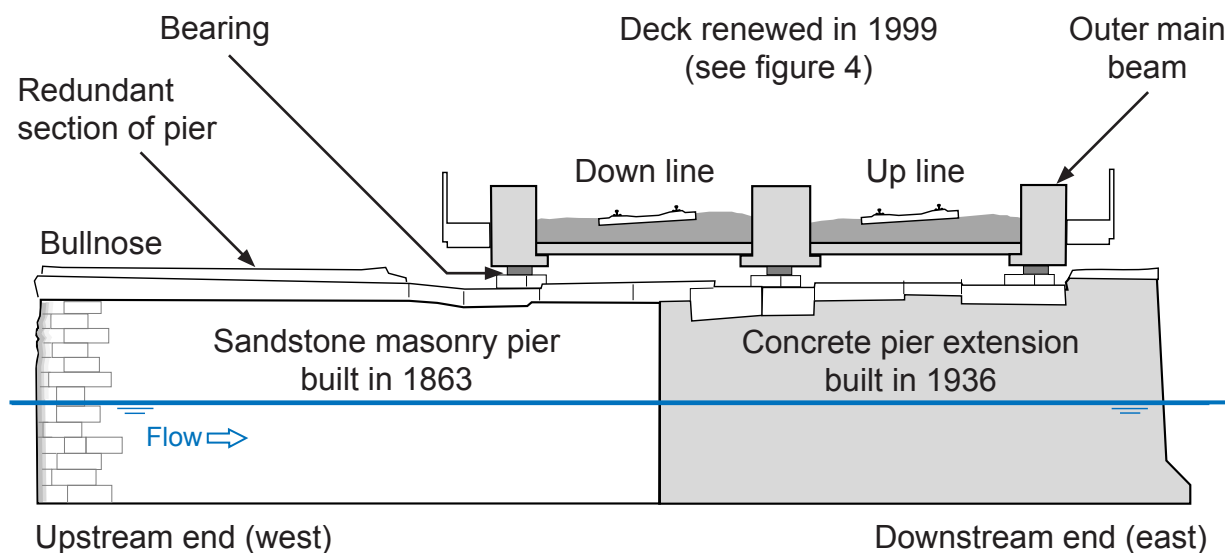
Figure 3: South face of pier 2 looking north, showing the position of current bridge deck in relation to the substructure. The up line is carried on the concrete pier extension (see also appendix D).

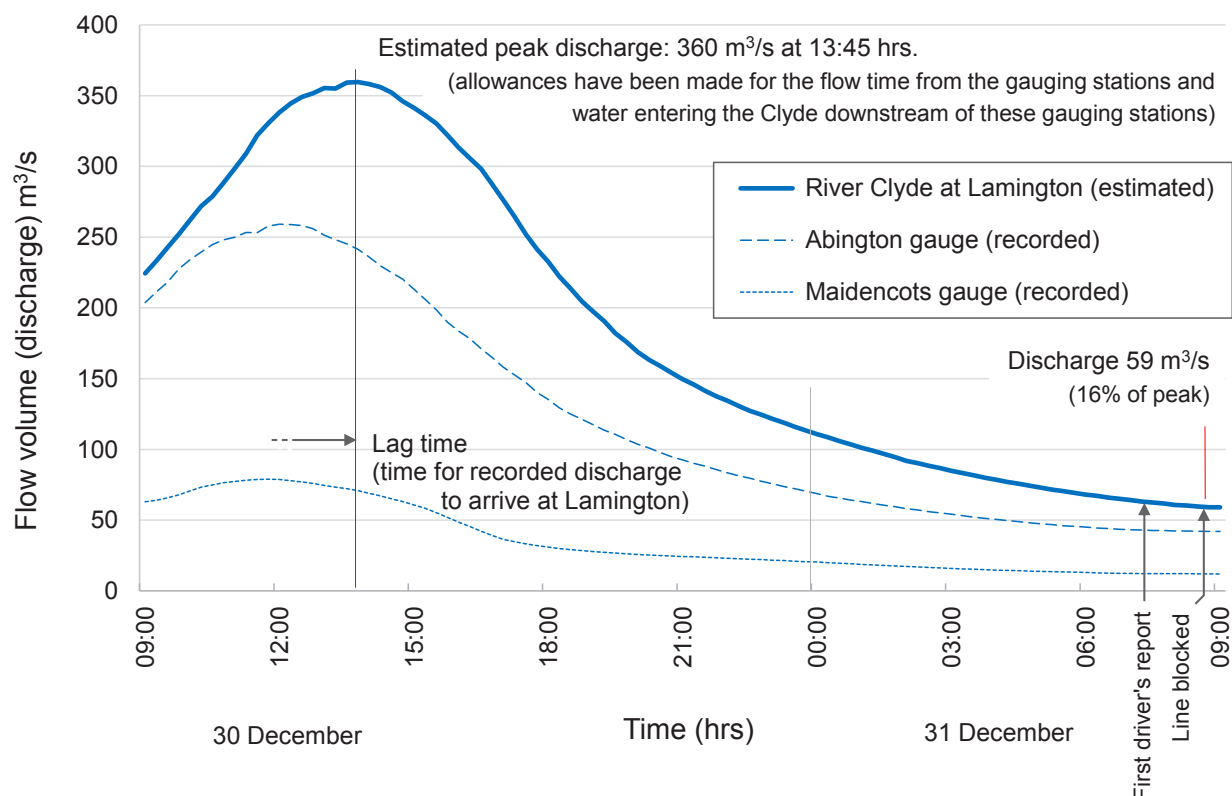
Estimated hydrograph for River Clyde at Lamington viaduct, 30-31 December 2015

- 36 The peak flow reached Lamington viaduct, 10 km downstream of Abington gauging station, several hours later (figure 7). The discharge volume may have reached 360 m³/s, based on the combined flow recorded at Abington and Maidencots gauging stations (337 m³/s), plus an allowance for inflow from other watercourses which join the Clyde between the gauging stations and Lamington. The next SEPA gauging station downstream is at Sills of Clyde between Carstairs and Lanark, 31 km beyond Lamington. Peak flow here did not occur until 23:00 hrs on 30 December.

Figure 7: Hydrograph showing estimated river flow at Lamington viaduct for 24 hours from 09:00 hrs on 30 December

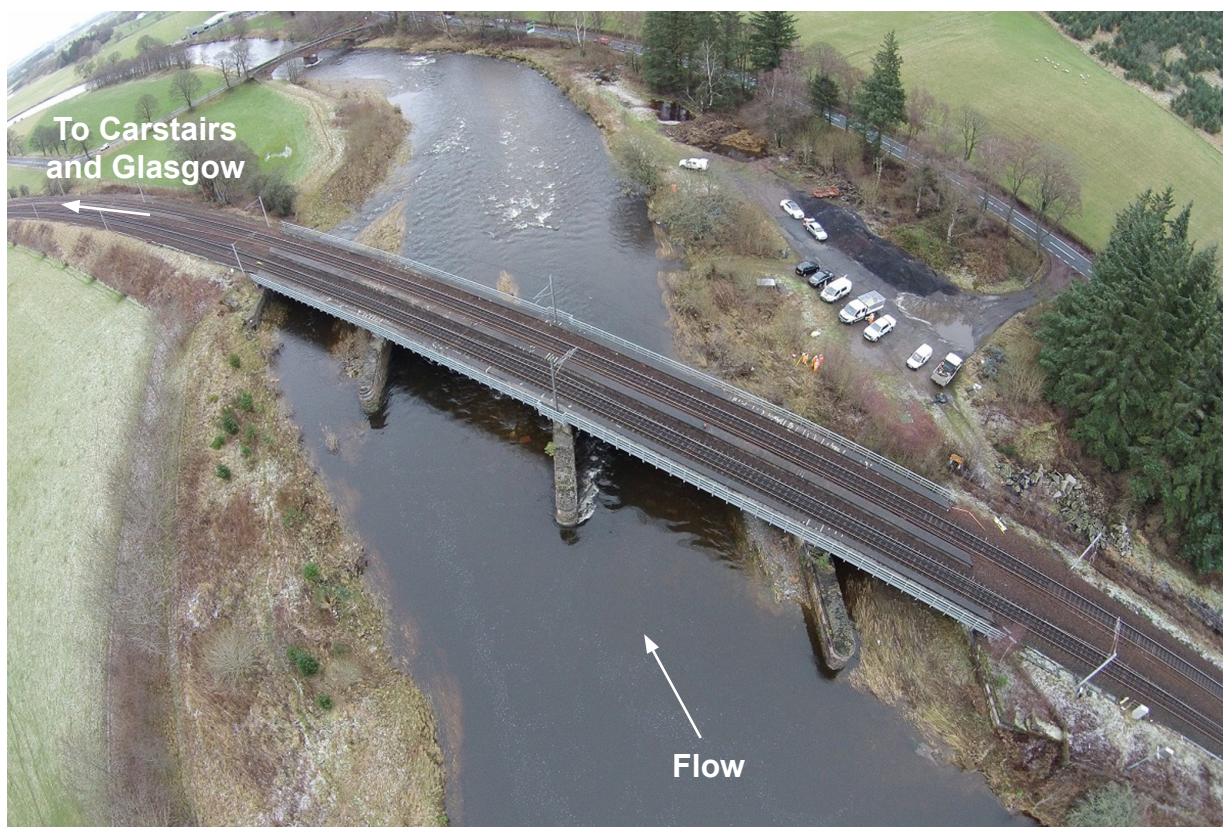
- 50 An underwater survey was attempted by divers on 1 January, but abandoned until the following day because the river flow was still too fast (figures 10 and 11). The survey found substantial scour damage affecting the masonry section of pier 2 and a void under the full width of the concrete pier extension.
- 51 Pier 2 continued to move after the line was closed. By early January, the outer main beam adjacent to the down line had dropped by 130 mm. The pier had also tilted by 180 mm towards the south abutment, displacing the bearings supporting the main beams (figure 12), causing the deck to subside and twist. A civil engineering contractor, brought in by Network Rail to stabilise and repair the structure, imposed an exclusion zone on and below the deck because of the risk that the pier might overturn or collapse.

Figure 10: Aerial view on 1 January 2016 (photograph courtesy of Network Rail Air Operations)

- 65 The missing masonry blocks were not found above river bed level by the divers and would have been too heavy to wash downstream. In addition, there is no abnormal surface turbulence visible in photographs taken on 31 December 2015 and 1 January 2016 (figure 9, figure 10 and figure 11). This evidence suggests that a scour hole had developed in the river bed that was of sufficient size and depth to accommodate the missing masonry from the pier. Once the angular masonry blocks started to pile up on the scoured river bed, they will have created a weir-effect, increasing turbulence and the risk of further scour occurring upstream and downstream.

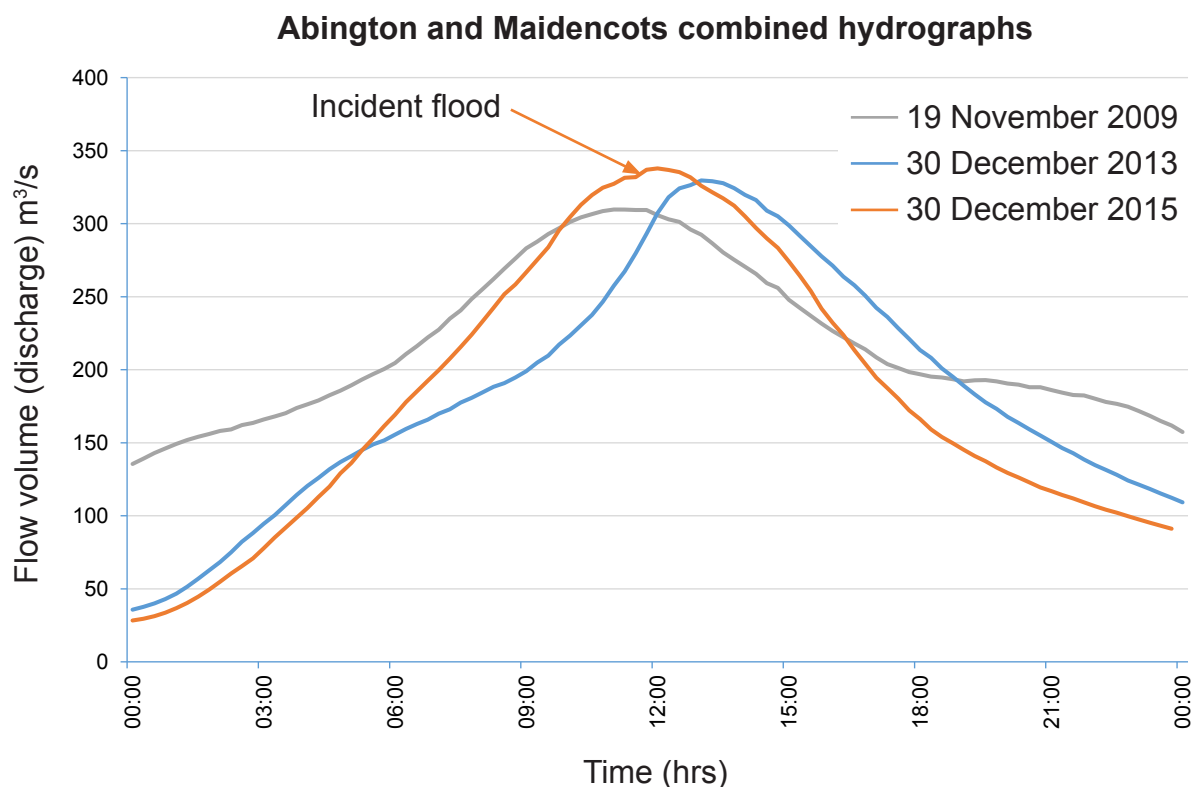
- 67 Historic river flow evidence is consistent with this assessment of probability. Although the river level on 30 December 2015 was high, witnesses confirm that it was not unprecedented. Comparable floods⁹ also occurred on 20 November 2009 and 30 December 2013 without apparently damaging the structure (figure 19). Although the structure may have been at significant risk during these events, the absence of significant damage shows that previous behaviour may not be a reliable indicator of risk.

Figure 19: Hydrographs for flood events in 2009, 2013 and 2015, recorded by SEPA's Abington and Maidencots gauging stations
