Rail Accident Report

Fatal accident at Tyseley depot 14 December 2019

> Report 09/2020 October 2020

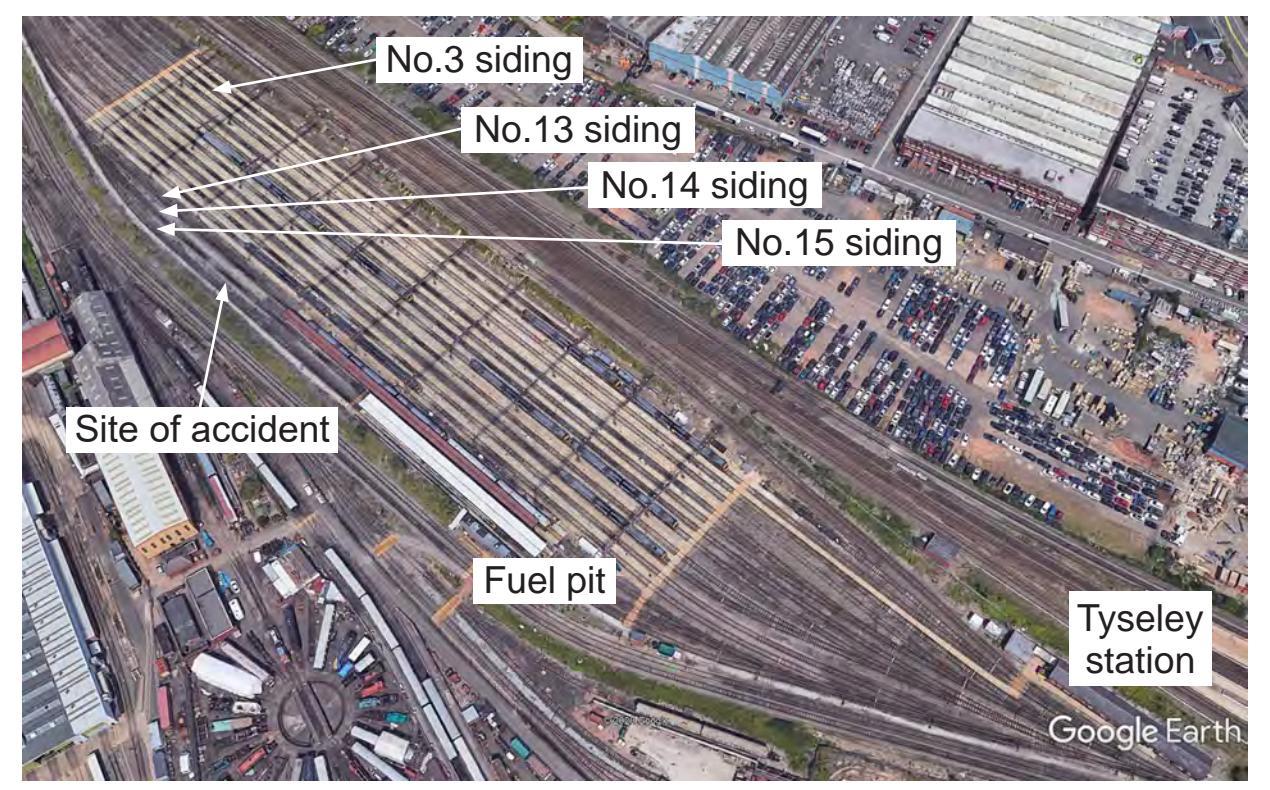
6 The carriage sidings at Tyseley depot consist of 15 parallel tracks (figure 3). These are numbered 1 to 15, with number 1 siding being closest to the main railway line. The sidings may be accessed from either end of the depot. Trains may enter or leave the depot at either its north (Birmingham) or south end.

Figure 3: The carriage sidings at Tyseley depot. Locations pertinent to the accident are indicated

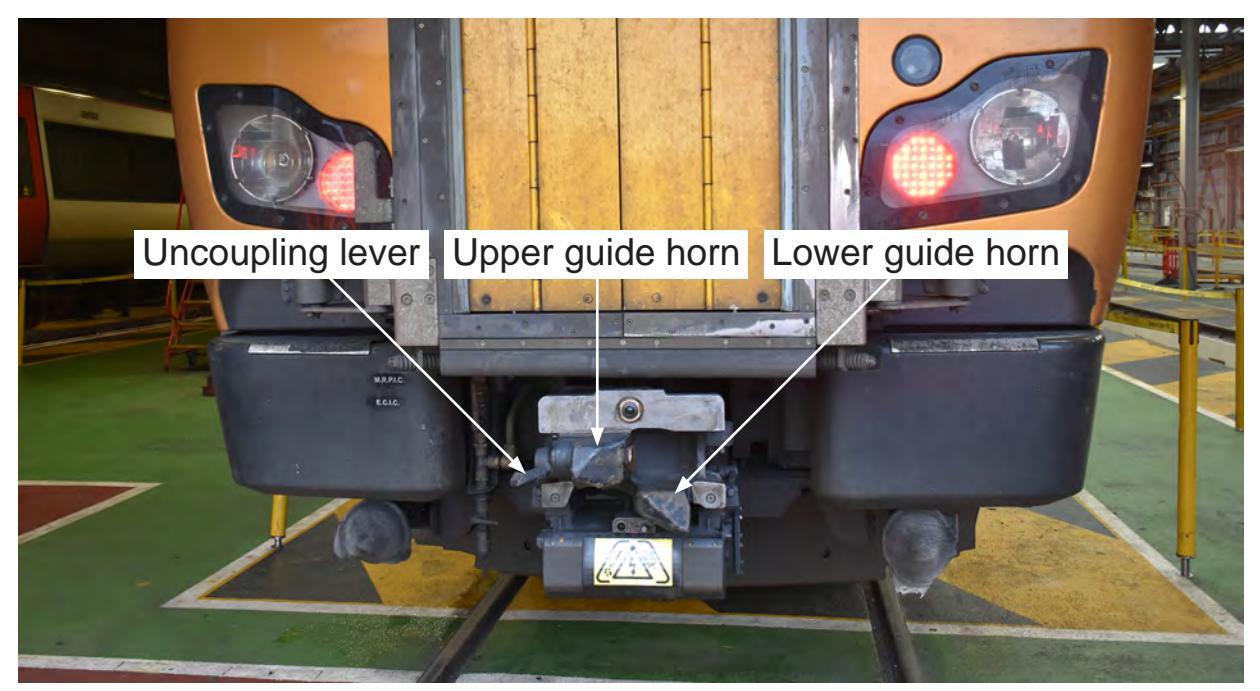
Figure 5: BSI autocoupler fitted to Class 172 unit

- 33 Although BSI autocouplers are generally reliable, units sometimes fail to couple correctly, generally due to misalignment between the autocouplers. In this event, drivers are trained to make a second attempt and to investigate the cause only if this also fails.
- 34 The gangway on a Class 172/3 unit is mounted immediately above the autocoupler. Gangways are pressed together by springs when the trains are coupled, and folding doors are then opened to allow passage between the units.

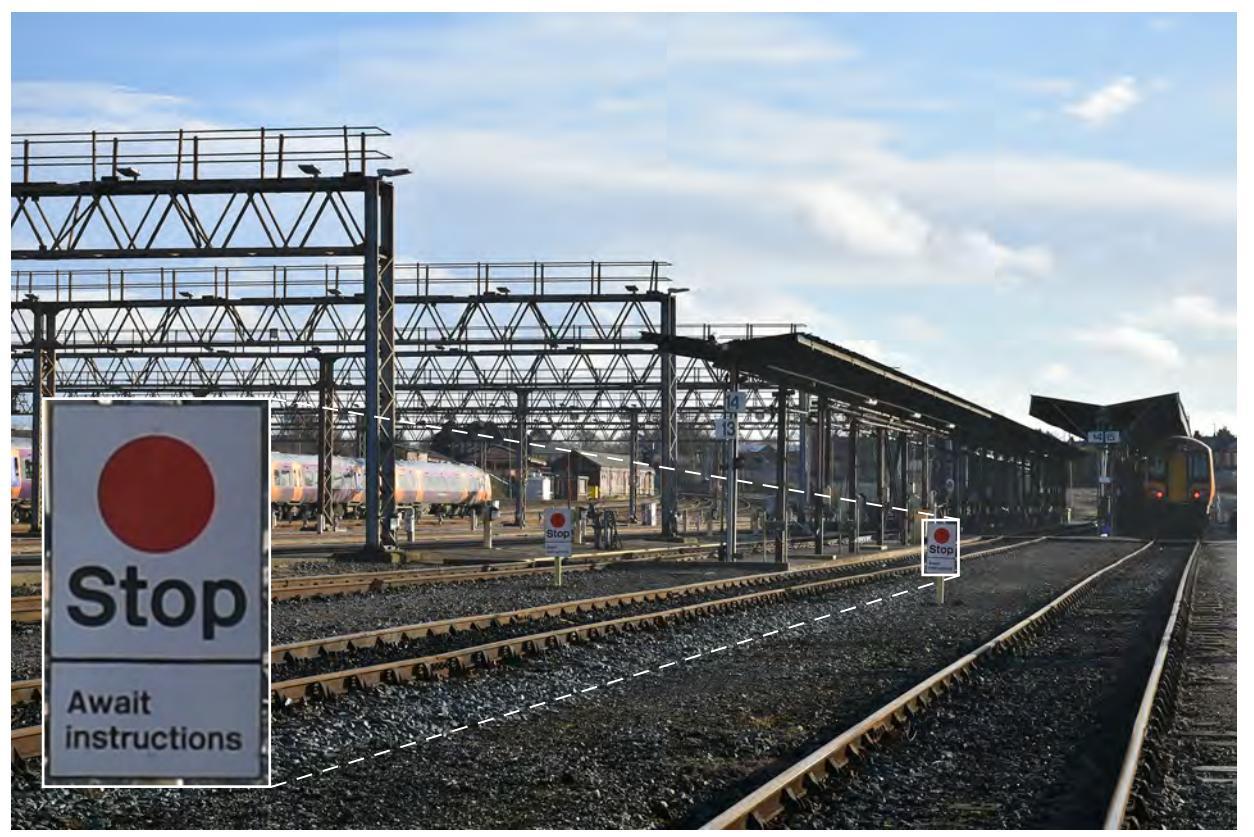
- 37 Almost all trains arriving at the depot pass through the fuel pit. Trains arriving onto numbers 13, 14 or 15 sidings are directed by the North End Shunter along one of these sidings using manually operated points. Once on these sidings, drivers are required to stop their trains at stop boards (figure 6) located to the north of the fuel pit. This is to ensure that trains enter the fuel pit in a controlled way. The boards are positioned to ensure that trains stabled on sidings 13, 14 or 15 do not interfere with movements on other sidings. Once stabled, only the designated person³ for the fuel pit can authorise a driver to bring a train into that area. In the event that the designated person does not immediately authorise an arriving train to proceed beyond the stop board, then the driver of an arriving train will normally stable their train adjacent to the stop board, and then leave the train cab. The area north of the stop boards, including that where the accident occurred, remains under the control of depot operations staff.

Figure 6: View looking south towards the fuel pit. Number 15 siding is on the right and a 'stop board' is indicated

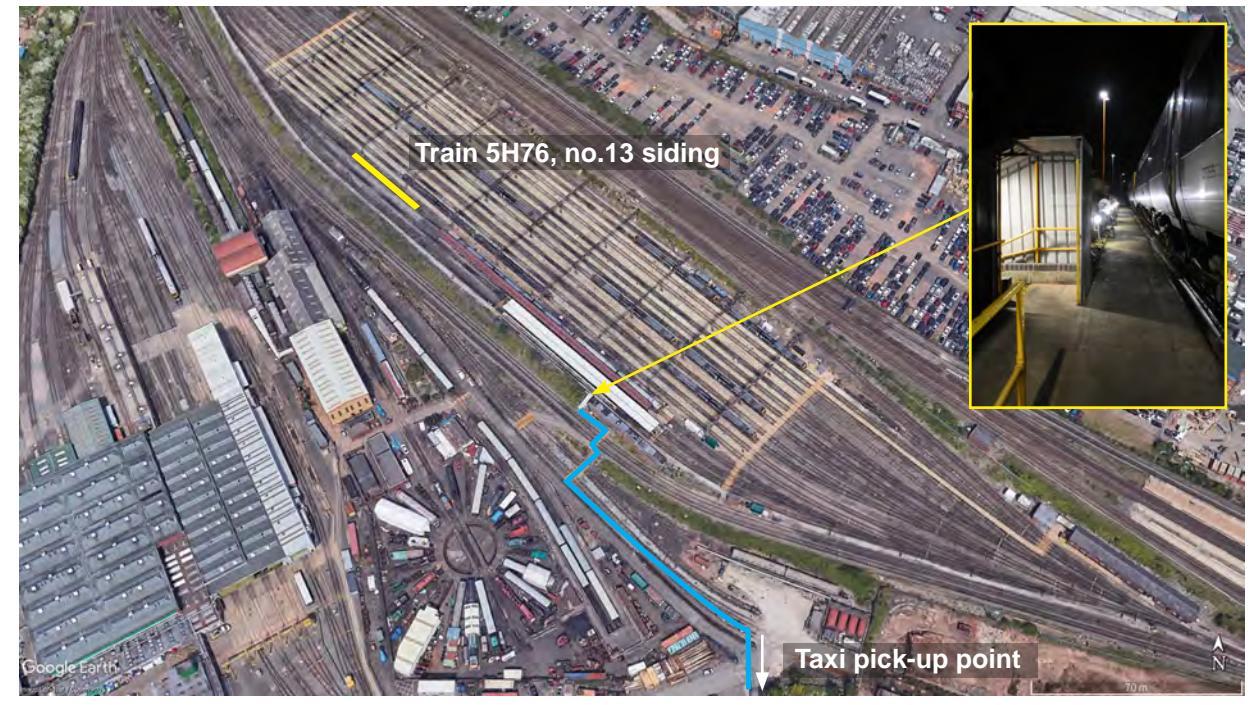
- 61 This pick-up location (figure 7) is some way from the carriage sidings at Tyseley and Driver A could have taken a number of possible routes to reach it. All of them involved first crossing the yard to reach the stairs (figure 8), which provided the only passage from the carriage sidings to the pick-up location.

Figure 7: Tyseley depot carriage sidings, showing the location of train 5H76, and the route from the fuel pit to the taxi pick-up location

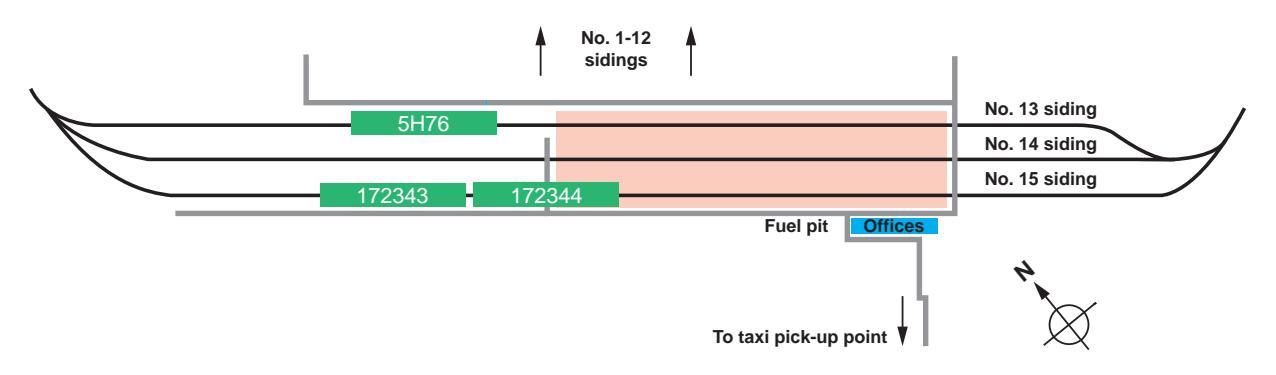
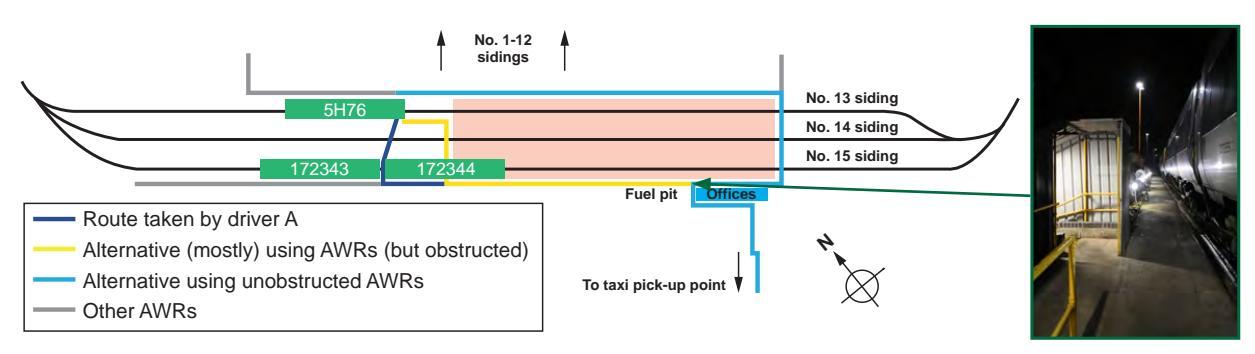
- 62 Three possible routes (figures 8a and 8b) were available to Driver A to cross the yard from the location on number 13 siding where he stabled train 5H76 to the top of the stairs. These were:

- the route which Driver A attempted to take (figure 8b) and which would have involved walking 135 metres to the top of the stairs. This route required the driver to pass between the two units involved in the accident before he could join an AWR

- a second, slightly shorter route, of 130 metres which mainly comprised AWRs. This route was not available to Driver A because the southern-most coach of unit 172344 was obstructing the authorised walking route where it crossed number 15 siding

- a third route of 200 metres, which used only those AWRs which were not obstructed at the time of the accident. This route predominantly used an AWR between numbers 12 and 13 sidings.

Figure 8a: AWRs in the vicinity of the stabled location of train 5H76

Figure 8b: The various possible routes available to Driver A between his train (5H76) and the top of the stairs leading to the taxi pick-up location

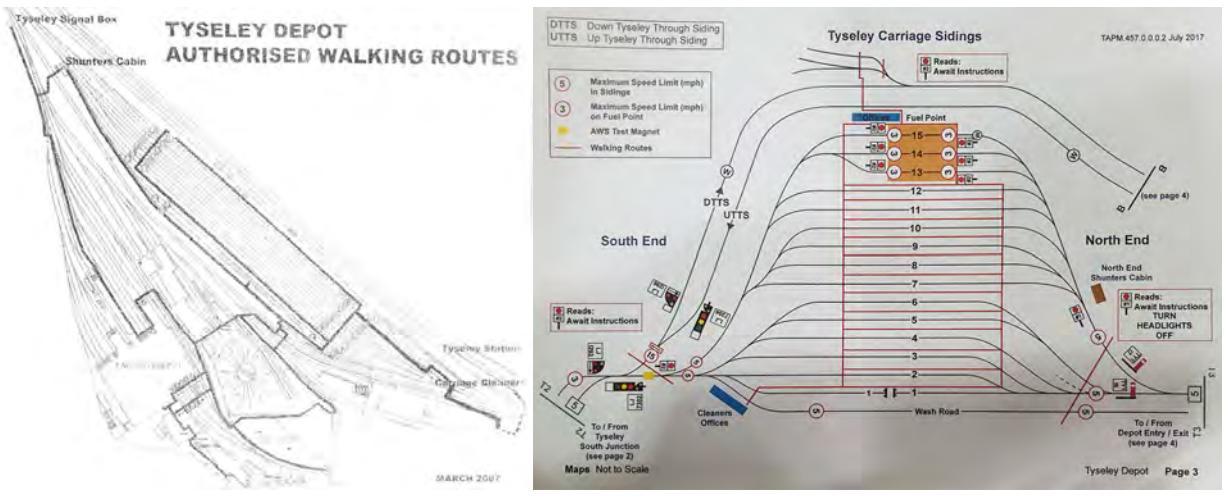
- 67 Maps showing the AWRs at Tyseley depot (paragraph 45) were displayed in notice cases at the depot itself and in information provided to drivers at the WMT traincrew facility at Birmingham New Street (figure 11). However, the maps provided at the depot and at Birmingham New Street were different to each other. WMT advised RAIB that it was the map on display at Birmingham New Street which contained incorrect information, but it was unclear to managers at WMT how this error had occurred, or what the process was at the time of the accident for agreeing the AWRs at the depot.

Figure 11: Maps showing the AWR maps as displayed at Tyseley (left) and at Birmingham New Street (right)
