Rail Accident Report

**Fatal accident at Waterloo Underground station,
London
26 May 2020**

Report 05/2021
September 2021

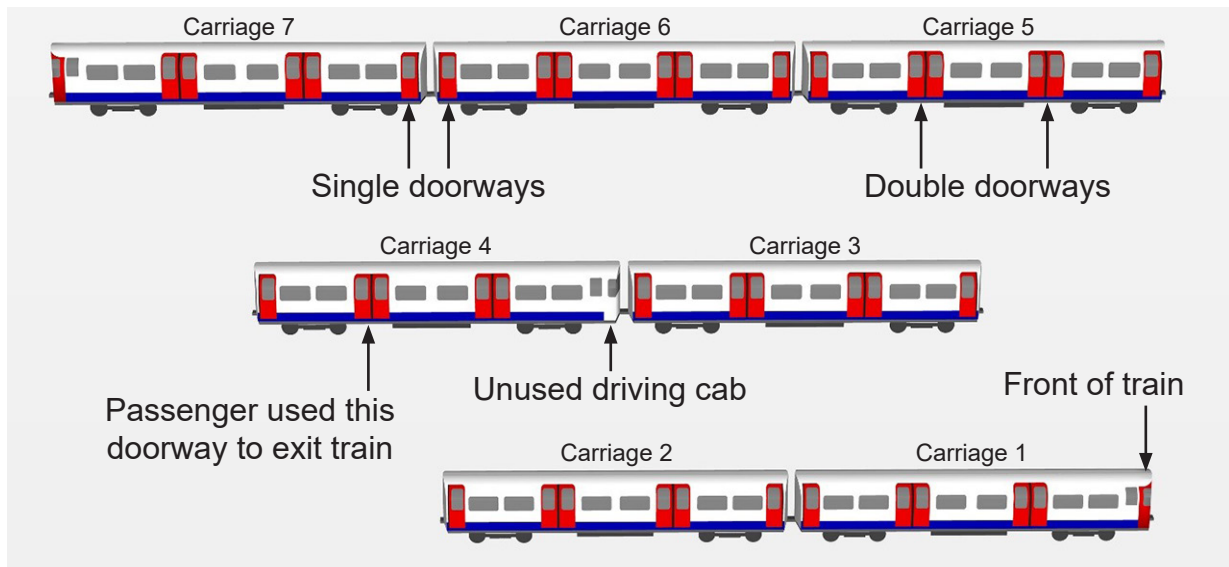
Figure 4: Arrangement of passenger saloon doors on 1972 tube stock trains

- 10 Both trains were formed of 1972 tube stock and consisted of 3-carriage and 4-carriage units operating as 7-carriage trains. Each carriage is about 16 metres long with two double doorways approximately one-third and two-thirds of the way along the carriage length, and single doorways at each end. The fourth carriage of the incident train incorporated a driving cab, so did not have a single doorway at the leading end (figure 4).

- 23 It has not been possible to determine if this announcement was made before the passenger alighted and, if so, whether it prompted him to get off the train. However, 176 seconds after the train had stopped, the passenger left the train from the rear set of double doors of carriage 4 (the fourth carriage from the front of the train, figure 4). After taking two steps on the platform, moving away from the train, the station CCTV shows the passenger becoming unsteady on his feet, stumbling backwards, and falling into the gap between the platform edge and the mid-point of carriage 4. He fell entirely below the level of the platform at a position where the curvature of the platform is particularly tight and so the gap between the platform and the side of the train was particularly wide (paragraph 6).
