Rail Accident Investigation Branch

Rail Accident Report

Signal passed at danger and subsequent near miss, Chalfont & Latimer station 21 June 2020

Report 04/2021
July 2021

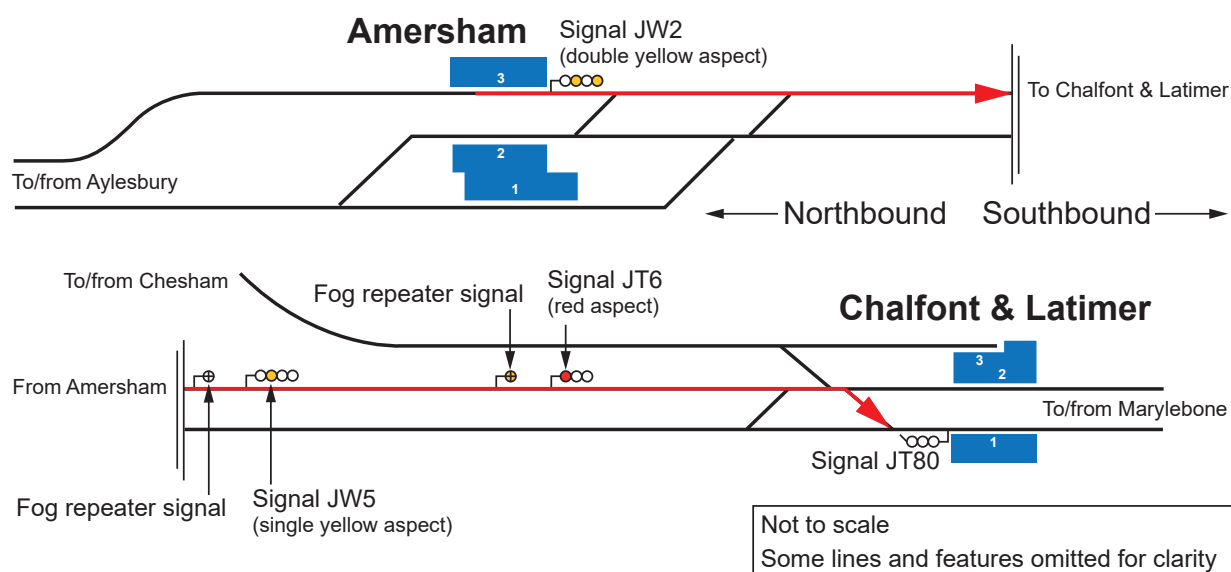
Figure 4: Metropolitan line between Amersham and Chalfont & Latimer

- 9 A crossover immediately north of Chalfont & Latimer station allows northbound trains to cross from the northbound main line to the southbound main line. The crossover comprises a short length of track linked to the main lines by a set of points at each end. A further set of points, described as the Chesham branch junction in this report, links the southbound main line to the single line serving Chesham station. In normal circumstances these three sets of points form the route to the Chesham branch from Chalfont & Latimer platform 1.

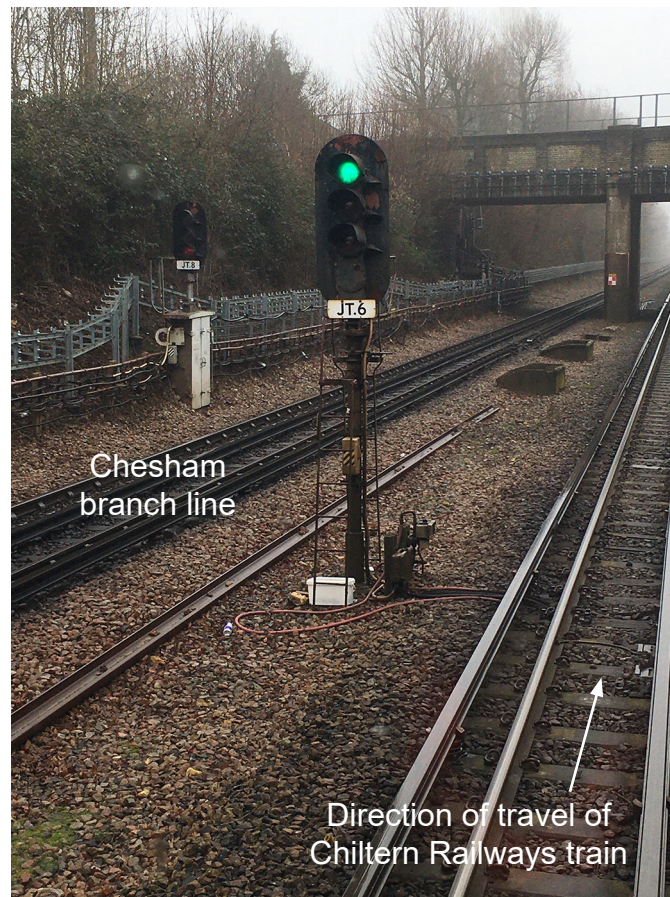
Figure 6: Signal JT6 (image courtesy of London Underground Ltd)

123 metres	Fog repeater for signal JT6	Yellow	Fog Repeater signals display a yellow aspect if the signal ahead is displaying a red aspect.
Stop signal	Signal JT6	Red	Approximately 842 metres from Chesham branch junction (see figure 6). A red aspect means 'danger'. The train must not proceed beyond the signal.
<p>These signal aspects are as seen by the driver of a southbound train when the route is set for a northbound train to cross the southbound main line and then take the branch to Chesham, and assumes that there is no other train between the southbound train and the junction.</p> <p>*Fog Repeater signals provide an advanced warning to the driver of the aspect displayed at the signal ahead. They are provided in areas susceptible to reduced visibility due to fog.</p>

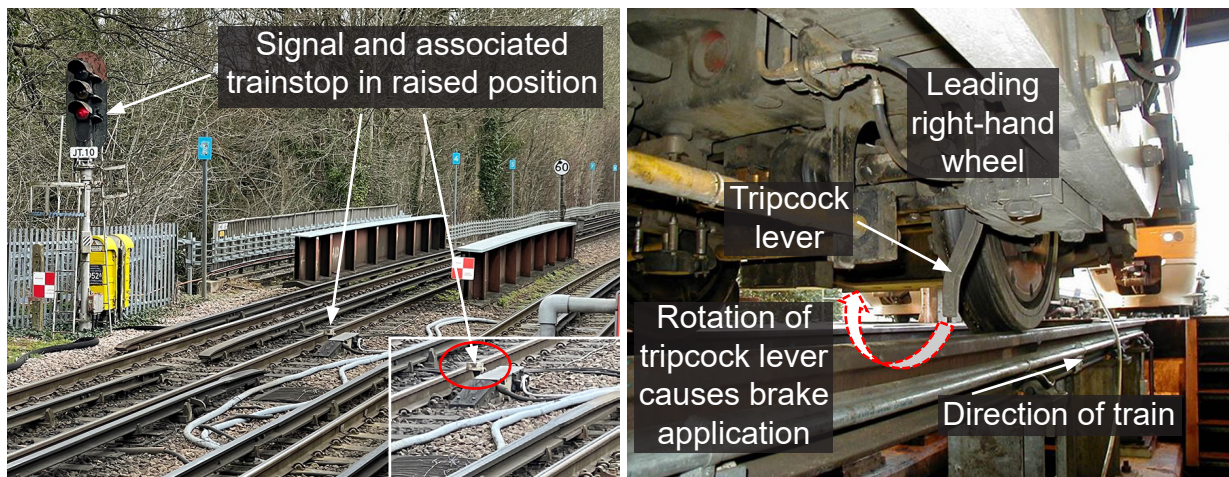
Figure 13: Trainstop (left image) and Tripcock lever fitted to class 165 train (right image) (images courtesy of LUL and Chiltern Railways respectively)

- 36 The tripcock safety system comprises trackside trainstops (figure 13 left image) and train-borne tripcocks operated by a lever (figure 13 right image). The mechanical trainstops are raised adjacent to signals showing a stop aspect and, in this position, will be struck by a train's tripcock lever causing the lever to rotate and operate the tripcock causing an emergency brake application. Trackside equipment was fitted to all signals capable of displaying a red aspect in the incident area. Tripcocks were fitted to all Metropolitan line trains. The tripcocks on the Chiltern Railways class 165 trains were always active, even when not operating over LUL infrastructure.
