Accident involving a rail grinding train in Stavoren, the Netherlands, on 25 July 2010

The Hague, September 2011

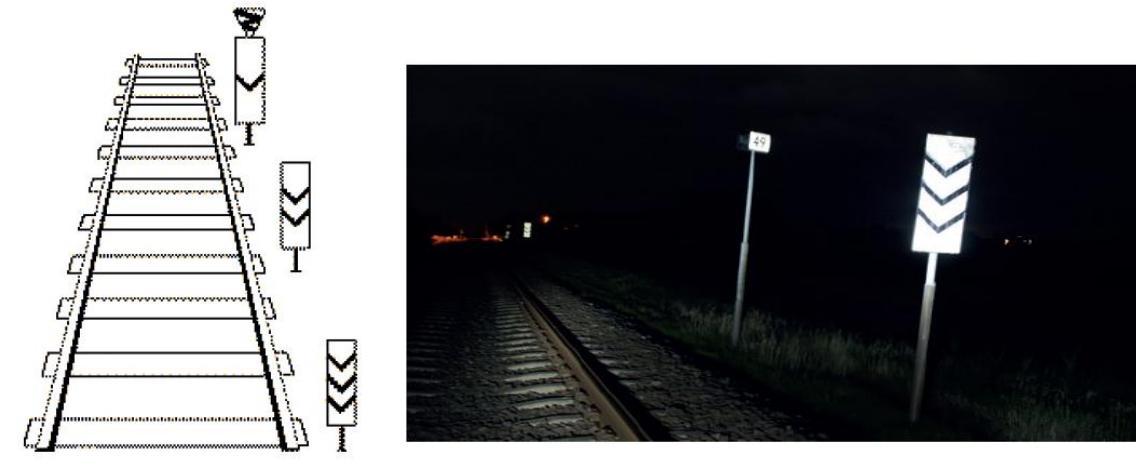
Figure 4: Illustration of the approach markers (consisting of a series of three signs with an intermediate distance of approximately 70 metres).

- Stavoren Station does not have the usual light signal entering a railway station. However, a series of approach markers (*keperbaken*) are located alongside the railway track at a distance of approximately twelve hundred metres from the end of the railway track (see figures 4 and 5). These approach markers consist of three signs located alongside the railway track spaced at an intermediate distance of approximately 70 metres from each other. These markers have the same meaning as an amber light signal ('limit speed to 40km/h, or reduce speed as much as is necessary in order to be able to stop at the next signal commanding the train to stop').

When approaching Stavoren, the rail grinding employee located in the cabin with the train driver and the vehicle operator asked the train driver a question about the rail grinding activities that were to be carried out later. In response to the question, the train driver consulted the visual instructions (a track layout plan) and spoke to the relevant employee (who was located behind him). On account of the language barrier the train driver turned his head in the direction of the Italian rail grinding employee for a number of seconds. As a result, the train driver was temporarily unable to see the section of the railway track in front of the train. The train driver himself estimates that the entire conversation took approximately half a minute. During that period the rail grinding train, which was travelling at a speed of approximately 95km/h, passed three approach markers (*keperbaakborden*) located alongside the railway track approximately 1200 metres from the end of the line. The train driver did not notice the approach markers, or in any event failed to recognise the significance of the approach markers. The Italian vehicle operator was not familiar with the approach markers and maintained the speed of the train (approximately 95km/h).

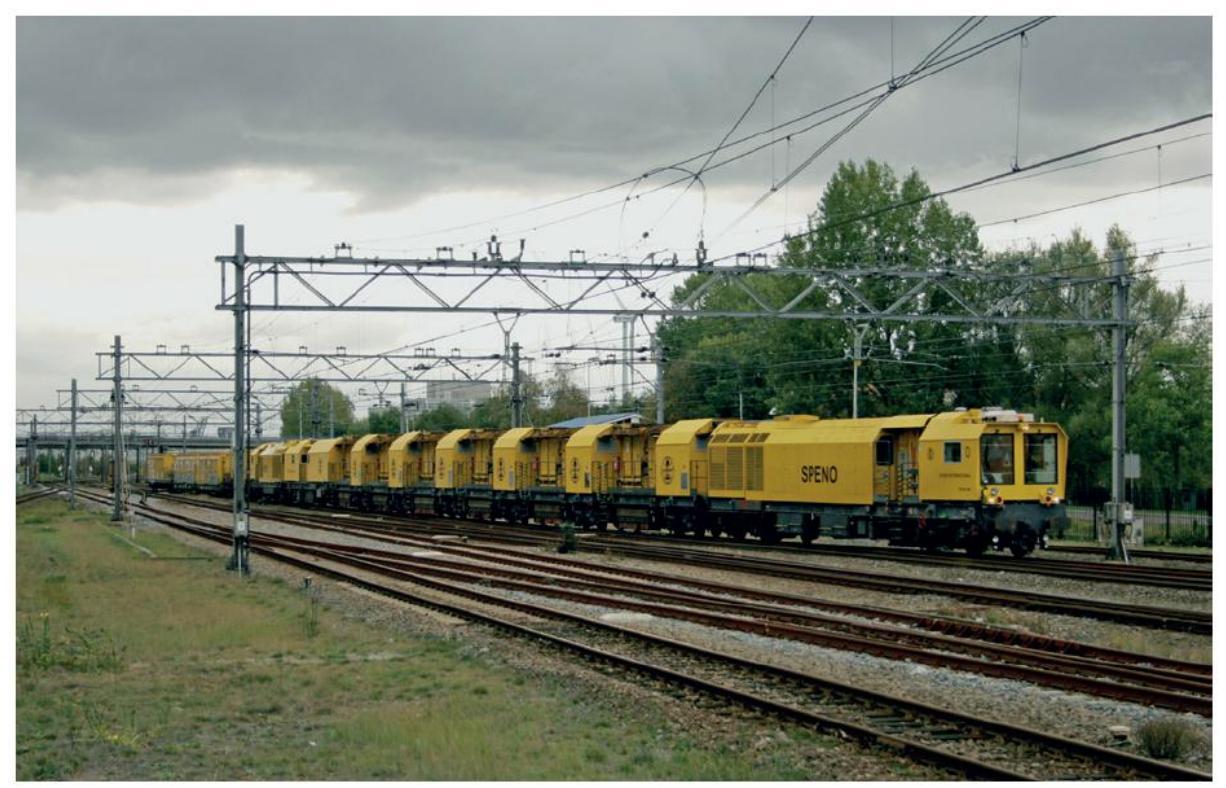
*Figure 6: This photograph shows a rail grinding train similar to the one involved in the Stavoren accident.* (Source: Vincent Prince)

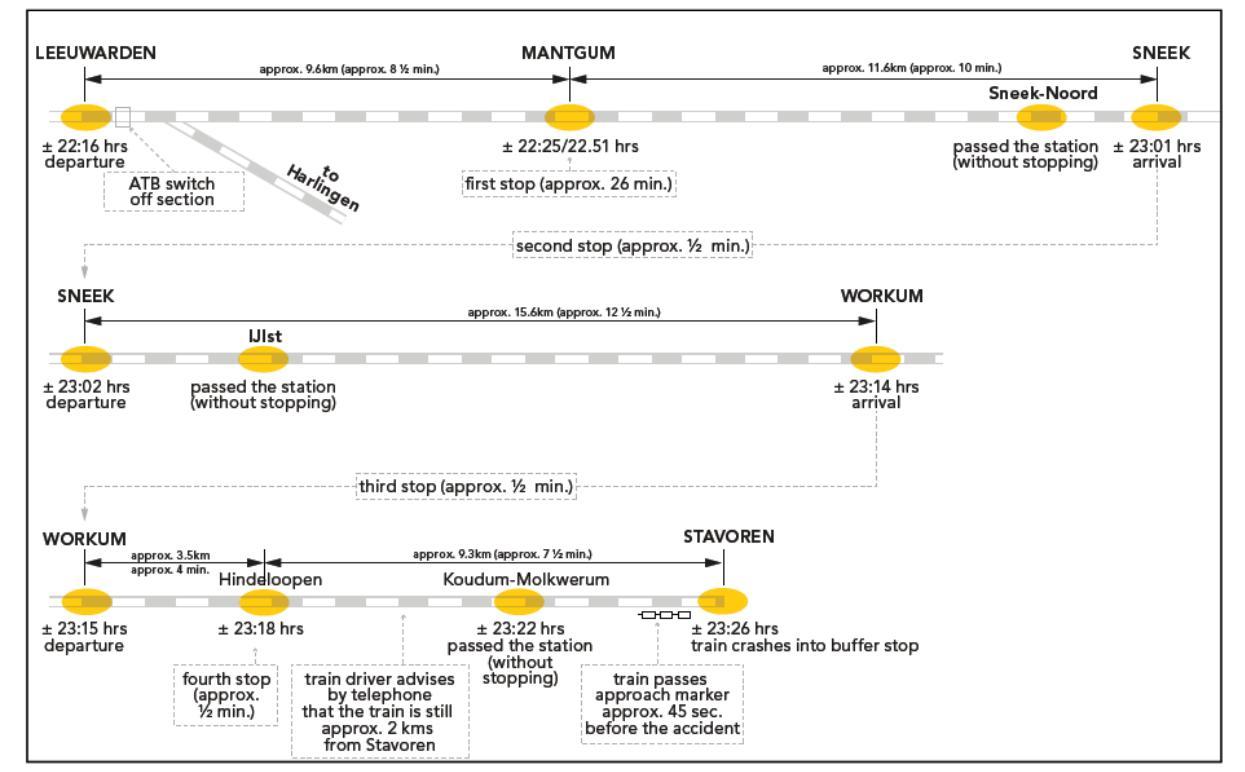
Figure 8: Diagram showing the course of the transfer journey from Leeuwarden to Stavoren

The 'Koeweg / Kooijweg' level crossing is located approximately 200 metres after the approach marker. This level crossing is well lit and the railway workers who were to carry out the rail grinding activities later on were standing there. When the train failed to reduce speed in passing the railway workers waved their arms in an attempt to attract the attention of the rail grinding train crew. In response to their signals, the rail grinding train employee in the rear cabin asked via the intercom whether the train should stop. The train driver thought he recognised the relevant level crossing and expected to see a speed sign shortly after the crossing indicating that the train should reduce speed to 40km/h. That sign was shown on the visual instructions that he had consulted just before that time. However, the sign did not follow. He then looked for a kilometre sign as a reference point but was also unable to locate that particular sign. Almost immediately after that, the train driver saw the end of the railway track further on and responded by instructing the vehicle operator to brake in German: 'Bremsen, bremsen, bremsen'. The vehicle operator promptly initiated an emergency braking action, but by that time the distance to the buffer stop was too short to halt the train on time. However, the three men still managed to get out of their seats and move to the rear wall of the cabin. The train then crashed into the buffer stop.

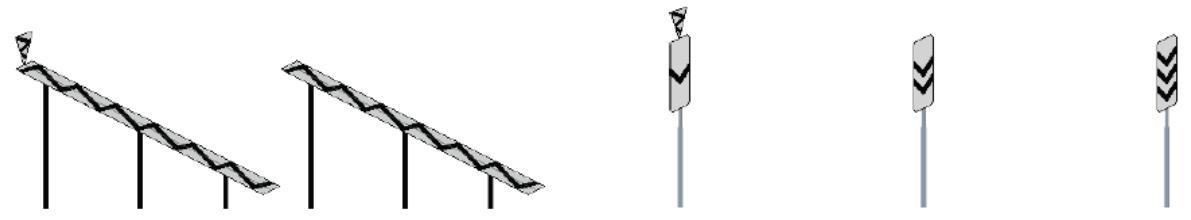
In these situations insufficient braking distance is therefore available between the warning signal and the main signal. In order to instruct the train to brake in time nonetheless, a marker containing a triangular sign painted with black and white zigzag stripes is placed at braking distance from the main signal. This may apply to both 'dual marker boards' and from 1969 also to the perpendicular approach marker boards containing a herringbone pattern instead of diagonal stripes (the Dutch word *keper* means 'herringbone' from which the Dutch name for the approach marker derives its name, i.e. *keperbaken*. Literally translated this means herringbone approach marker).

*Figure 23:* 'dual zigzag marker board' (left) and 'herringbone' approach marker (right). (Source: www.klassiekebeveiliging.nl).

The zigzag or herringbone pattern shows the train driver that he has approached a main signal at braking distance. If the train driver cannot read the position of the accompanying warning signal (located at a distance which is shorter than braking distance from the main signal), for safety reasons he must apply the brakes at the location of the marker.
