Rail Accident Report

Locomotive failure near Winchfield 23 November 2013

Report 13/2014
June 2014

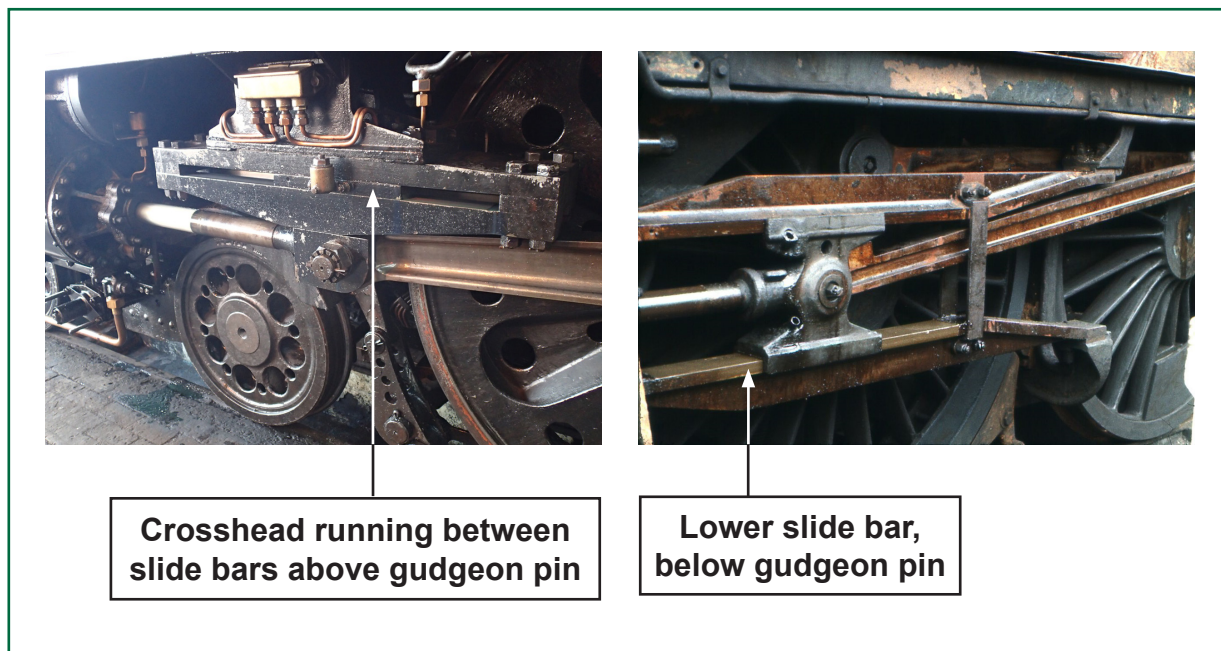
Figure 5: Comparison of single and double type slide bar arrangement

- 38 The T-shaped upper part of the crosshead runs in the *slide bars*, which are bracketed off the locomotive frames above the piston rod. There is thus nothing to prevent the connecting rod from dropping to ground level if it becomes detached at the small end, unlike other designs of locomotive which have a crosshead which runs between upper and lower slide bars (figure 5).

- 87 The design of the Bulleid small end uses slide bars only above the gudgeon pin, so that there is no lower slide bar to restrain a connecting rod if the small end becomes detached (figure 5). This arrangement was first used in Britain in 1918 on the Great Northern Railway (GNR) and from 1925 on the Southern Railway. It has been generally accepted for over 90 years.

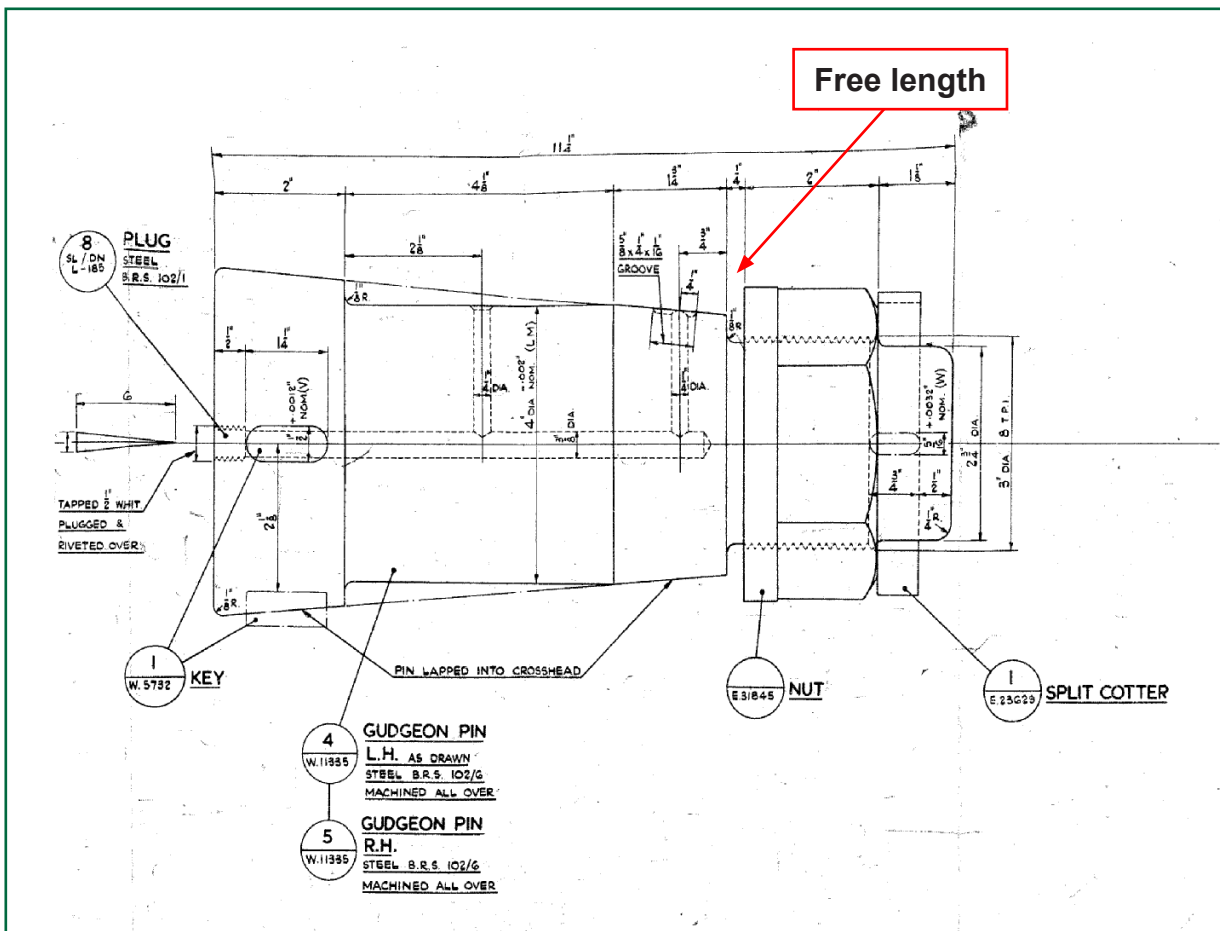
Figure 7: Detail drawing of gudgeon pin (extract from British Railways (Eastleigh) drawing W11335). Drawing reproduced by courtesy of the National Railway Museum/Science & Society Picture Library

- 47 The nature of the joint and the size of the components is such that the tightening of the nut will lead to only a very small extension of the gudgeon pin. The nominal *free length* (in a bolted joint, the length between the nut face and the bolt head) (figure 7) between the tapered section of the pin and the face of the nut is of the order of 6 mm ($\frac{1}{4}$ "). However, the sharing of the internal stresses between the various components means that some of the tapered section, the thread and nut deflection (compression during tightening) will contribute to make a greater effective free length. Assuming that the actual effective free length is of the order of 25 mm (1"), and a *preload* of 400 kN (90000 lbf) could be achieved, the extension of the gudgeon pin over the free length would be approximately 0.012 mm (0.0005"). This very small extension means that only a very small movement of the nut on the thread is required to greatly reduce or even eliminate the preload, which makes the nut susceptible to non-rotational loosening processes such as embedding loss. Besides embedding, relaxation of the joint can occur as a result of *creep* and similar effects. The joint would behave very differently if there was any mismatch between the tapers of the gudgeon pin and the crosshead bore, but there is no evidence that this was the case in this instance.

- 57 The original design of this assembly used a plain, rather than a castellated nut (figure 7). There is no evidence that this design caused any problems when the locomotives were in service with British Railways (BR), and many of the locomotives that have been preserved, either directly after leaving BR service or via the Barry scrapyard, have plain nuts on the small end assembly.

¹⁹ The specified gudgeon pin material (see figure 7) was BR Spec.102/6; that for the nuts old British Standard spec. BSS9C. Equivalent BS specs. were BS24: 1955 Railway Rolling Stock Material, part 4, no. 8D and 8C respectively. Tensile strength for Class D was 620 – 700 MPa (90,000 – 101,000 psi); class C 500 – 590 MPa (72000 – 85000 psi).
