# Rail Accident Report

## **Collision between a train and a car at Jetty Avenue level crossing, Woodbridge, Suffolk 14 July 2013**

This report is published by the Rail Accident Investigation Branch, Department for Transport.

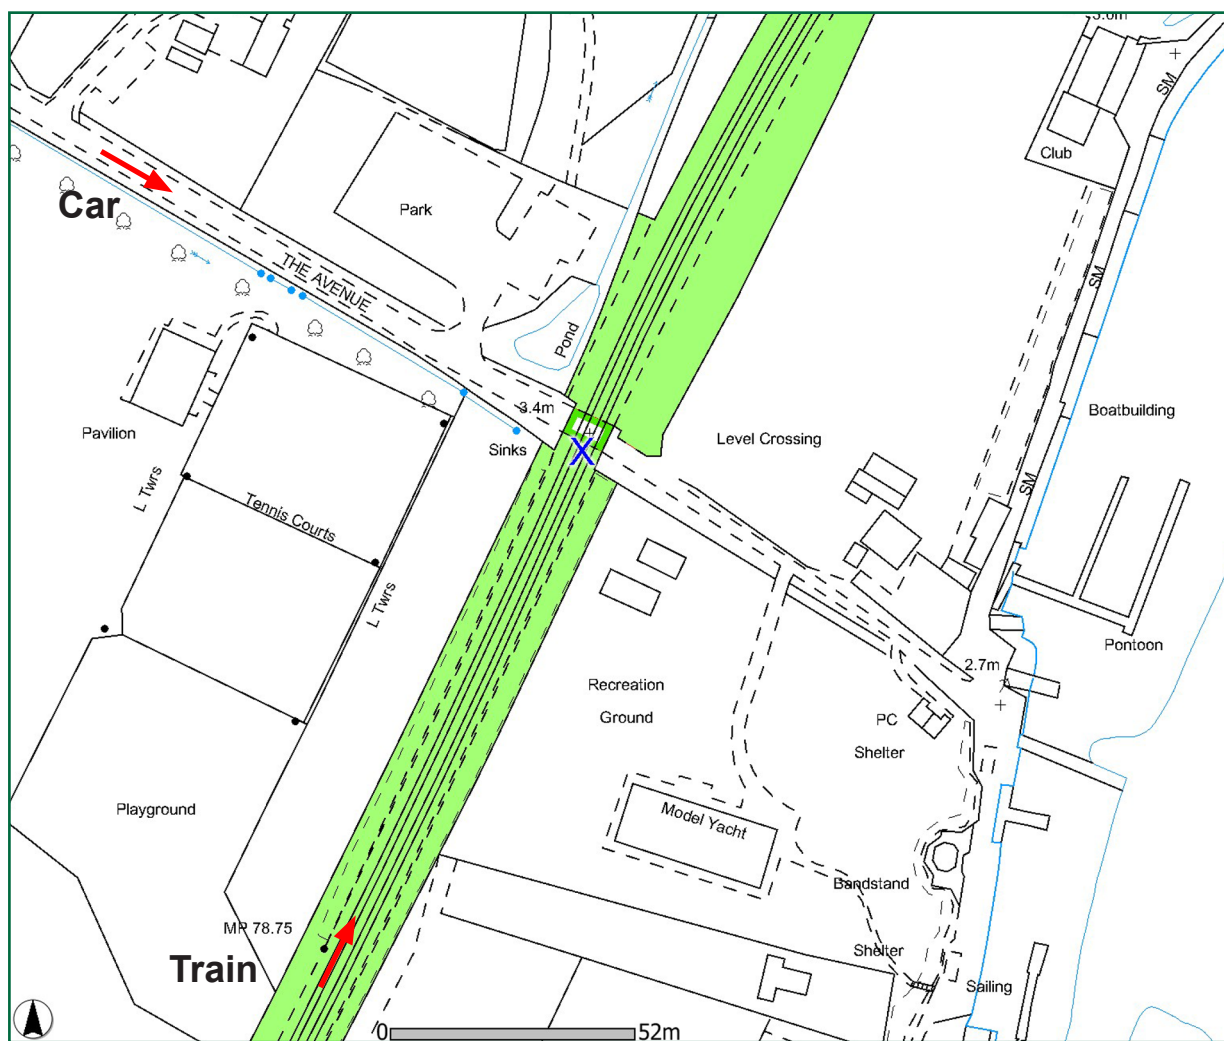
Figure 3: Map showing Jetty Avenue UWC (marked X), and extent of Network Rail infrastructure shaded green (courtesy of Network Rail). The car and train approached the crossing in the directions shown.

The car driver was using the level crossing to access a private boatyard situated between the railway and the River Deben. He was a volunteer, assisting in removing equipment following a local regatta which had been held partly on land owned by the boatyard earlier in the day. The car driver had used the level crossing on previous occasions, but had not been briefed on its use.

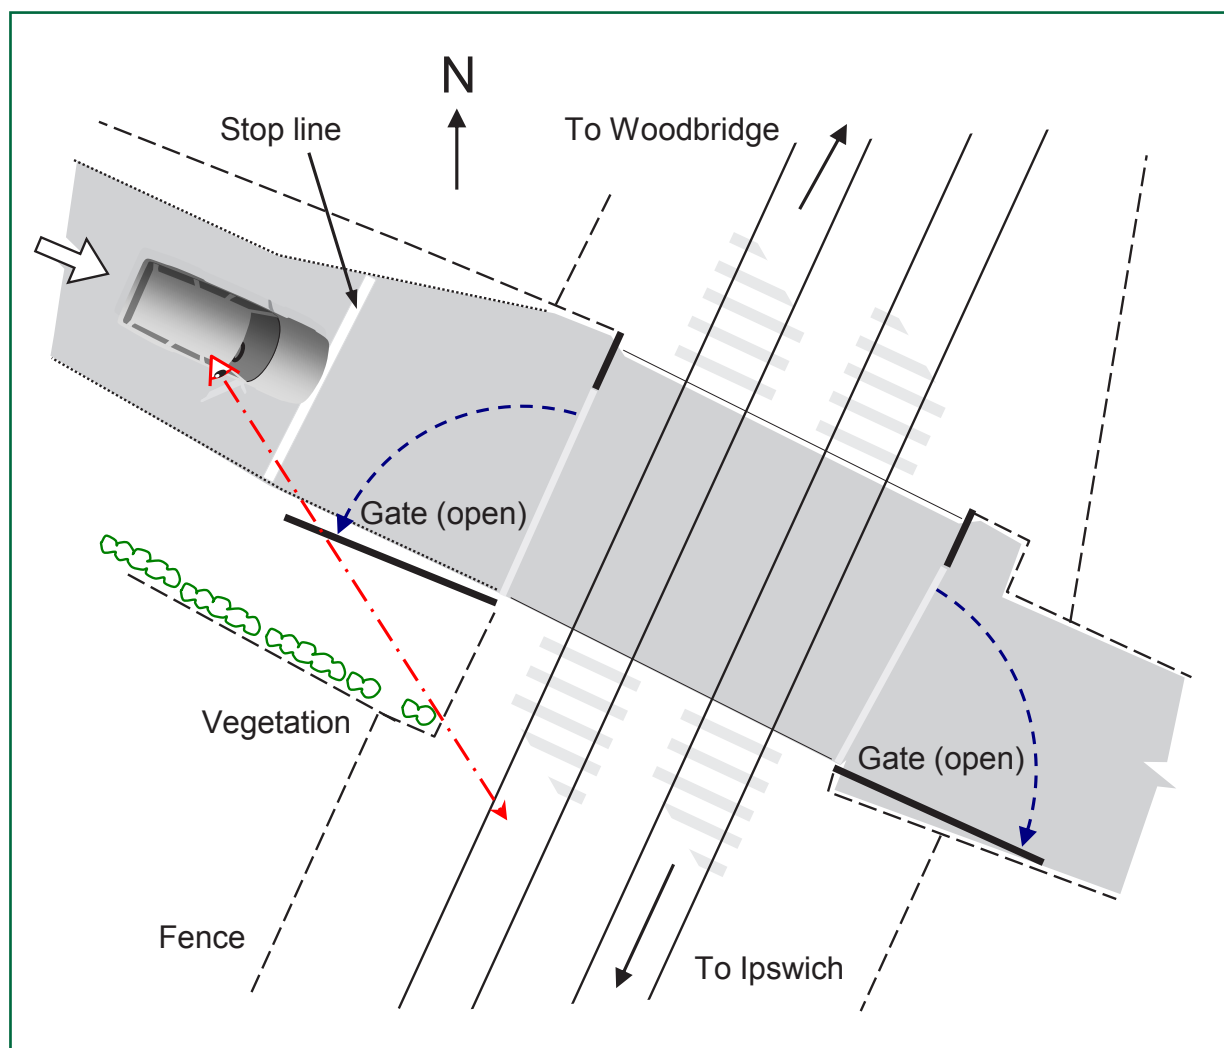
Figure 8: Diagram showing crossing layout

- 58 The car driver states that he did not see the approaching train when he opened the nearer gate. A member of the public opened the far side gate on his behalf, meaning that, unusually, he did not have to cross the railway to do so. The car driver being unable to see the train at this time is consistent with a reconstruction and observations by the RAIB, which has found that a typical vehicle driver would take a total of 20 to 24 seconds to swing open and secure the gate, return to his vehicle at the stop line and drive it up to the crossing (figure 8).

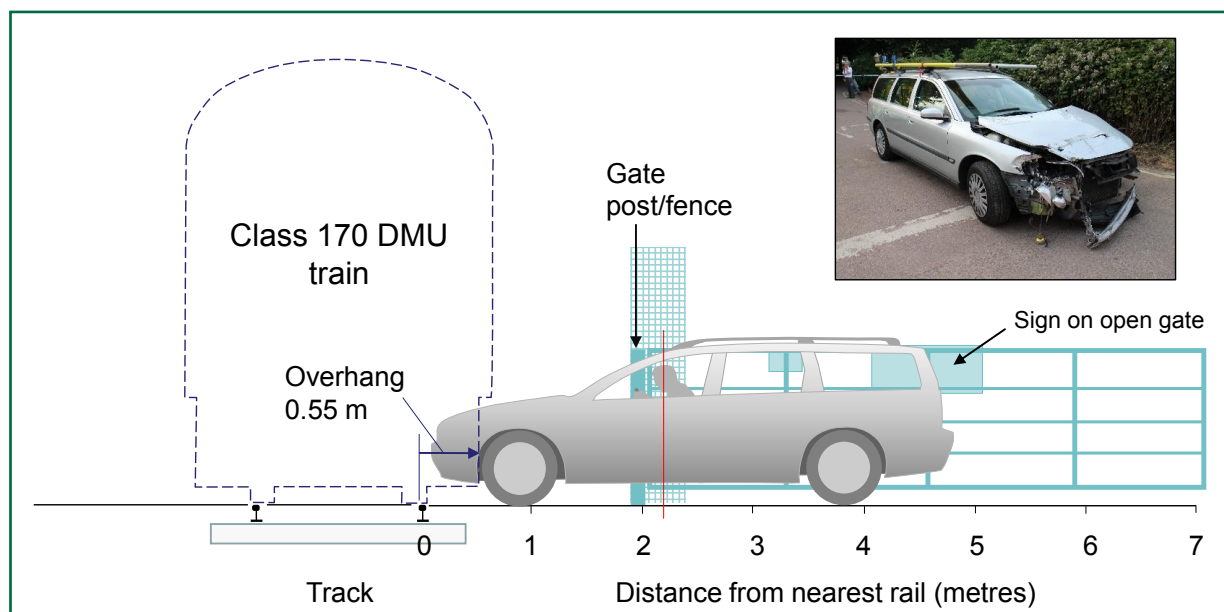
Figure 12: Diagram showing position of car at moment of collision

- 61 Damage to the front of the car (figure 7) indicates that the first 0.5 metres of the car was foul of the train at the moment of collision. As the car did not reverse and the train overhung the rail by about 0.5 metres (paragraph 47), this indicates that the front bumper of the car had stopped approximately above the first rail encountered by the car (figure 12). The car driver's viewing (eye) position was between 2.1 and 2.4 metres behind the front bumper (depending on whether he was leaning forwards in his seat).

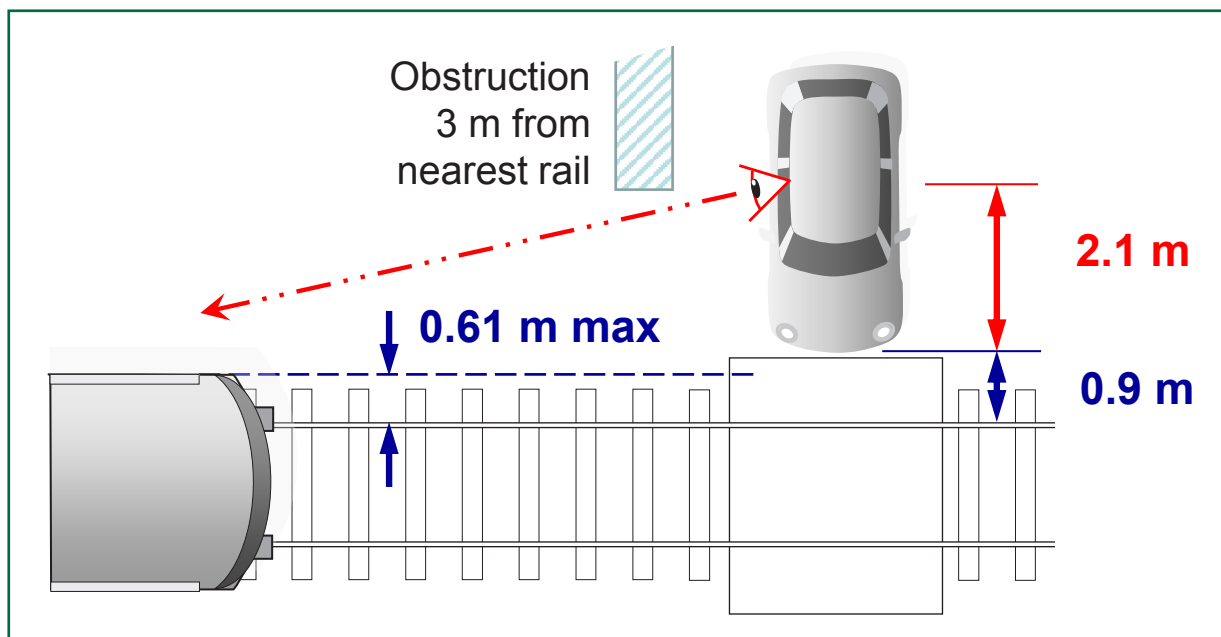
Figure 13: Diagram showing clearance for small car with driver's eye three metres from nearest rail

- 82 The RAIB has considered a small car (BMW Mini) and a large car (Volvo V70) with the driver's seat set at the maximum distance from the steering wheel in the position normally adopted by a tall driver. As indicated in table 2, with the driver's eye position 3 metres from the nearest rail, the front of both vehicles is unacceptably close to the track. The gap between a Mini and a passing train could be as little as 0.3 m (figure 13), and the front of a large car could be clipped by a train (figures 14 and 15).

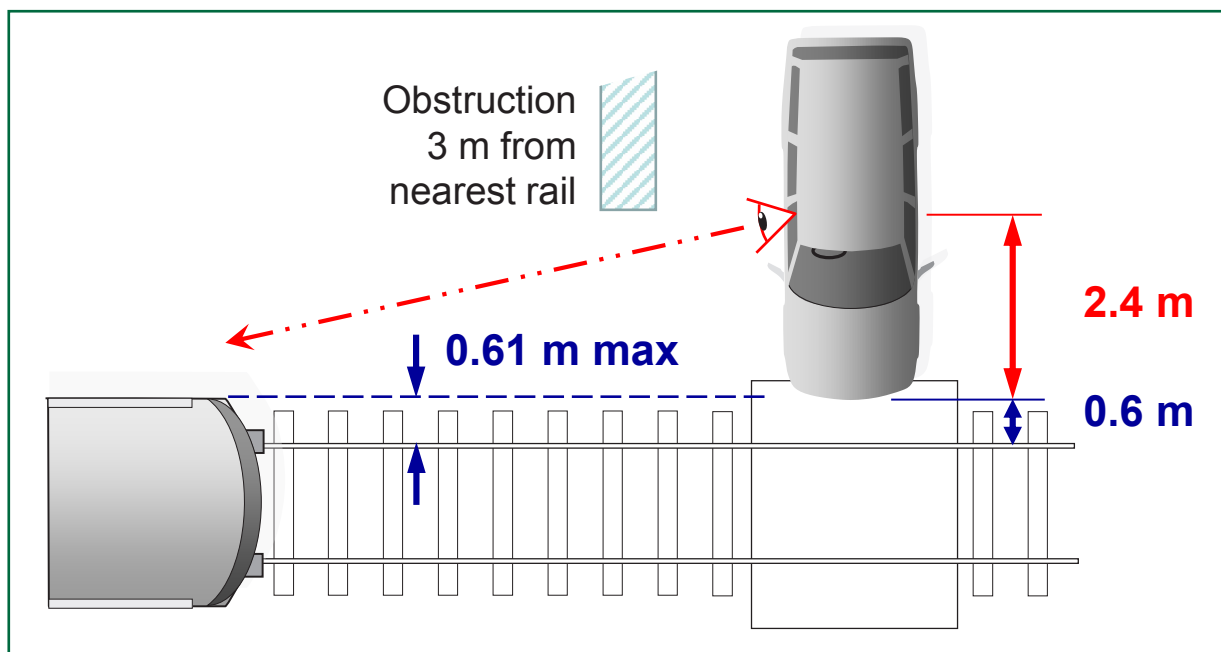
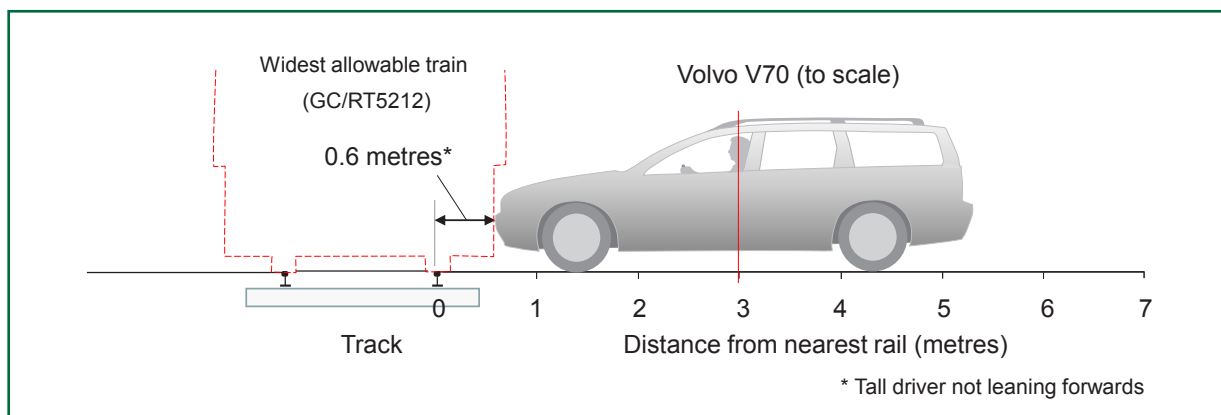
Figure 14: Diagram showing clearance for large car with driver's eye three metres from nearest rail

Figure 15: Diagram of large car with driver's eye position 3 metres from nearest rail

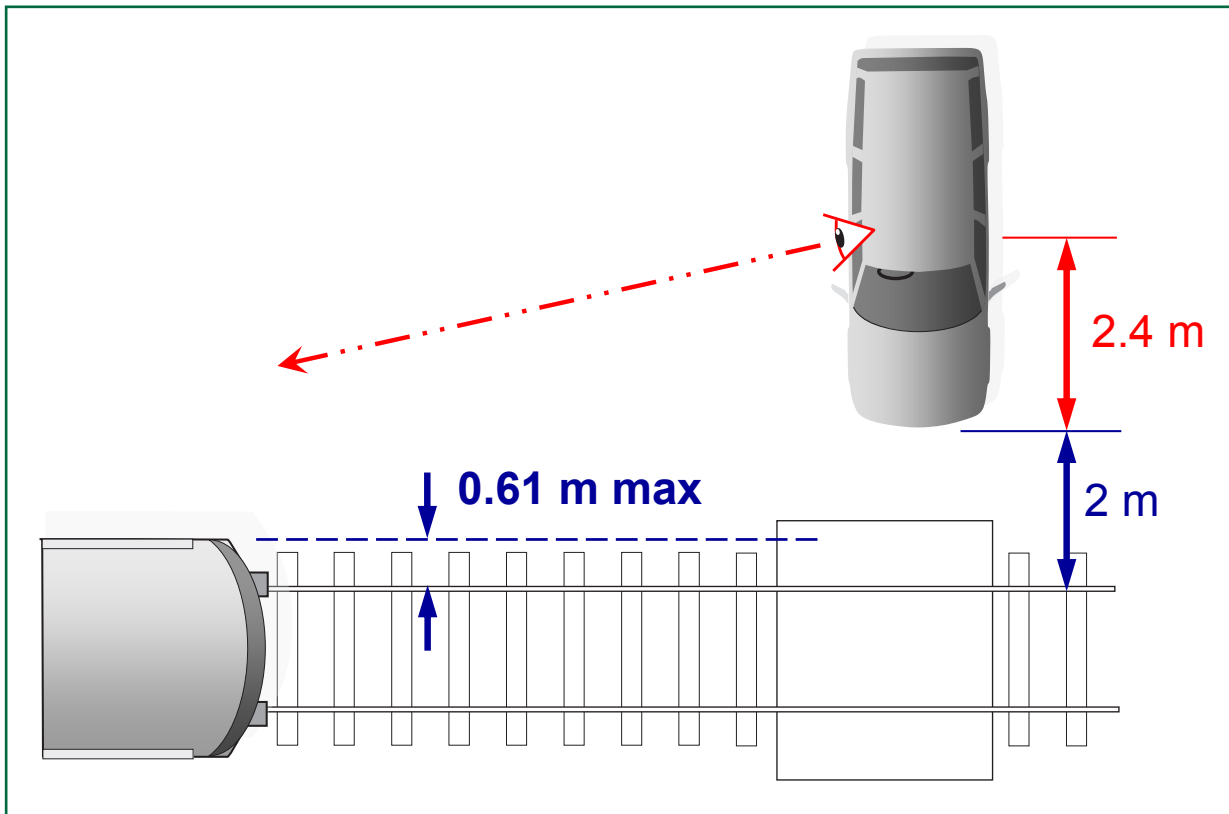
Figure 16: Large car maintaining 2 metres clearance from nearest rail

- 83 Leaflets sent to authorised users by Network Rail advised them to make sure that the front of their vehicle or equipment was at least two metres clear of the line when waiting to cross (paragraph 37). If the two metres clearance requirement is applied to a large car, the decision point may need to be 4.4 metres from the nearest rail (figure 16). It is possible that a greater distance would be required for some other large cars and for some other vehicles such as agricultural tractors. The RAIB's investigation into a collision between a train and a tractor at White House Farm UWC (Report 06/2012) found that the front of the tractor in this incident was approximately 3.7 metres from the driver's position, giving a decision point 5.7 metres from the nearest rail. This illustrates that checking sighting distances from a single location may not be sufficient for all types of vehicle.

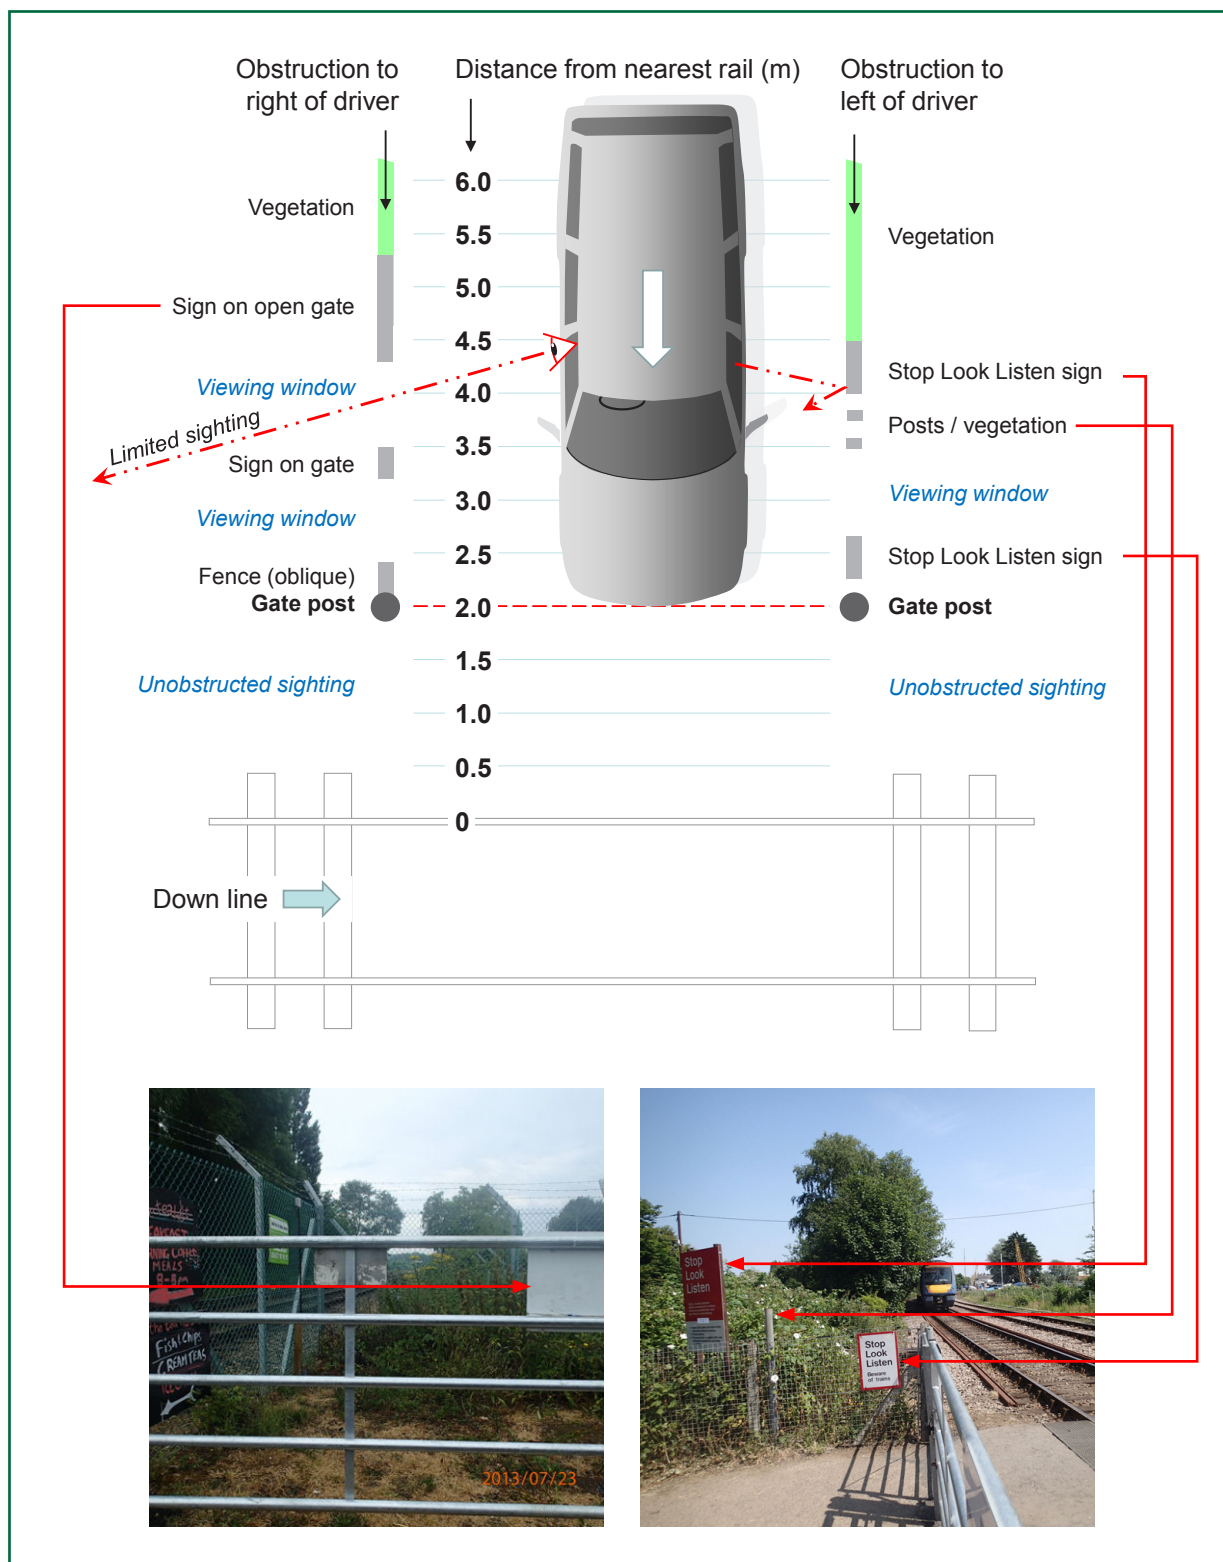
- 84 A car driver using Jetty Avenue UWC at the time of the accident and applying the leaflet guidance would have stopped in a position where their view of approaching trains was obstructed or inadequate (figure 17). Looking to their left, the view would have been obscured by a 'stop look listen' sign and vegetation. Looking to their right, drivers would have had a restricted view between signs giving a sighting distance of about 100 metres (paragraph 60). This is significantly less than the 157 metres sighting distance required for the crossing to be compliant with Network Rail standards (appendix D).

Figure 17: Schematic diagram showing features obscuring a car driver's view of the railway from the down (west) side of crossing with the front of their vehicle two metres clear of the line
