THE DUTCH
SAFETY BOARD

Train collision at Barendrecht,
24 September 2009

The Hague, January 2011

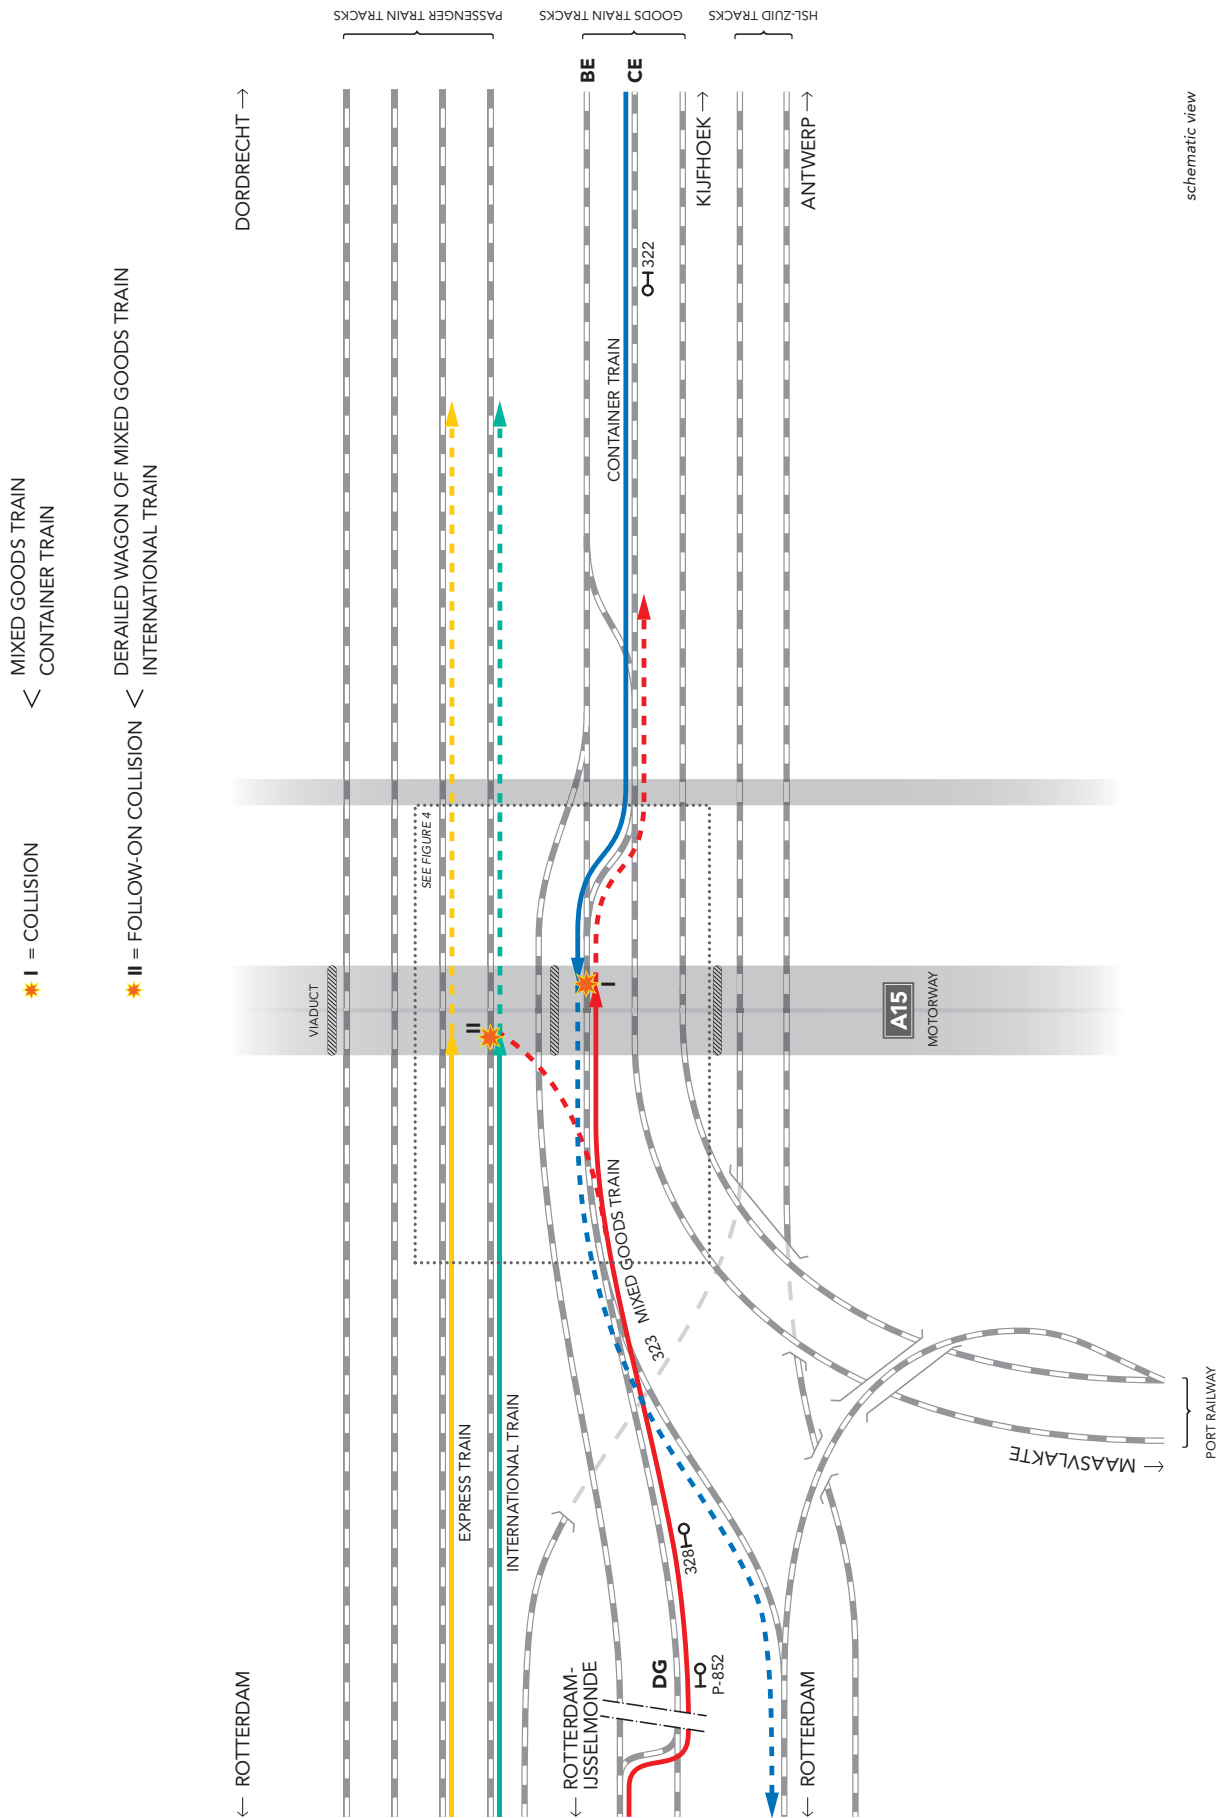
Figure 2: Diagram of the railway tracks at Barendrecht

to the collision. The subsections also review the occurrences at the relevant rail traffic managers in the period around the collision.²⁷ The routes followed by the trains are shown in Figure 2.

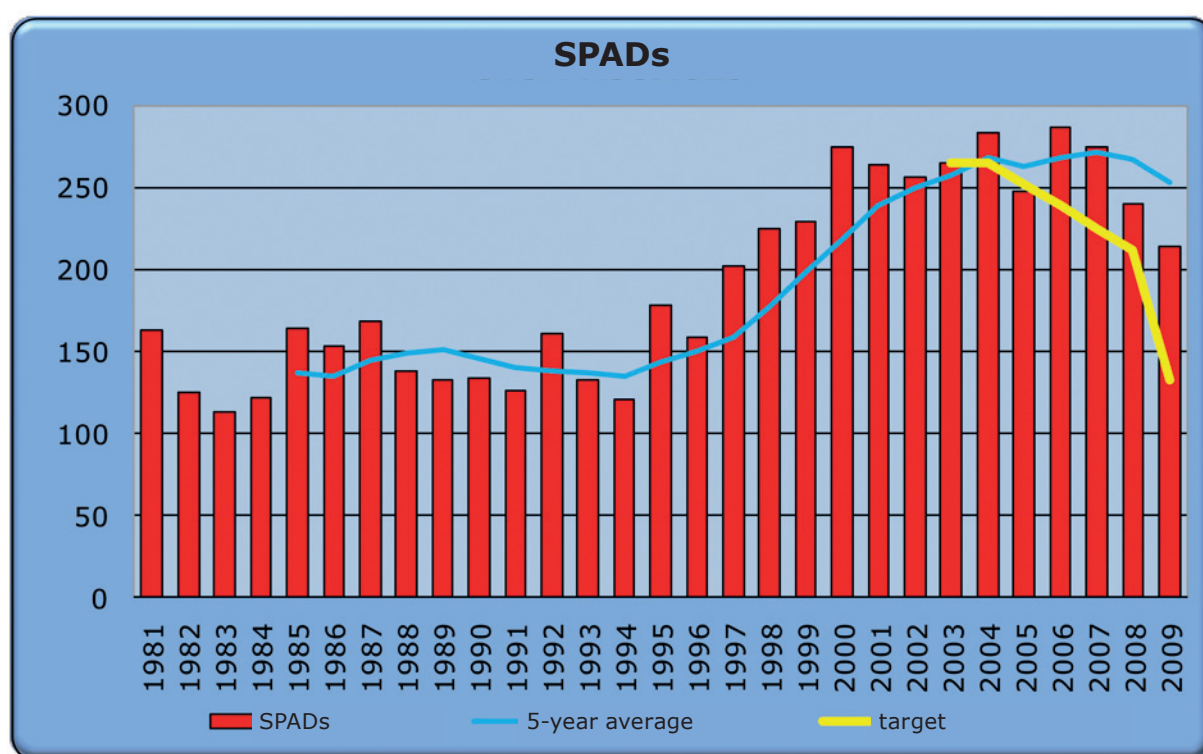
Figure 6: Number of SPADs in the period 1981 to 2009

Figure 16 shows the movement in the number of SPADs since 1981. No reliable data are available for the period before 1981. The figure reveals that the number of registered SPADs increased during the second half of the nineteen-nineties from between 125 and 150 per annum before 1995 to between 250 and 275 per annum at the beginning of the current century. When examining these figures it is important to note that the number of train movements has changed over the years and that there may be changes in the degree to which SPADs are reported and in the number of signals set at danger train drivers encounter during their journeys. Consequently, although the figures do give an indication of the number of SPADs they need to be interpreted with due care. Moreover, no automatic records are made of interventions by ATP systems and, consequently, these are not included in the statistics. These latter figures relate to the number of SPADs that would have occurred if the ATP systems had not intervened.

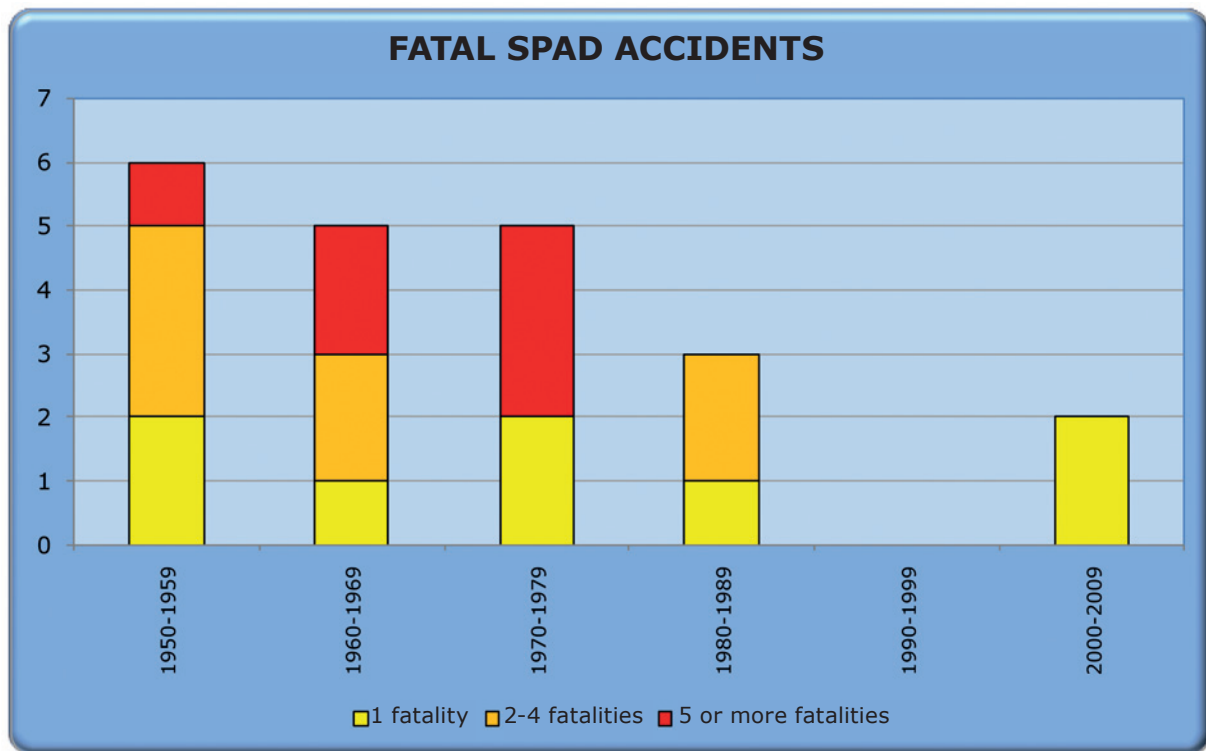
Figure 7: SPADs resulting in fatal accidents (number of collisions in ten years)

Figure 7 shows that the number of SPADs resulting in fatalities has decreased sharply since 1980:

- During the period from 1950 to 1980 there was a collision resulting in a fatality on an average of once every two years and there was a collision resulting in five or more fatalities on an average of once every five years;
- During the past twenty years (1990-2010) there were two accidents which each caused one fatality, namely on 20 March 2003 at Roermond and on 24 September 2009 at Barendrecht. In both instances the victim was one of the drivers of the trains involved in the collision.

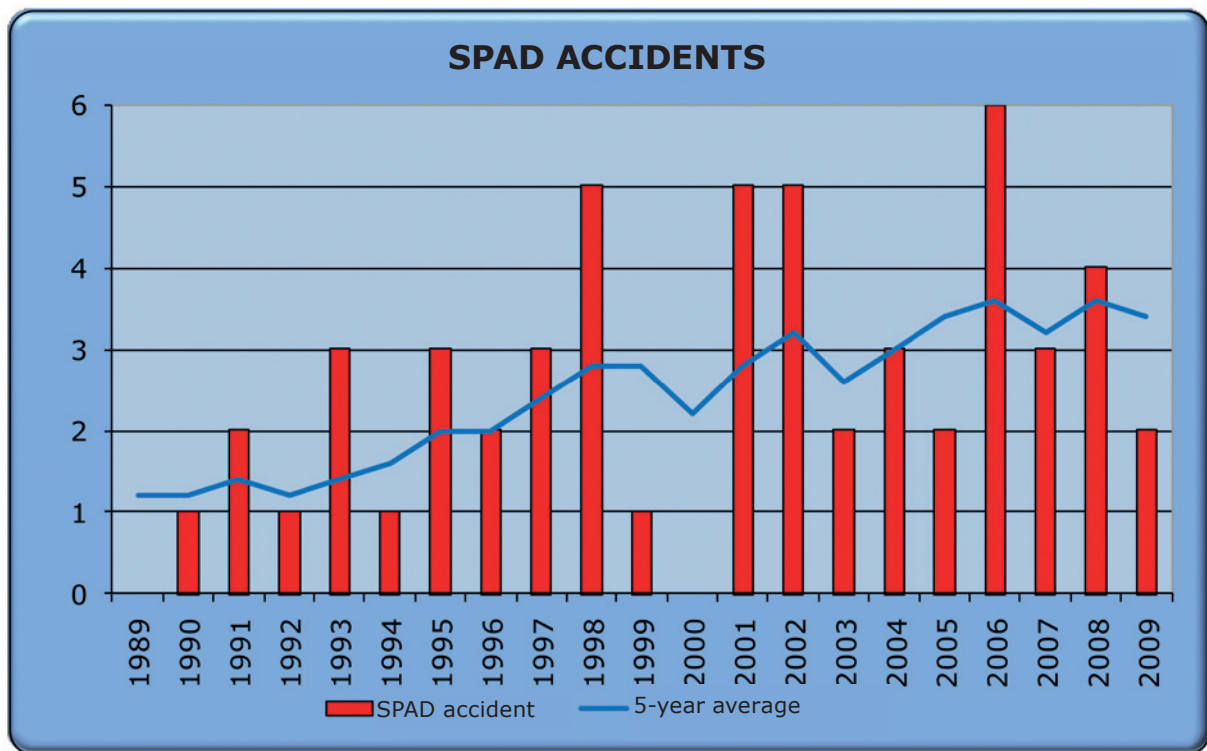
Figure 8: Accidents related to SPADs

Figure 8 shows the movement in the number of accidents (collisions and derailments) involving SPADs in the past twenty years. The figure clearly reveals that twenty years ago the five-year average fluctuated at around one to two accidents a year and then doubled in the nineteen-nineties to around three to four accidents a year.
