**REPUBLIC OF BULGARIA**  
**NATIONAL AIR, MARITIME AND RAILWAY TRANSPORT, ACCIDENTS**  
**INVESTIGATION BOARD (NAMRTAIB)**

**FINAL REPORT**

**Investigation of railway accident – fire in locomotive № 91520044063-3, serviced passenger train  
№ 80132 in Yambol station on 20.07.2023**

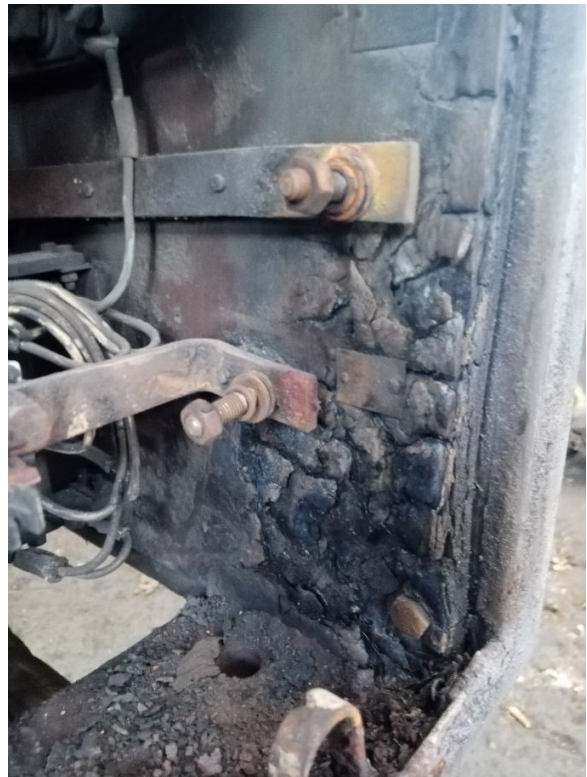
**Fig. 4.21.**

in the same area (Fig. 4.20). The power supply unit of the compressor is located there, as well as its fuse (Fig. 4.21).
