**STATE COMMISSION ON RAILWAY ACCIDENT INVESTIGATION**  
**Ministry of the Interior and Administration**

**REPORT No. PKBWK 5/2023**

**on the investigation of a railway accident  
that occurred on 20 February 2023 at 18:11 hrs on the Chałupki – Krzyżanowice route,  
track no. 2, Category B level crossing, at km 47.973  
of railway line no. 151 Kędzierzyn-Koźle – Chałupki,  
the area of the infrastructure manager PKP PLK S.A. Railway Line Plant  
in Tarnowskie Góry**

**WARSAW, 19 December 2023**

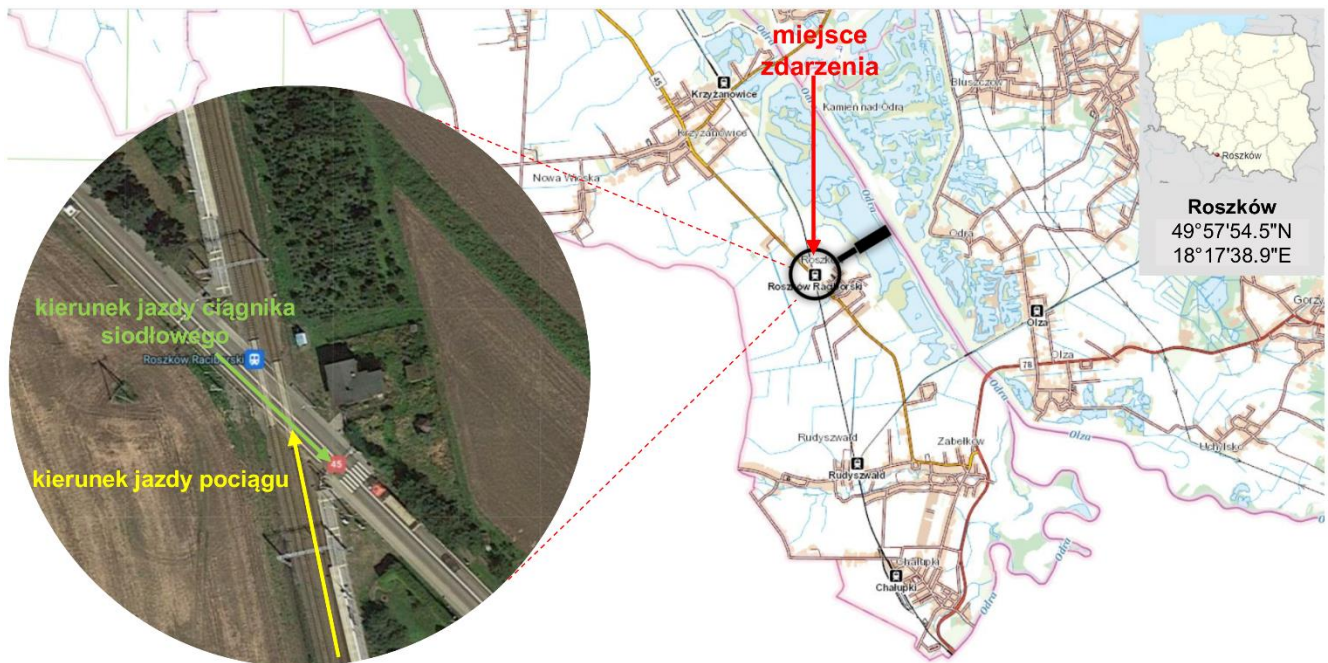
Figure 2 - A sketch of the accident

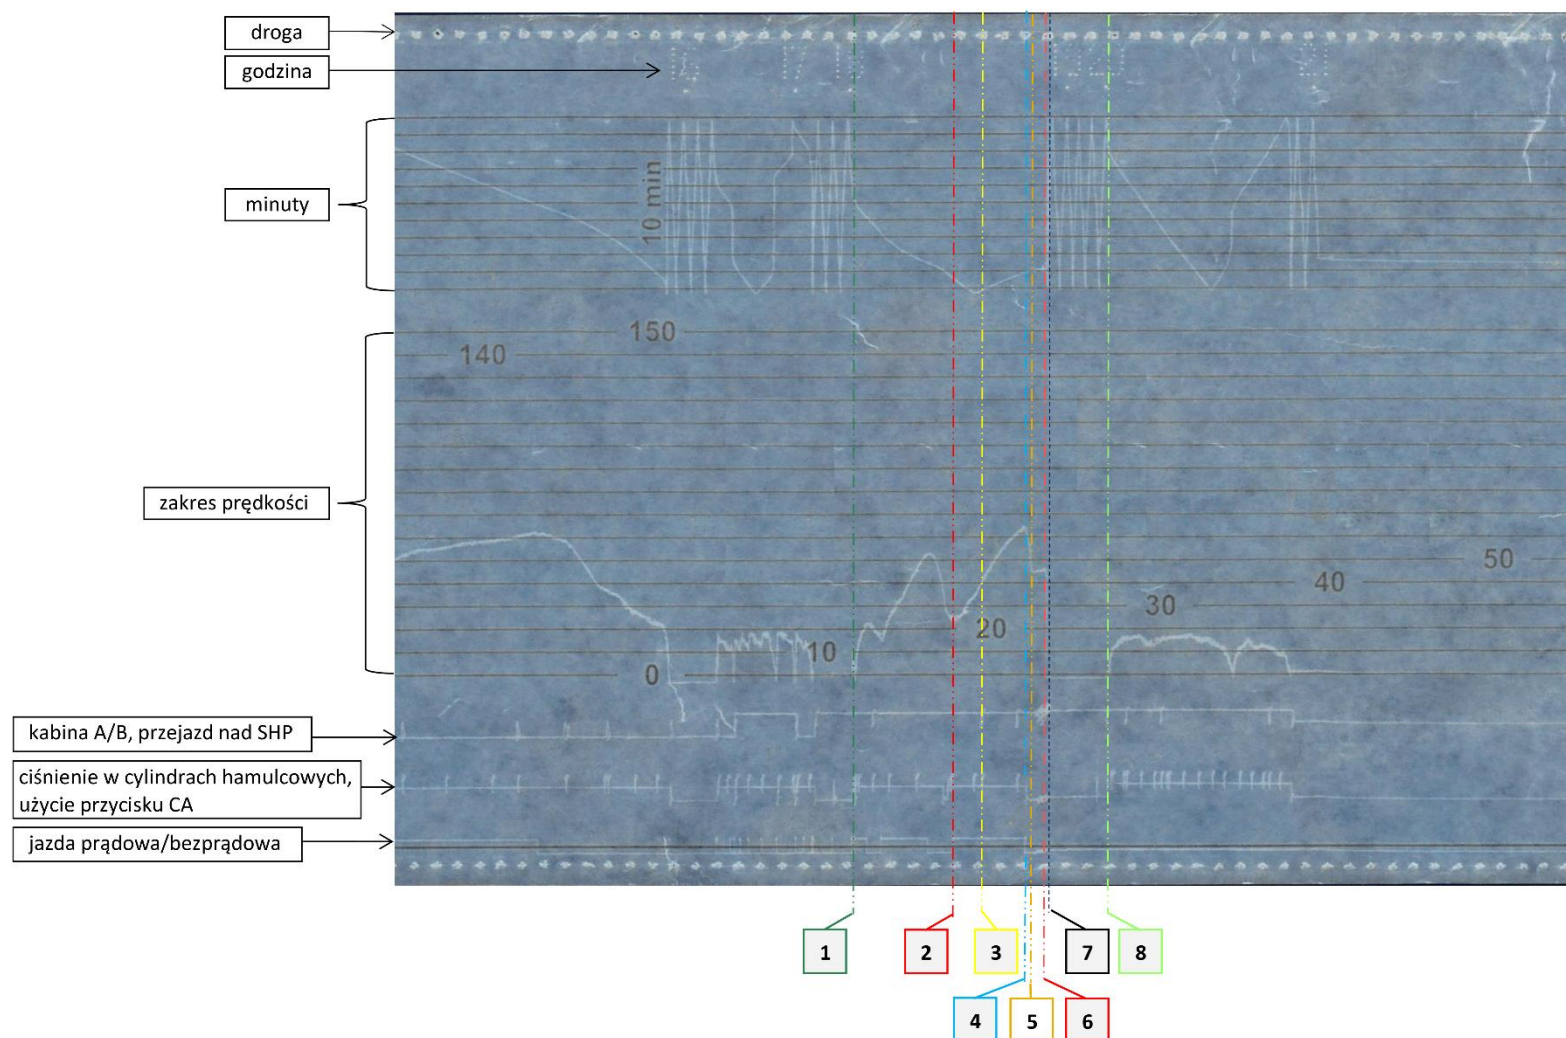
Figure 4 - A chart of driving parameters of the ET22-1062 locomotive (developed by PKBWK)

A description of the driving characteristics of train no. 441008 Bohumin Vrbice – Tychy Fiat on the route Chałupki – the occurrence site (key to Figure 4):

- 7 - starting at 18:11 hrs, the train stationary on the route
- 8 - 20:02 hrs, train brake released and non-electric drive (the train is towed to the Chałupki station)
