**REPUBLIC OF BULGARIA**  
**NATIONAL AIR, MARITIME AND RAILWAY TRANSPORT, ACCIDENTS**  
**INVESTIGATION BOARD (NAMRTAIB)**

**FINAL REPORT**

**investigation of railway accident – fire in locomotive № 91520044202-7, serviced international  
fast train № 464 between the stations Zmeyovo – Tulovo on 01.12.2023**

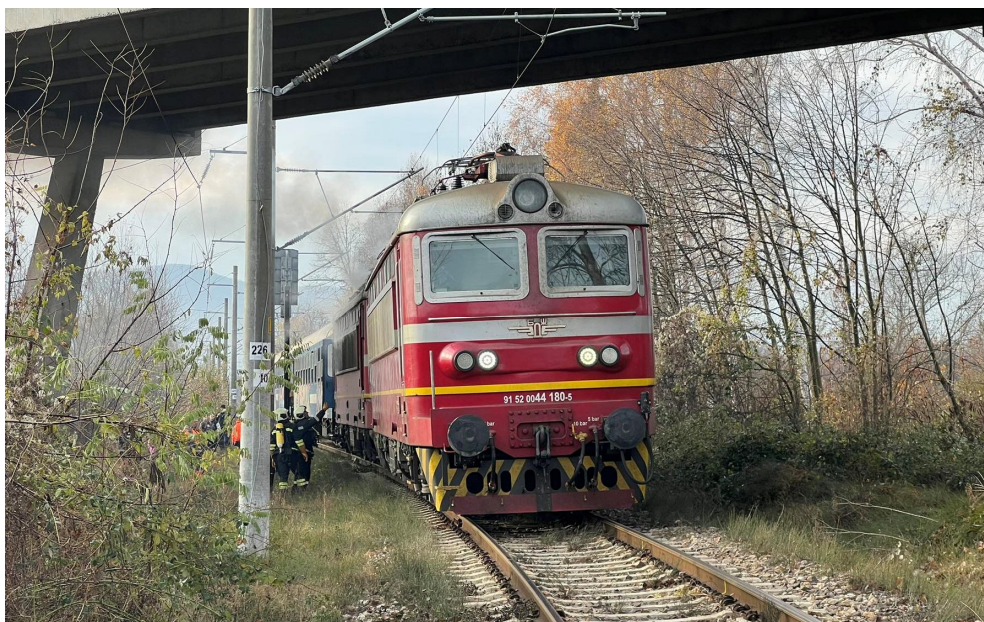
**Fig. 1.5. IFT № 464, towed at km 226+642 (entrance signal at Tulovo station) by auxiliary locomotive № 91520044180-5**

Between the stations Zmeyovo and Tulovo at km 226+900 at 07:46 a.m. a fire occurred in electrical locomotive № 91520044202-7, serviced IFT № 464. The locomotive driver stopped the train, and then auxiliary locomotive towed the train to km 226+642 for the locomotive extinguishing (fig. 1.5).

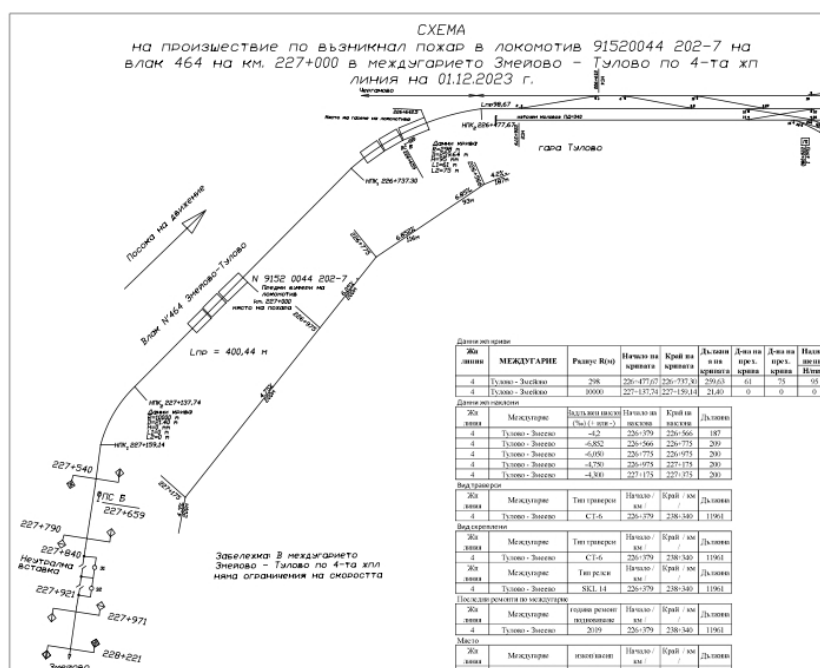
**Fig. 1.6. Scheme of the fire occurrence in locomotive № 91520044202-7 between the stations Zmeyovo and Tulovo**

The most probable cause of the fire during movement in locomotive No. 91520044202-7, which serviced IFT No. 464, was the temperature overheating of the power unit 221, feeding the motor-compressor 235. The auxiliary rectifier 221, feeding the engine compressor, was not cooled at that time as the fans were turned off during the train movement on inertia.

When the engine driver activated the FEI, it did not work. That helped the fire to spread and caused material damage. Due to the heavy smoke in the engine compartment, extinguishing with manual fire extinguishers was not possible.

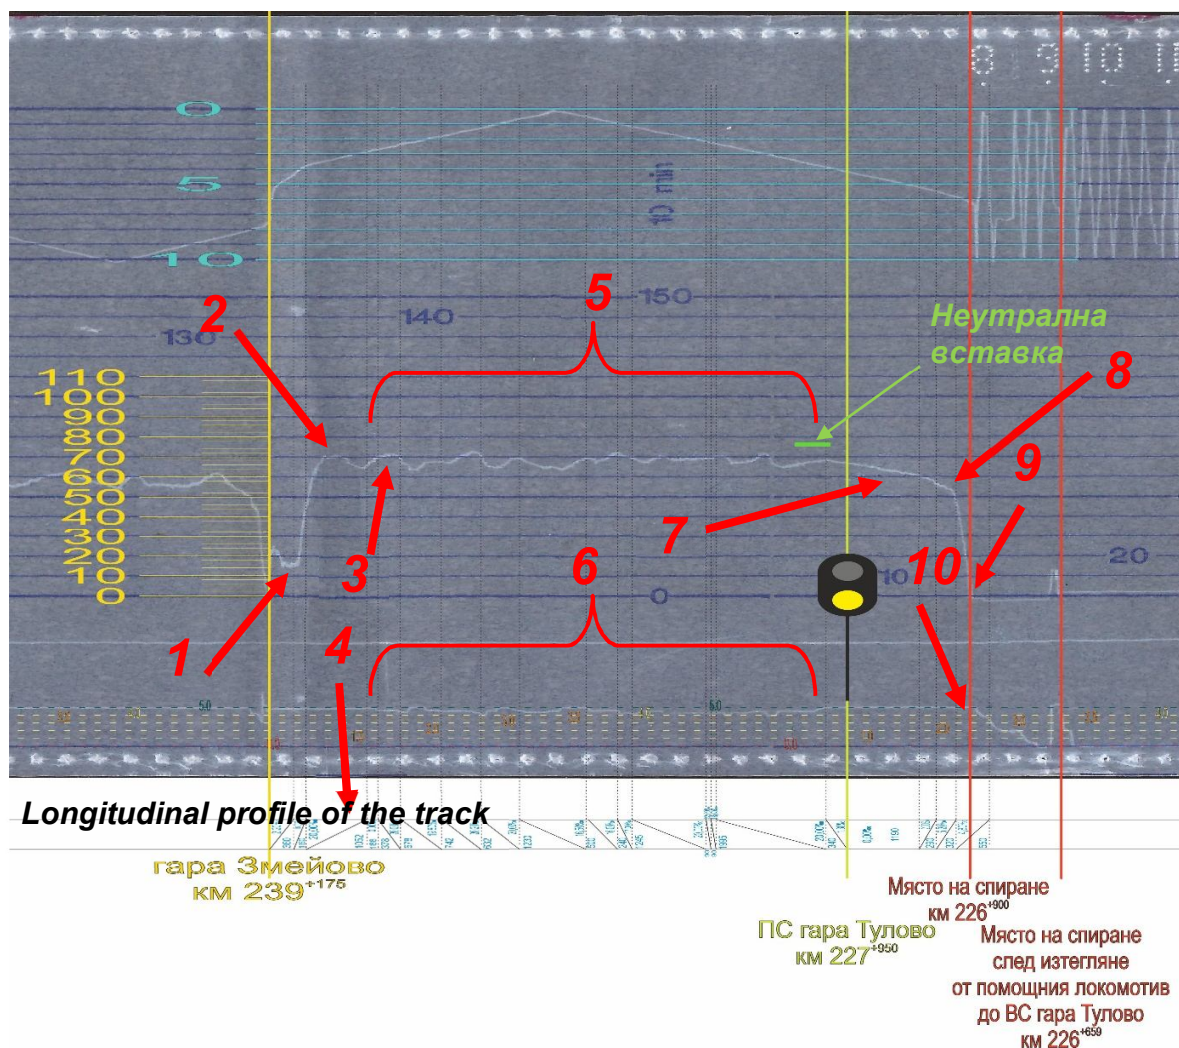
Fig. 4.3.

IFT No. 464 served by locomotive No. 91520044202-7 departed from Zmeyovo station at 07:33 a.m., accelerated to 22 km/h, then the speed decreased to 15 km/h and thus it travelled 300 meters in about 1 min. 50 sec. (fig. 4.3, item 1). After covering that distance, the speed started to increase again and in about 400 meters, it reached 70 km/h (Fig. 4.3, item 2). At that speed, it travelled about 400 meters, after which the speed decreased to 64 km/h and again increased to 72 km/h (Fig. 4.3, item 3). The train travelled about 1500 meters in 1 minute and 30 seconds in traction mode due to the profile of the rail track, which is uphill (fig. 4.3, pos. 4). From that moment on, the profile went downhill and the locomotive went into braking mode, traveling about 7,500 meters from 07:37 a.m. to 07:44 a.m. in 7 minutes (Fig. 4.3, item 5). During this time, the locomotive driver adjusts the speed with the help of the automatic train brake (pneumatic), (Fig. 4.3, pos. 6), and the speed changed from 62 to 73 km/h, with a

permissible speed of movement of 75 km/h in the interstation. About 340 meters before the warning semaphore (PS) at Tulovo station, the slope of the rail track decreased from 20 ‰ to 1.3 ‰, then became level (0 ‰) and followed a slight uphill with values of 2 ÷ 6 ‰. Therefore, the movement was carried out by inertia with a smooth decrease in speed from 68 to 54 km/h for 2100 meters in about 2 minutes (Fig. 4.3, item 7). At 07:46 a.m. the speed began to decrease at a much higher gradient, with a distinct

downward break on the bar graph (Fig. 4.3, item 8) without the automatic train brake applied (Fig. 4.3, item 9), and after about 30 seconds the train stopped at km 226+900 (fig. 4.3, item 10).

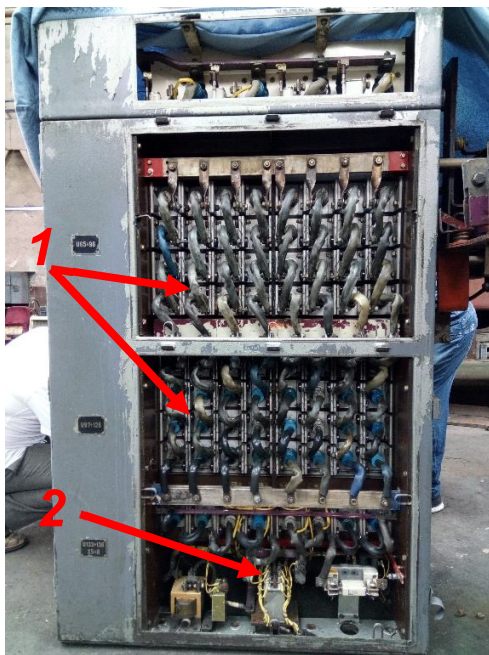
**Fig. 4.4.**

The rectifier groups on the 44 series locomotives are of the cabinet type, each cabinet having its own separate traction group. The interior of the cabinet can be conditionally divided into three parts: upper, lower and side. In the upper part, the valves from the traction bridge are located, which work in traction mode together with the traction motors (Fig. 4.4, item 1). In the lower part, the elements of the four auxiliary bridges are collected, which are included in the circuits of the auxiliary machines (Fig. 4.4, pos. 2), and in the side part there are signal lamps, blinker relays and the R-C groups, which are composed of resistors and capacitors (Fig. 4.5)
