## FINAL REPORT ON SERIOUS ACCIDENT INVESTIGATION

Serious accident type: Train collision

Train Nos: 25412 and 49028/73478

Location: Municipality Odžaci, between the settlements Ratkovo and Odžaci,  
open track between the station Ratkovo and Odžaci

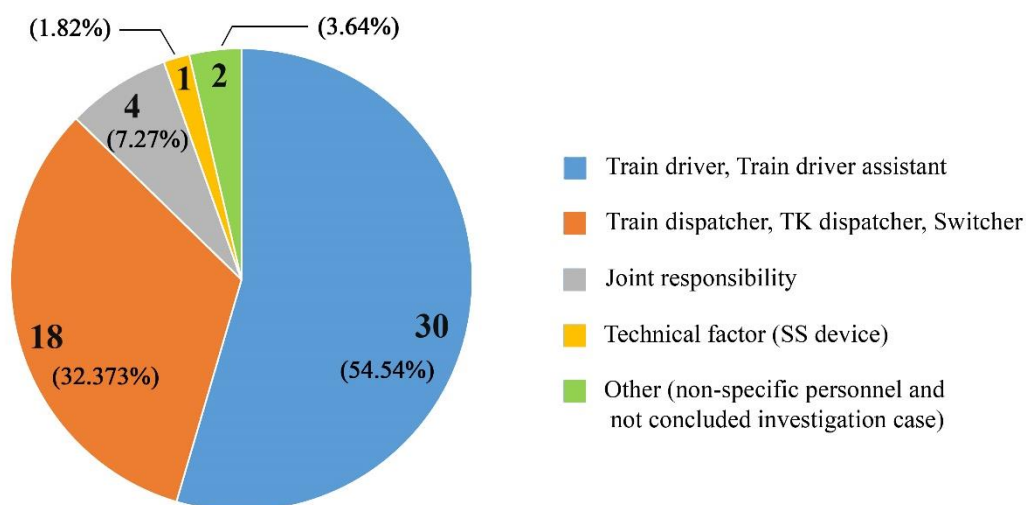
**Graph 3.7.1:** The structure of causes of accidents and incidents of a similar nature on the railway network of “IZS” a.d. from January 1st, 2013, to November 17th, 2023

attributed to the SS device, while in another case, responsibility was attributed to non-specific personnel. One case is still pending (investigation not yet concluded).

The structure of causes of accidents and near-misses of a similar nature on the railway network of “IZS” a.d. from January 1st, 2013, to November 17th, 2023, is shown in graph 3.7.1.

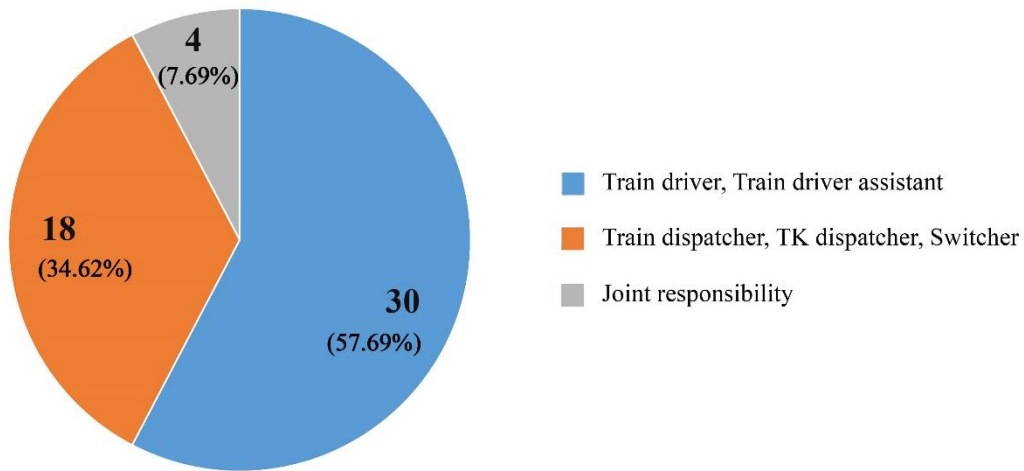
**Graph 4.2.7.4.1:** The structure of accidents and incidents caused by the railway workers in the period from 2013- 2023. on the railway network of “IŽS” a.d.

From the analysis of data obtained from “IŽS” a.d. regarding accidents - train collisions with railway vehicles and incidents - avoided train collisions with railway vehicles occurring on the “IŽS” d.o.o. railway network from January 1, 2013, to November 17, 2023 (see point 3.7.), it can be concluded that out of a total of 55 cases, in 52 cases (94.54%), the cause of the events was human factor (negligence of railway workers). In the remaining cases (3 cases, or 5.46%), the causes were technical factors (SS device malfunction), responsibility of unidentified individuals, and one case remains unresolved (investigation not concluded). Railway workers responsible for these accidents and incidents (52 cases) were: worker who operated the traction vehicles (train drivers/assistant train drivers, in 30 cases that is, 57.69%), traffic controllers (train dispatchers, TK dispatchers, telegraphers, switchers, in 18 cases that is, 32.73%) and joint responsibility of workers (in 4 cases that is, 7.27%).

The provided overview of accidents and incidents in railway traffic lacks elements regarding the influence of human factors because specific data on these aspects unfortunately do not exist (e.g., fatigue, decreased responsibility, poor communication, routine, stress impact, etc.). It is certain that accurate information about events and the results and conclusions of their analysis are of great importance. Therefore, the use of relevant and updated information is necessary for a quality process of identification. This includes identifying all sources of risk, events, and/or a series of circumstances that may signal the occurrence of a risky event, accident factors, incidents, and their potential consequences.
