# JNS Normal Procedure

## "Accident Gotthard base tunnel - broken wheels"

JNS report | version 5.0

### ECM Working Instruction for the visual inspection of the component tread braked wheel

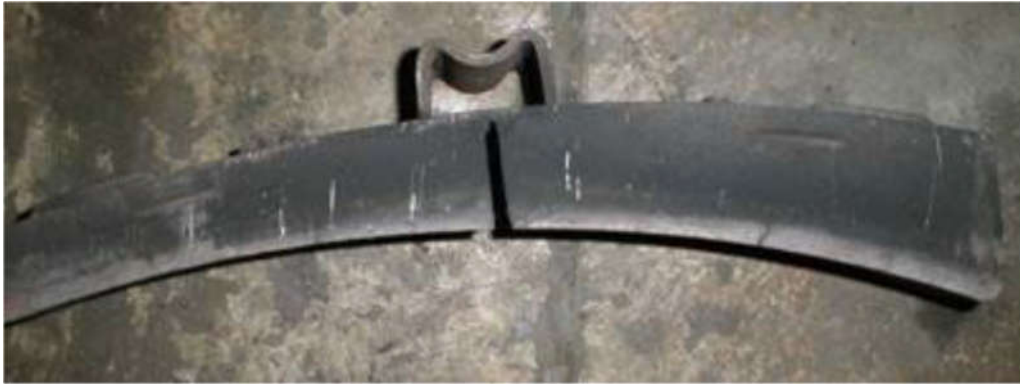
Figure 1: Organic brake blocks: 'White layer' in the rubbing surface near to the surface area, up to 10mm thick, friction carbon deposits [UIC Leaflet e541-4, 3. Edition]

- To fulfil the in-service limit requirement for the mileage interval
- During change of brake blocks in- or outside of workshops (except the rail wheel – contact)
- During axle inspections done in accordance with the European Visual Inspection Catalogue (EVIC) (see EN 15313, chapter 6.5.13.2)
- wagon heavy maintenance (revision)
- During off-vehicle maintenance
- If the ECM during wagon technical inspection gets aware of any indication of thermal overload of the wheel or thermal indications on the brake blocks (see Figure 1 to Figure 4) or after detected fixed brakes

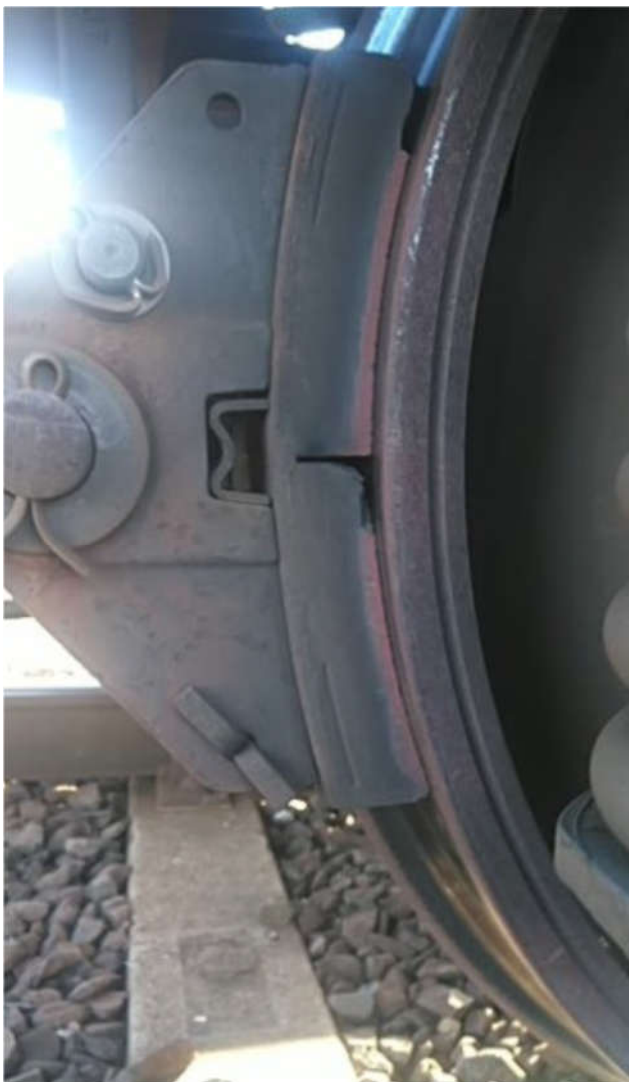
Figure 2: Organic brake blocks: 'Red layer' in the rubbing surface, up to 10mm thick [UIC Leaflet e541-4, 3. Edition]

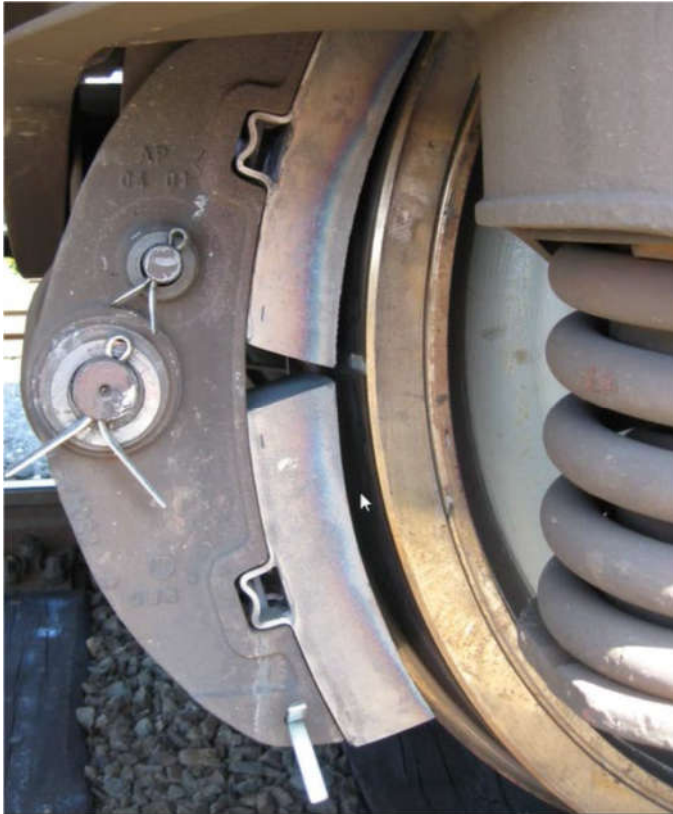
Figure 3: Sintered brake blocks: White-blue layer' in the rubbing surface, up to 10mm thick [UIC Leaflet e541-4, 3. Edition]

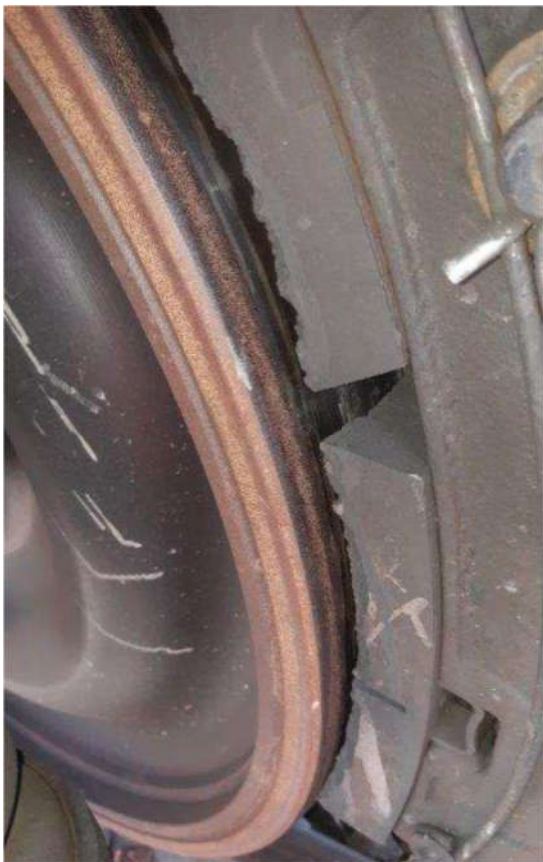
Figure 4: All type of brake blocks: Crumbling of the rubbing surface, friction carbon deposits high, up to 10mm thick [UIC Leaflet e541-4, 3. Edition]

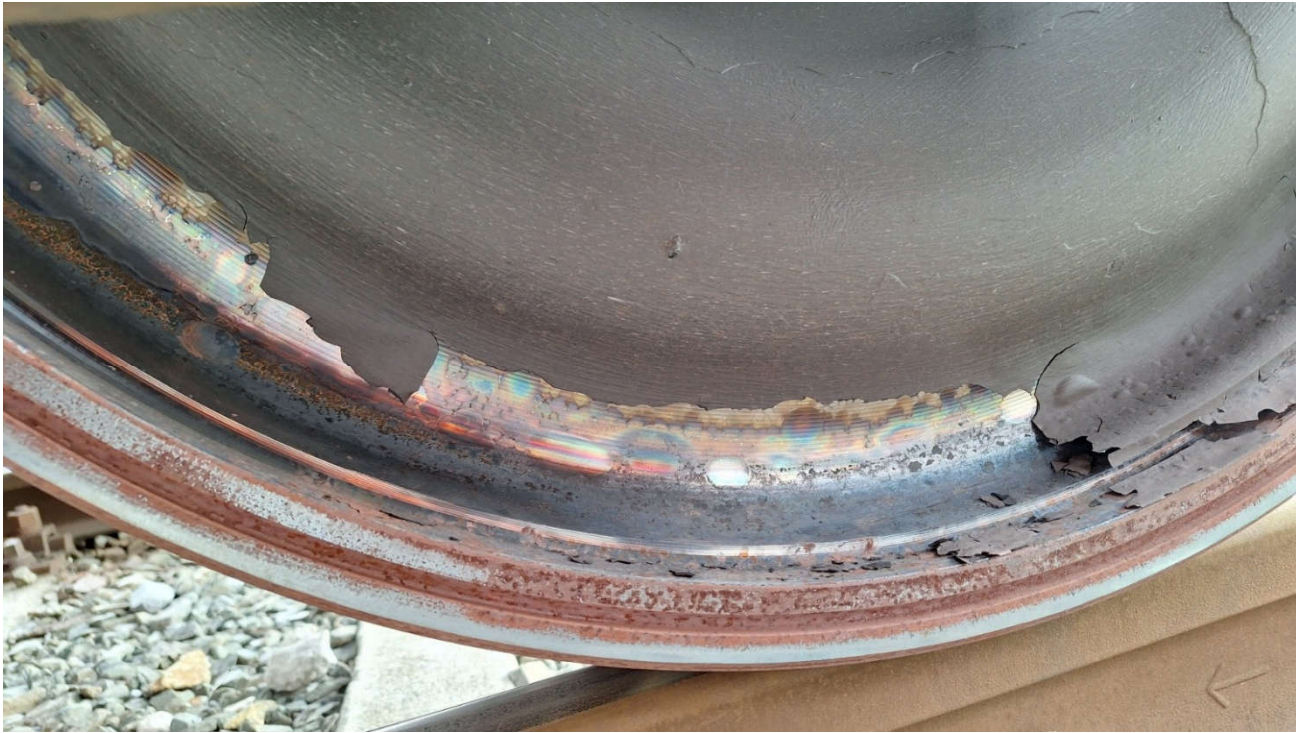
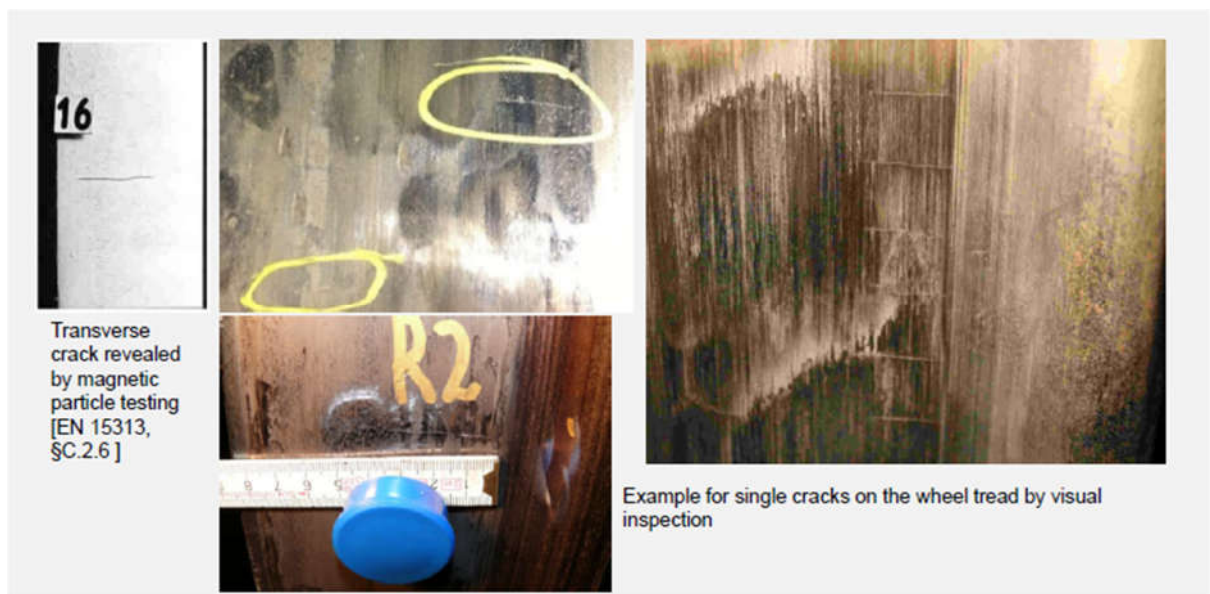
*Figure 6: single cracks on the wheel tread*

- Single cracks in the tread are not acceptable – see pictures in Figure 6.
- Cracks in the rim and/or in the web are not acceptable – see pictures in Figure 7 .
- signs of thermal overload on the wheel, like Burn-off of the thermally sensitive paint – see pictures

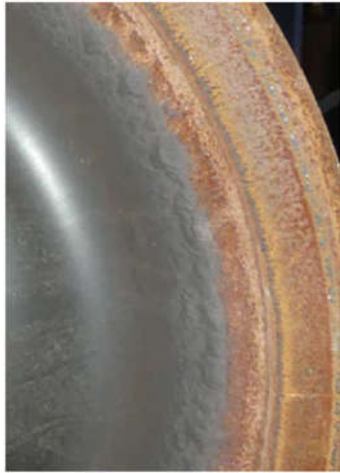
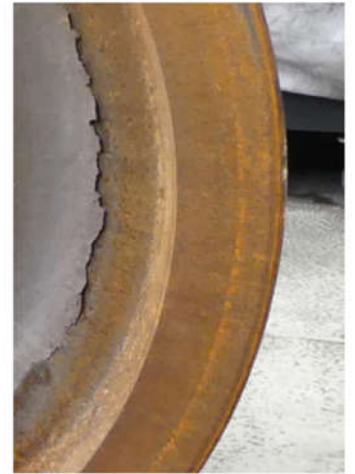
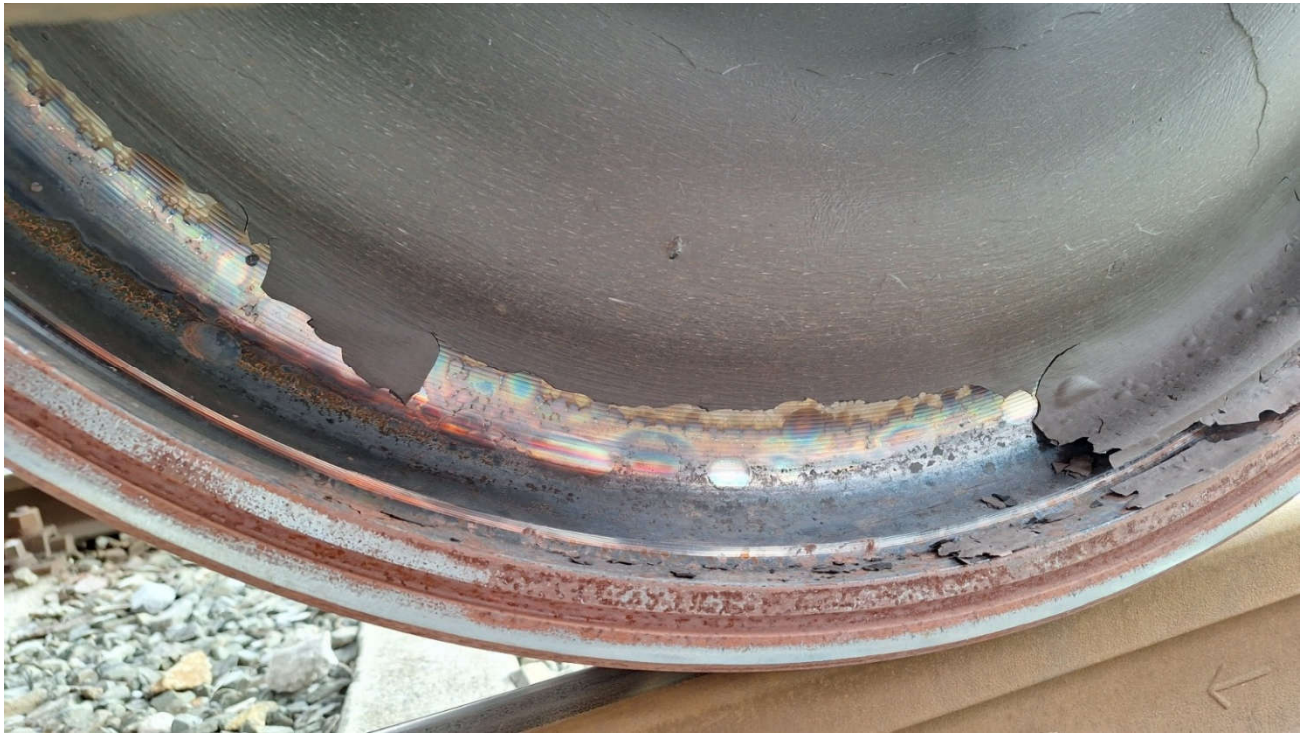
Figure 8: Signs of thermal overload of the wheel – burnt paint

- Figure 8 and discoloration of the tread and metal build-up on the tread – see pictures Figure 9 are not acceptable.

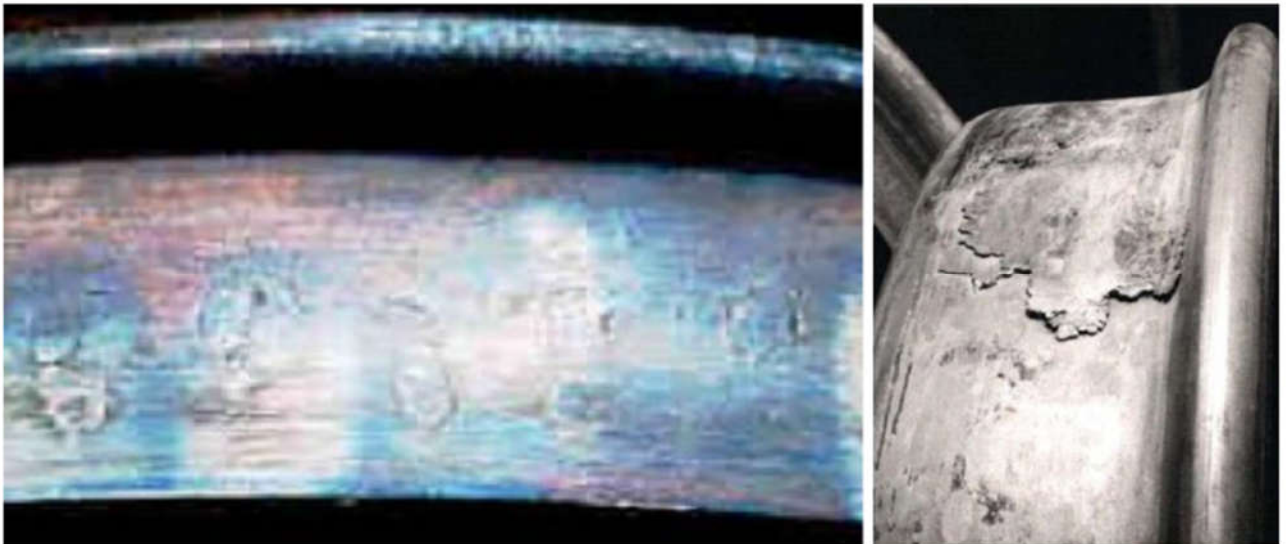
Figure 9: Signs of thermal overload of the wheel - discolouration of the tread and metal build-up on the tread
