ANNUAL REPORT OF THE INVESTIGATION BODY FOR RAILWAY ACCIDENTS AND INCIDENTS **2016**

PITTEM (25/11/2015) - COLLISION OF A DE LIJN BUS BY A SNCB TRAIN ON A LEVEL CROSSING

BINCHE (13/01/2016) - COLLISION BETWEEN TWO SNCB/NMBS PASSENGER TRAINS

LANDEN (18/02/2016) - RUNNING AWAY OF AN SNCB/NMBS TRAIN BETWEEN LANDEN AND TIENEN

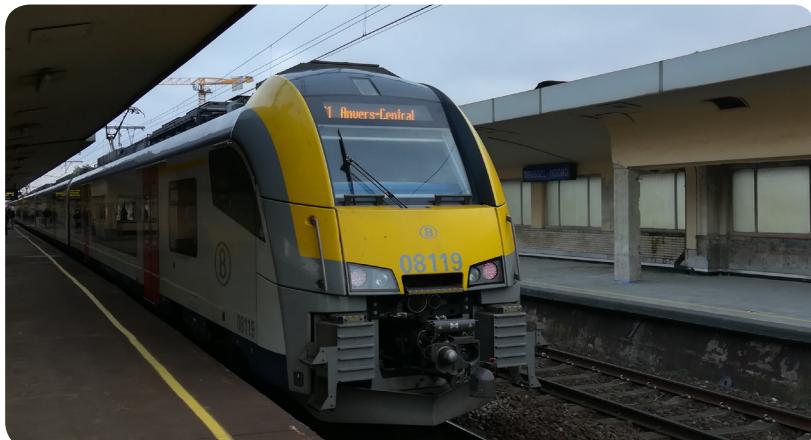
The SNCB/NMBS committed itself to equipping all its vehicles with TBL1+ by the end of 2013, the planning has been respected.

At the level of its rolling stock (works trains), Infrabel was supposed to modify its own rolling stock: by the end of 2015, 99% of stock was equipped with the TBL1+ system (100% of special units and 99% of locomotives). At an infrastructure level, Infrabel had decided to accelerate the timetable of TBL1+ implementation. In December 2015, Infrabel had installed TBL1+ in the tracks as the IM had planned.

Since 2009 and in a more accelerated way since the Buizingen catastrophe in 2010, one of the measures taken by the sector in order to reduce the number of SPAD involves installing ATP systems (Automatic Train Protection) on the tracks and on board rolling stock.
