Swiss Transportation Safety Investigation Board STSB Annual Report 2018

Swiss Transportation Safety Investigation Board STSB

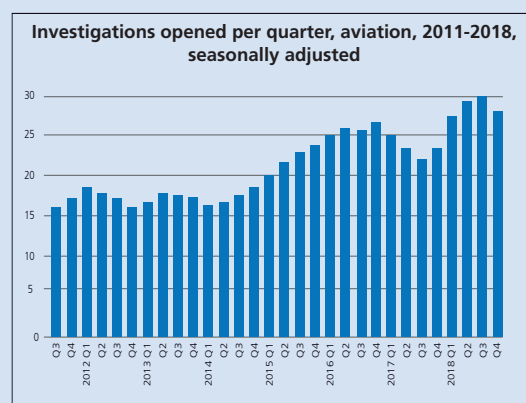
Diagram 2: Number of investigations opened per quarter in aviation due to reported incidents. Seasonal effects were adjusted by means of a moving average.

Since 2011, the number of reported incidents has steadily increased, to a provisional maximum of 1556 in 2018 (diagram 1). As a consequence, there was an increase in the number of investigations opened during the same period, to a provisional maximum of 119 in 2018 (diagram 2).

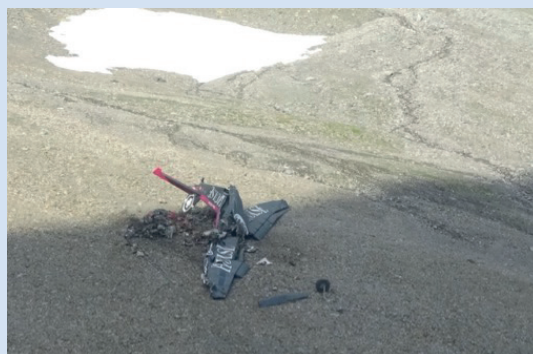
On 4 August 2018 at 16:10, an historic Junkers Ju 52/3m g4e commercial aircraft, registered as HB-HOT and operated by Ju-Air from Locarno airport, took off on a flight to Dübendorf military airfield. The plane collided approximately vertically with the terrain at 16:56 about 1.2 km

Considerable corrosion damage was found on the wreck of the HB-HOT on the spars, hinges and fittings of the wings and in the area of the cabin floor plate. Two of the three engines were equipped with newly manufactured cam disks which had defects.

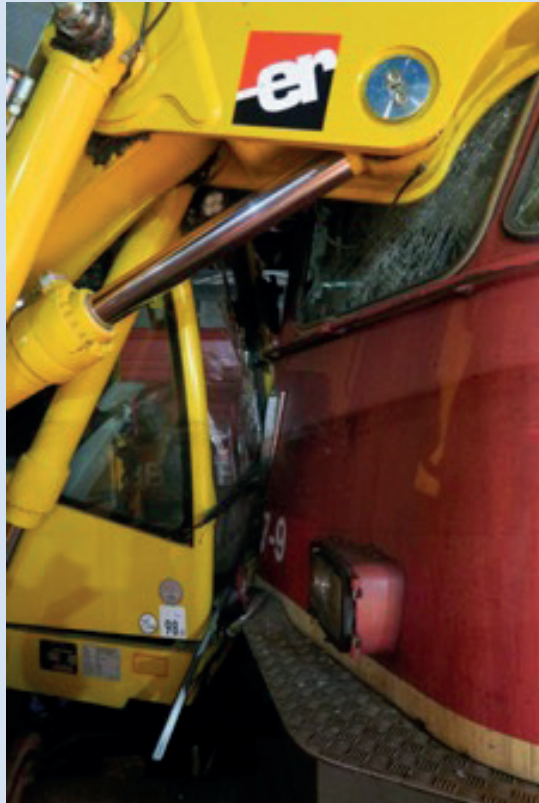
A roadrail vehicle joining, between two axle counting points, a closed track equipped with a clear track detection device in the form of an axle counter system does not automatically generate an occupied signal for the track concerned. The presence of the vehicle is not signalled to the signal box. This means that the track closure can be lifted, even though there is a vehicle on the track.

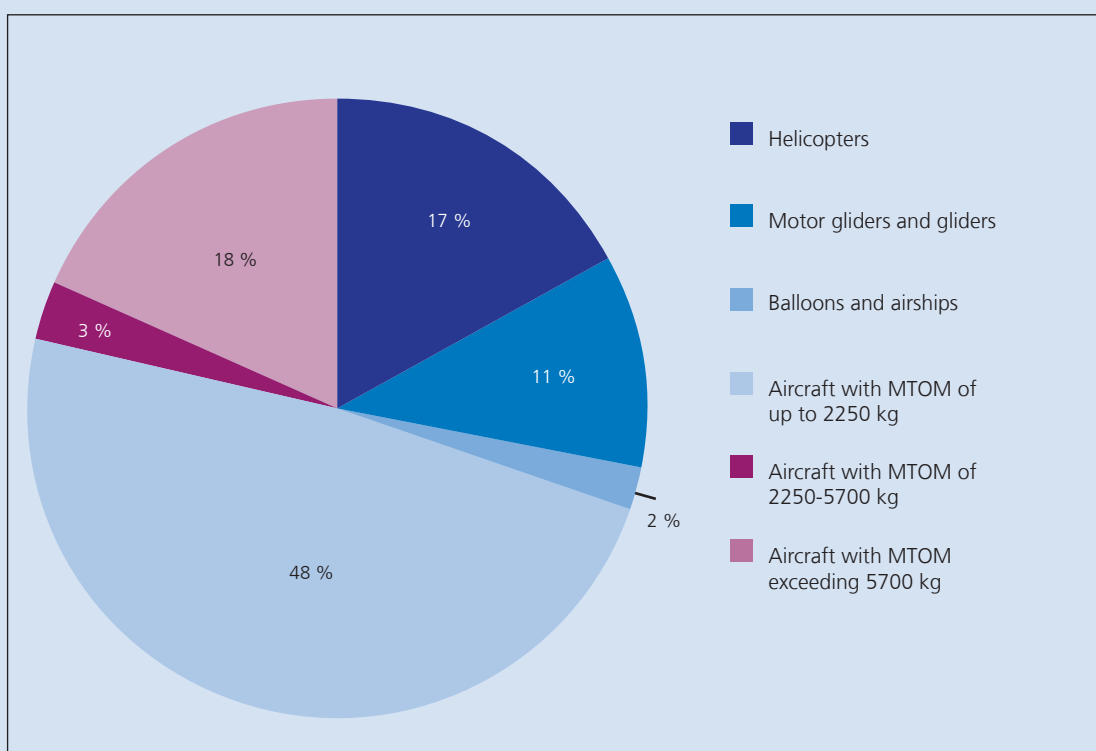
3.2.3 Accidents and serious incidents by type of aircraft involving Swiss-registered aircraft

2018	2017
Aircraft with MTOM of up to 2250 kg	48 %	67 %
Aircraft with MTOM of 2250-5700 kg	3 %	3 %
Aircraft with MTOM exceeding 5700 kg	18 %	8 %
Helicopters	17 %	14 %
Motor gliders and gliders	11 %	9 %
Balloons and airships	2 %	0 %
