**Accident Investigation Board of Finland  
Annual Report 2006**

**Onnettomuustutkintakeskus**  
**Centralen för undersökning av olyckor**  
**Accident Investigation Board**

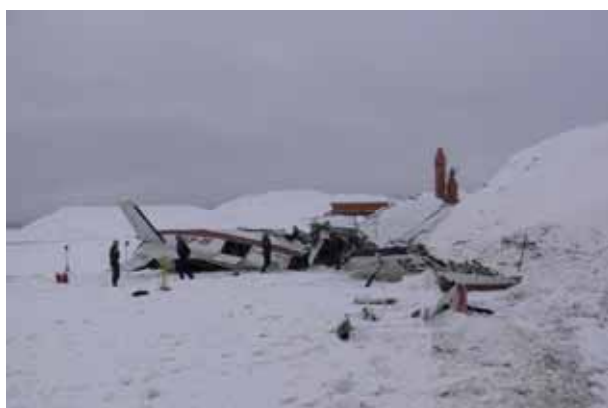
**B2/2005L**

**Aircraft accident at Helsinki–Vantaa airport  
31.1.2005**

Investigation revealed that the pilot did not succeed in brushing the snow and ice off of the upper surfaces of the wings, fuselage and stabilizers. When the wreckage was examined, it was estimated that the coat of snow, frozen slush and ice on the upper surface of the wings and on the sides of the fuselage varied between 0.5-1.5 cm in thickness. As the pilot retracted the flaps from the takeoff setting, the compacted snow and ice on the upper surface of the wing disturbed the lift enough to induce a stall. The aircraft rolled to the right and lost altitude. The pilot was unable to recover and the aircraft hit the ground at a shallow dive angle and was destroyed. At the time of impact the trailing edge flaps were in the clean configuration. The Emergency Locator Transmitter (ELT) was activated in the crash. An aircraft accident alarm was immediately sounded. A Border Guard helicopter located the wreckage of the plane approximately half an hour after the accident took place.

The primary cause of the accident was that the pilot executed a takeoff with an aircraft whose aerodynamic properties were fundamentally degraded due to the accumulated ice and snow on the upper surface of the wing. During the initial climb and immediately after flap retraction, airflow separated from the surface of the wing and the pilot did not manage to regain control of the aircraft. The pilot did not recognize the stall and did not act in the manner required to recover from one or, it might be that he had not received sufficient training for such situations.

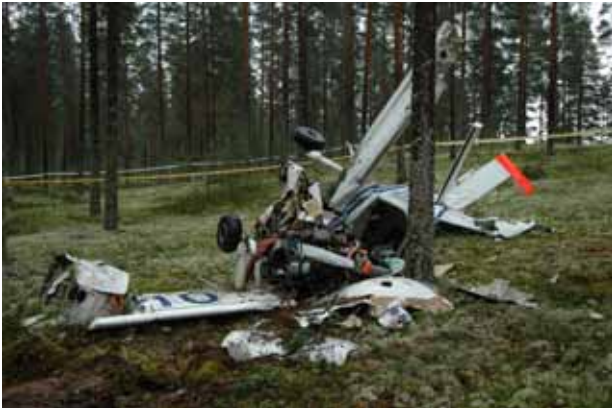
### **B3/2005L**

#### **Aircraft accident in Jämijärvi 24.7.2005**

It emerged during the investigation that for both pilots checking the weather during flight preparation was insufficient. Also they were not able to see approaching rain shower due low position of the take-off point. Due to rain shower the performance of the tow combination was weakened and high humidity caused thick moisture on canopy surface. Therefore the glider lost the forward visibility.

After the tow line release the glider landed on runway 33 without using airbrakes. The cause of the accident was the decision of both pilots to conduct flight in rapidly changing weather conditions. The glider drifted to a position where it lifted the tail of tow plane up. Due to low altitude the tow plane crashed into forest.

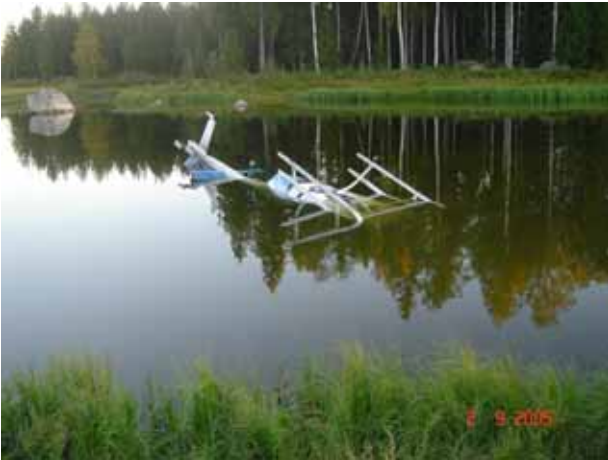
**B5/2005L**

**Helicopter accident in Paltamo 2.9.2005**

At Paltamo Metelinniemi golf course occurred September 2nd 2005 about 13.30 Finnish time a flight accident, in which a Bell 206B helicopter OH-HLP, owned and operated by First Invest Oy, fell down in a water pool during a photographing flight. Besides the pilot there were two other people in the helicopter, one of which was lightly injured. The helicopter was badly damaged. To investigate the accident the Accident Investigation Board Finland set an investigation board with investigator Juhani Hipeli nominated as its chairman and investigators Antti Kaarnamo and Jari Huhtala as members.

According to the opinion of the investigation board the reason for ending up into an uncontrolled flight state with unintentional rotation to the right around the vertical axis was a loss of effectiveness of the helicopter tail rotor. The low flying speed, sideslip to the left when the right pedal is pushed, turn to the right, relatively high flying weight and tail wind contributed to the loss of effectiveness. The torque, imposed on the helicopter in low speed flight by the main rotor power, is balanced by the tail rotor thrust. The torque, caused by the combined contributions mentioned above, exceeded the tail rotor effectiveness leading to the unintentional rotational motion and loss of control of the helicopter. It also transpired in the investigation that the pilot had incomplete knowledge about the helicopter's handling characteristics and aerodynamics probably due to a deficient training.

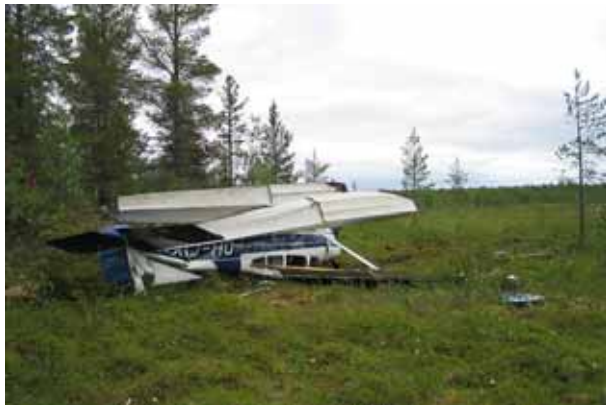
## **C2/2005L**

### **Forced landing in Sodankylä 28.6.2005**

Also he had relatively limited experience about long cross-country flights and he did not use a flight plan form for preparing the flight. With the help of a form he could have noted, that the amount of fuel now filled up would definitely have required a landing stop for refueling. The investigations did not show any technical defect in the aircraft.

The primary cause of the accident was the flight, carried out without a landing stop for refueling. The flight was stopped when the engine died, caused by a disturbance in the fuel supply to the engine. In spite of his efforts the pilot did not succeed in keeping the engine going and he had to make a forced landing on the marsh.

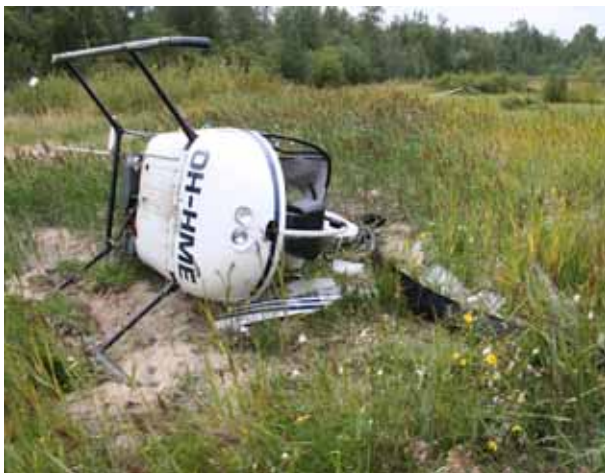
**C4/2005L**

**Helicopter accident in Hailuoto 19.8.2005**

The helicopter was at maximum take-off weight and controllability at take-off required larger than normal control inputs. The possibly too large control inputs to the left already before the take-off may have led to a situation, in which the helicopter immediately after leaving the ground has departed in the direction specified by the control inputs. The large corrective control inputs to the right, possibly made by the pilot, combined with the higher than normal torque moment, caused by the high take-off weight, may have led to strong swinging to the right. The rotating motion and low flying altitude of the helicopter, combined with loss of altitude, have led the left landing gear striking to the ground on its side. The collision has caused a so called dynamic collapsing to the left. Based on the investigations, no technical fault was noticed, that could have caused the accident.

The key event leading to the accident was the loss of control and the following collapsing of the helicopter to the left hand side. The too large control inputs, made by the pilot, were an immediate cause. A contributing factor may have been the alcohol, which was present in the pilot's blood.

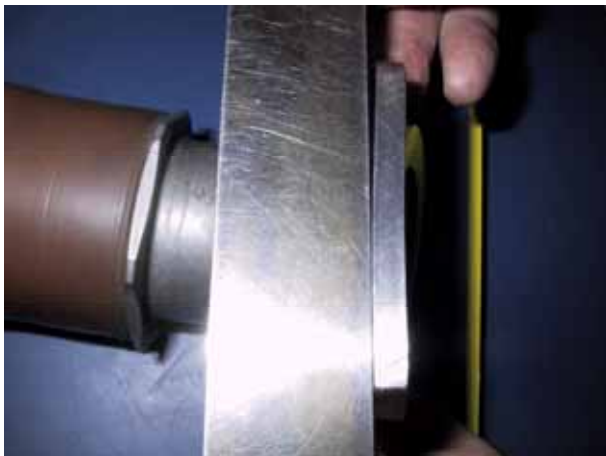
**C5/2005L**

**Passenger aircraft fuel leak during flight  
15.8.2005**

On August 14 to 15 2005, between 20.38 and 05.55 UTC, an incident occurred on a scheduled flight from Helsinki to Peking, when fuel started to leak from a joint in the fuel line of the left engine of an MD-11 aircraft. The aircraft, registration number OH-LGF, was owned by McDonnell Douglas Dakota Leasing, Inc and operated by Finnair Oyj. On August 24 2005, in its decision C 5/2005 L, the Accident Investigation Board Finland decided to conduct an investigation into the incident. Investigator Tapani Vanttinen was nominated as chairman and investigator Markus Bergman as a member of the investigation commission.

The left engine of the three-engine MD-11 passenger aircraft had been replaced in June 2005. During the flight fuel started to leak from the engine which had been replaced. The flight was, in spite of the leak, continued to the scheduled destination without shutting down the engine. In Peking the reason for the leak was found, the leaking joint was tightened and the aircraft returned normally back to Helsinki.

The investigation revealed that the instructions used in the installation of the main fuel hose of the engine were partly inaccurate and partly incomplete. Furthermore, the design of the joint between the main fuel hose and the engine pylon was unsatisfactory. In addition, the actions performed by the flight crew in the fuel leak situation were inadequate.

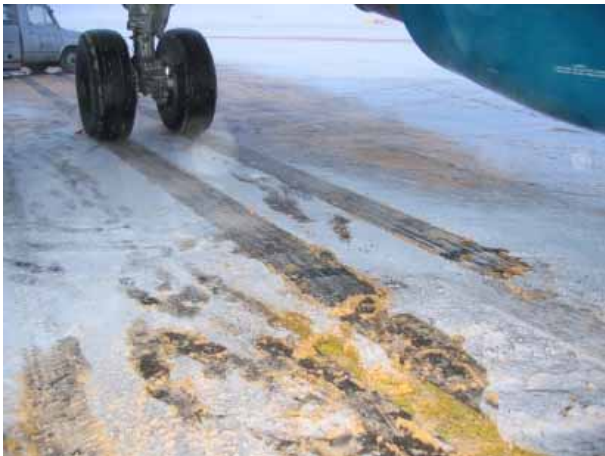
**C7/2005L**

**Falling of passenger stairs at Rovaniemi airport on 14 December**

On Wednesday 14 December 2005 at 10.17 UTC, an Airbus A321 airliner registered G-OOAH landed at Rovaniemi airport, Finland. The aircraft was operated by First Choice Airways on a charter flight from Bristol, Great Britain, with the call sign FCA536C. The aircraft was taxied to stand number nine guided by Rovaniemi airport staff. At 10.32.40, about eight minutes after the aircraft was stopped, it began to move backwards. The open aircraft door caused the passenger stairs to fall, and four persons were slightly injured.

The aircraft started to move because the surface at the stand was sloping. The angle of slope exceeded the maximum allowed in the standards for construction of aircraft stands. The wheel chocks could not keep the aircraft in place, but slid in front of the turning wheels due to the slippery surface and the structure and material of the chocks. The captain used the parking brake in accordance with the cockpit procedure intended for freezing conditions. However, the aircraft manufacturer has also published a standard procedure which allows the parking brake to be engaged on a slippery stand. After the incident and during the investigation, the airline has already changed the instructions given to its pilots.

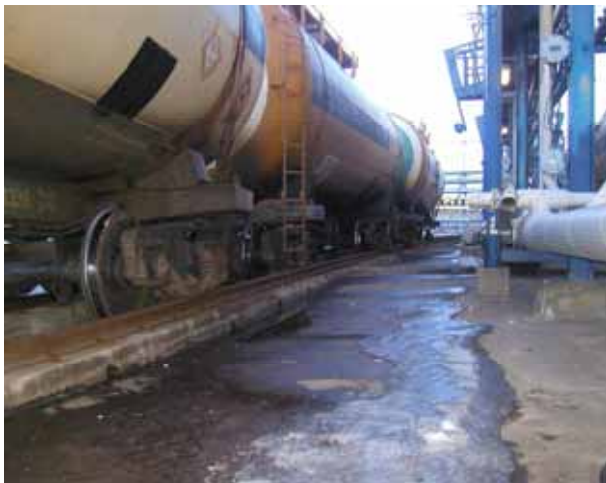
**C2/2004R**

**Methanol carrying wagons derailling on  
Kaukomarkkinat Oy's track at Hamina port  
on 15 April, 2004**

On Thursday April 15, 2004, an incident took place at Hamina port: three methanol carrying Russian tank wagons derailed. As a result, the track was damaged over a length of about 50 metres.

The incident was caused by the poor condition of the track owned by Kaukomarkkinat Oy. In fact the welding of the j-form rail fastenings made of flat bar iron proved deficient, as only the ends of the fastenings had been welded to the base plates. The detaching of a few fastenings generated a chain reaction that resulted in the detaching of the outer curve fastenings over a track length of about 40 metres and in a widening of the track under the wagons.

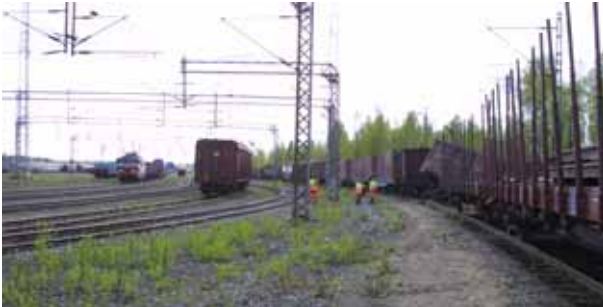
**C4/2004R**

**Freight wagons derailing on Pieksämäki railway yard on 11 May, 2004**

On Tuesday May 11, 2004 the fifth and sixth wagons of freight train T 2211A travelling from Kouvola to Pieksämäki, derailed on Pieksämäki railway yard. The bogies of the sixth wagon were badly damaged and track was also damaged over a distance of about 80 metres.

The incident was caused by the poor condition of the track. The wooden sleepers were in poor condition and lateral deflections had generated at the rail joints. Another factor having contributed to the incident was the carriage of rails that the train was performing. In fact the first three wagons of the train that were carrying rails may have generated torsion in the rail of the outer curve and hence when proceeding, they had probably deteriorated the strength of the track.

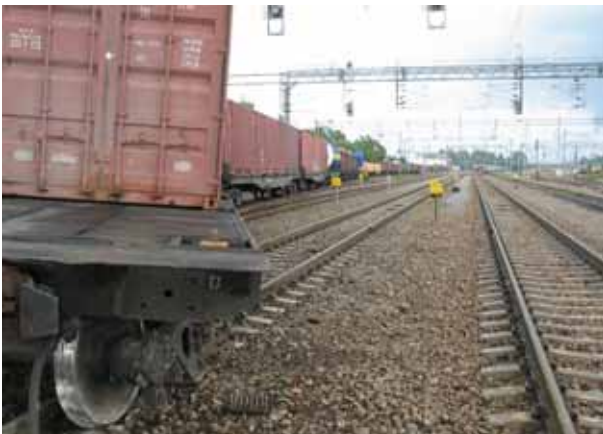
**C10/2004R**

**Derailment of two freight cars in Kouvola on 30 July, 2004**

The accident was caused by longitudinal forces, created by the braking freight train, which lightened the vertical load of the rear bogie of the Russian wagon situated on top of a discontinuity point on the running surface of the crossover. In addition, wear on the discontinuity points on the running surface of the crossover, the heavy brakeless wagon behind the light wagons and the train's uneven weight distribution contributed to the derailment.

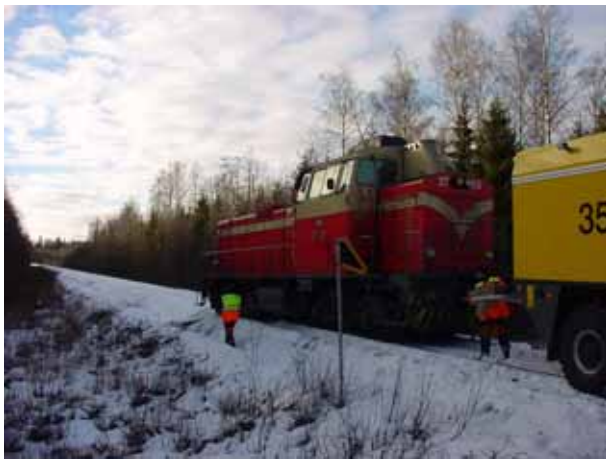
**C1/2005R**

**Collision of shunting unit and articulated vehicle in Mäntyluoto on 10 March, 2005**

The accident occurred when the shunting unit was returning to Mäntyluoto from a wagon-weighing assignment. At the level crossing of the road leading to the Kemira Pigments Oy plant area, the shunting unit collided with the articulated vehicle, which had simultaneously entered the crossing. The driver of the articulated vehicle had time to notice the shunting unit approaching behind the cover of trees and to apply the brakes, but was unable to prevent the collision. The articulated vehicle collided with the right side of the engine and slid into a ditch running along the bank.

Two factors were crucial to the accident: the driver's intention not to stop at the level crossing, and defects in the braking system of the articulated vehicle which weakened the effect of the brakes. Two defects affected the brakes of the articulated vehicle simultaneously at the time of the accident, which caused the behaviour of the vehicle upon braking to surprise the driver. On account of the accident, the Accident Investigation Board recommends enhancing the maintenance of the brakes of articulated vehicles and supervision thereof.

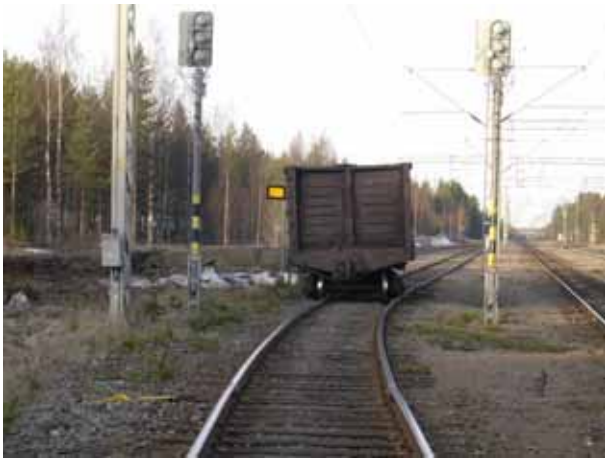
### C3/2005R

#### **Derailment of a Russian freight car loaded with pellets in Eskola on 27 April, 2005**

The accident happened when the train arrived to undertake a coupling while in motion on track three, at which point the last wagon became derailed on the outside curve and detached from the train. There were no personal injuries. Approximately ten metres of rail and railway equipment were damaged. The derailed wagon was also damaged. The accident was caused by the stiffness of the Russian Vok-type wagon's bogies, the screw attachment of the rails, the wooden sleepers and their condition, as well as the rail type and the wear on the rail on the outside curve. The stiffness of the bogies was due to wear and lack of greasing in the pivots. The worn K43 rail attached with screws to slightly worn wooden sleepers allowed the momentary widening of the rails as the bogies broke. When this happened, the space between the rails became large enough to allow the wheels on the inside curve to slip between the rails. And after that the wheels on the outside curve rose over the rail, derailing the wagon.

Worn pivots pose a direct derailment risk on worn rails, as well as an indirect one through premature wear on the wheels. Therefore the Accident Investigation Board reiterates recommendation S58, given in investigation report C 4/1996 R and reiterated in reports C 37/1997 R and C 4/2003 R. The condition of the pivots of Russian wagons and their greasing should be ensured. C4/96R/S58 Because the condition and greasing of pivots are difficult to control when undergoing border checks, the pivots of Russian wagons should be greased every time the bogies are detached from the wagon in Finland, for example to change the wheel set. The Russian party should, furthermore, be informed of the problems caused by stiff pivots. As the problem of stiff pivots is ongoing, the Rail Administration should continue its attempts to find a system to measure the stiffness of pivots at border crossing points. In addition, any pellet wagons with stiff pivots should be directed away from the third track of the Eskola yard. The third track has wooden sleepers and the rails are fastened with screws.

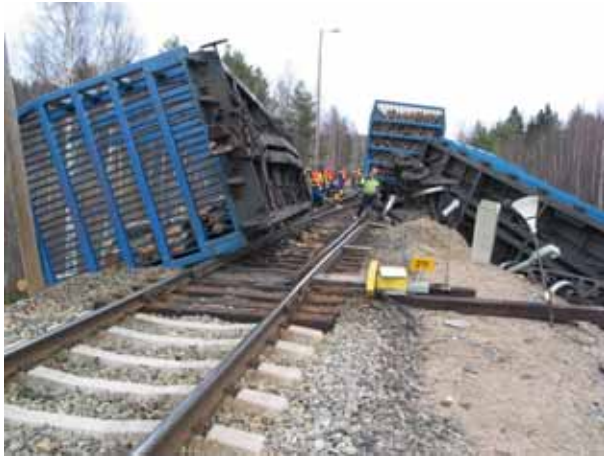
#### **C4/2005R**

#### **Derailment of five freight train cars in Heinävesi on 28 April, 2005**

The incident was caused by the poor condition of the track. The wooden sleepers were in poor condition and lateral deflections had generated at the rail joints.

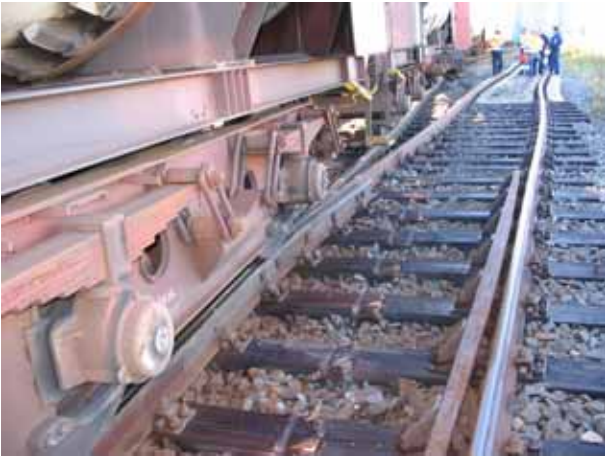
**C6/2005R**

**Liquid gas wagon derailling at Raahe on 30 August, 2005**

On Tuesday 30 August, 2005, the rear bogie of a wagon loaded with propane gas derailed on Raahe freight yard. The wagon in question was the sixth wagon of the train and the second one of a group of six propane gas wagons. The wagon derailed when the train was being pulled from a track to another track. No personal injury was caused. The derailed bogie of the derailed liquid gas wagon and its wheelsets were damaged. The frame beam of the wagon deflected and the rear-end traction equipment was damaged. One side buffer in the front end of a liquid gas wagon that was located behind the derailed wagon, as well as its traction equipment and brake conduit were damaged. The western junction track was damaged over a length of about 30 meters from derailling turnout onwards. The eastern track was reopened for traffic the same evening while the western track had to wait yet three days. The total costs generated by the incident amounted to about € 29,000.

The derailling of the bogie of the wagon resulted from a turnout position with both blades slightly open, when the wheelsets of the bogie entered the turnout. Therefore both wheel flanges slipped between the blade and the rail. The turnout had probably failed to be turned and the point had been trailed when the wagons were pushed toward the trailing point at a low speed, and hence the turnout remained in an intermediary position. When the pulling of the wagons was commenced, the turnout started to return to its initial position and when the wheels of the third bogie entered the turnout, it had assumed an intermediary position that allowed both wheels to penetrate between the blade and the rail. The turnout having probably failed to be operated implies a human error, to which several simultaneous stress factors contributed. Moreover the system in no way prevented the performance of shunting movements while the turnout featured an erroneous or intermediary position.

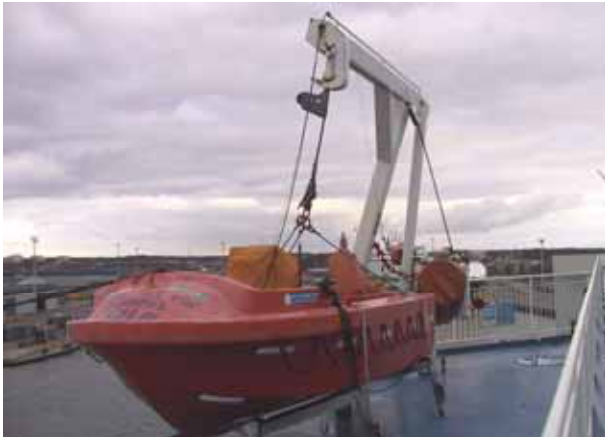
**B6/2004M**

**Ms SUPERFAST VIII, Fall of an MOB boat to the sea in a drill in Hanko West Port on 9.11.2004**

The aim has been to prevent the accidental opening of suspension hook of the boat by means of a security pin and further by means of a safety spring, but these were not in place when the opening took place. In the opinion of the investigators, it has not been possible for the safety spring and the security pin to come loose by accident, and so it is likely that the pins have been removed either at the beginning of the drill or they have not been in place even before the drill. The purpose is not to remove the pin until the boat is close to the surface of the water, which those in the boat have said they knew. The instructions in the boat contain no mention of the removal of the pin nor of the fact that this should not be done until after the boat has been lowered to the water.

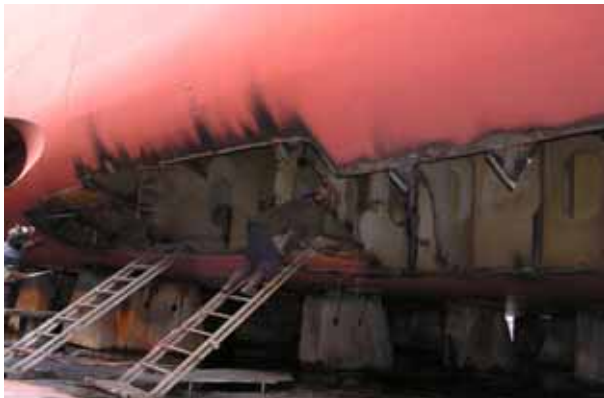
**B7/2004M**

**Ms SUPERFAST VII, Grounding off Hanko  
on 12.11.2004**

The Ro-Ro passenger vessel SUPERFAST VII was on way from Rostock to Hanko on 12 November 2004. She had 140 passengers. Her cargo was trailers, trucks and cars. The vessel took a pilot between Russarö and Gustafsvärn at 19:05. The vessel reached the turning area outside the port at 19:14, when the tugboats the Ajax and the Iso-Pukki were fasted on her starboard side.

The investigation revealed that the strongest background factor of the accident were the defective instructions of the Safety Management System (SMS) of the shipping company. This resulted in insufficient utilisation of the existing navigation equipment and a lack of bridge co-operation. The instructions did not contain port steering in a storm, which resulted in a defective estimation of the wind effect.

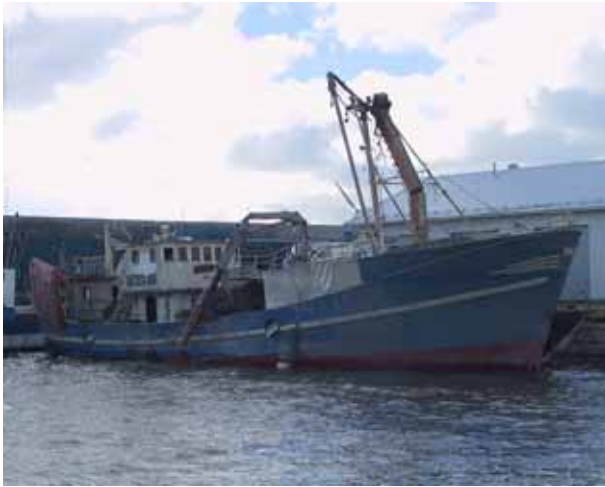
**C1/2004M**

**F/V BRATTVÅG, Sinking of the vessel off  
Pori 17.1.2004**

The investigators concluded that a bilge pump failure lead to the water ingress to the boat. This was because the discharge pipe was not fitted with a non-return valve.

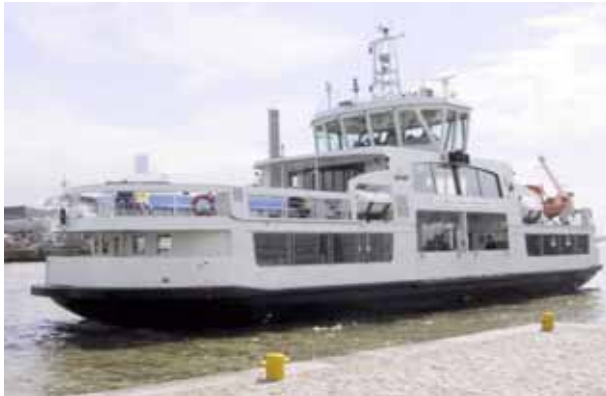
#### **C4/2004M**

#### **Passenger vessel SUOMENLINNA II, Grounding in Helsinki on 5.7.2004 and seven other incidents**

Technical faults experienced on 5.7.2004 and 12.8.2004. On both occasions, the vessel suffered a blackout and loss of manoeuvrability. On the first occasion, this resulted in a bottom contact off the shore of the island Valkosaari. On the second occasion, the vessel collided with a bridge in Suomenlinna. These situations were caused by malfunction of the fuel system and incorrect installation of electrical cables. In both cases, the situation was compounded by faults in the diesel-electric propulsion system settings, resulting in total failure of the electrical system. There was no personal injury, and other damage was minor.

Ships are normally built in small series. Accordingly, most ships can be considered prototypes. This is particularly true of the SUOMENLINNA II, because vessels of this size have never before been built equipped with electric-powered rudder propeller systems at both ends. Utilising new technology and new vessel types promotes progress in the marine technologies and provides new kinds of possibilities and characteristics for the vessel in question. On the other hand, such solutions increase the risks and require high-quality operations of all parties.

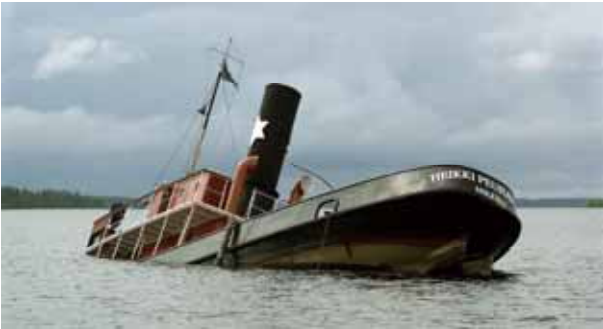
**C2/2005M**

**S/S HEIKKI PEURANEN, Grounding at Sai-  
maa 25.6.2005**

Water was leaking in trough the bow cabin's open porthole and trough the toilet, which opened straight outside. The vessel sank partly and remained on the shoal. The passengers were evacuated quickly by a pleasure boat, which was cruising nearby and the personal injuries were avoided. The tugboat was being lifted up couple some weeks later and docked for repairing.

The cause of the accident was the lack of local water area expertise outside the fairway area and erroneous visual observations. The direct reason for the sinking was the leaking of the vessel's hull. This was caused by the open porthole and the erroneous structure of the toilet.
