**The Rail Safety  
Inspection Office**

# **NIB ANNUAL REPORT 2020**

according to Article 23(3) of Directive 2004/49/EC

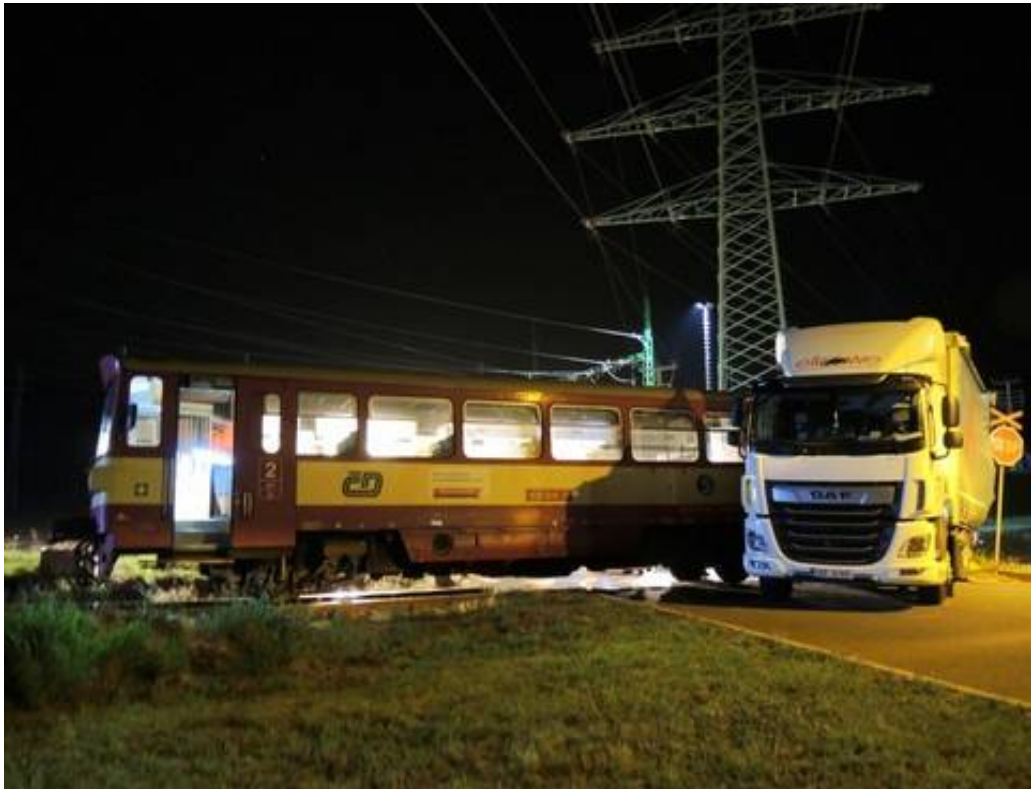
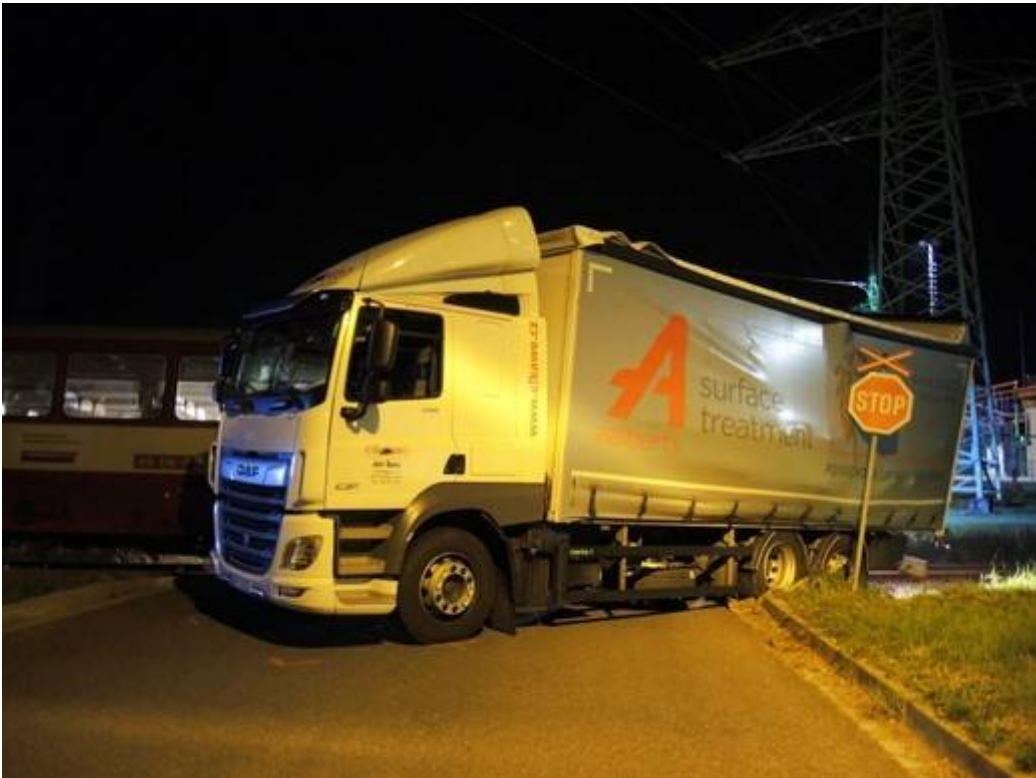
| Direct cause: | <ul style="list-style-type: none"><li>a lorry driver's failure, he did not respect the light and acoustic warning and he was driving across the level crossing at the time when it was forbidden and the visual and acoustic warnings were being given.</li></ul> |
| Contributory factor: | <ul style="list-style-type: none"><li>increased claims on the lorry driver's attention, he is obliged to give priority to oncoming vehicles when turning left and at the same time, to evaluate the condition of the warning lights of the level crossing safety equipment at high traffic intensity.</li></ul> |

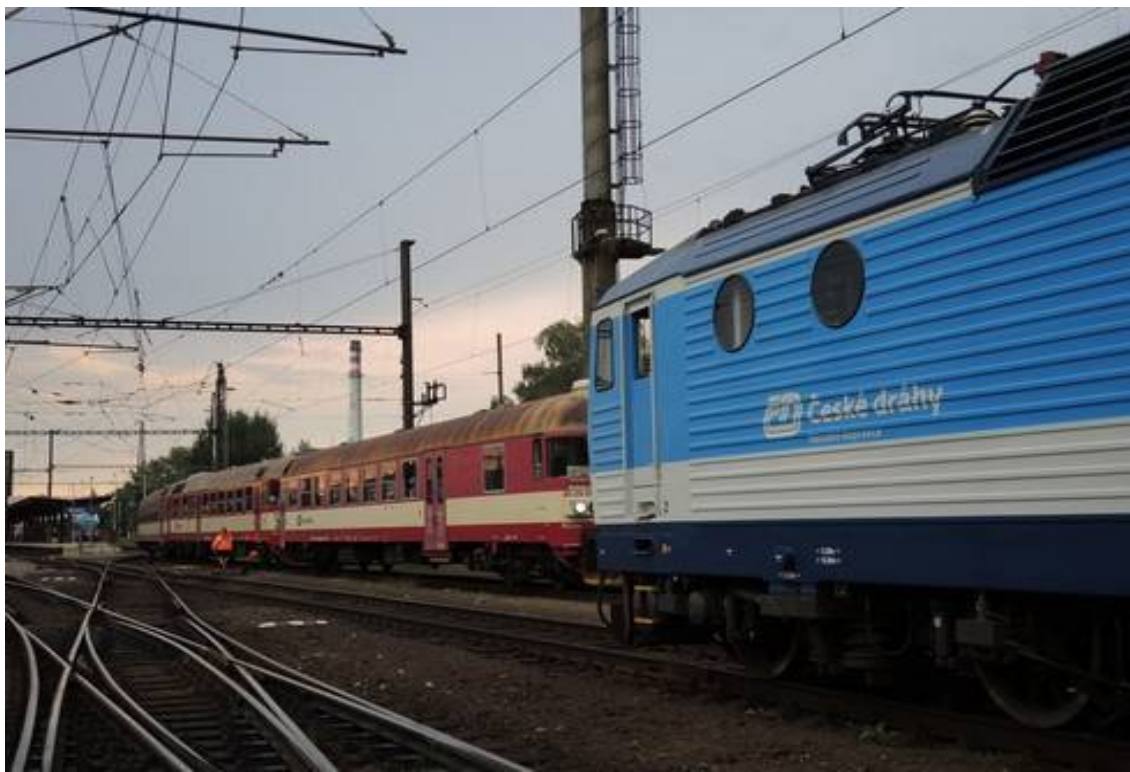
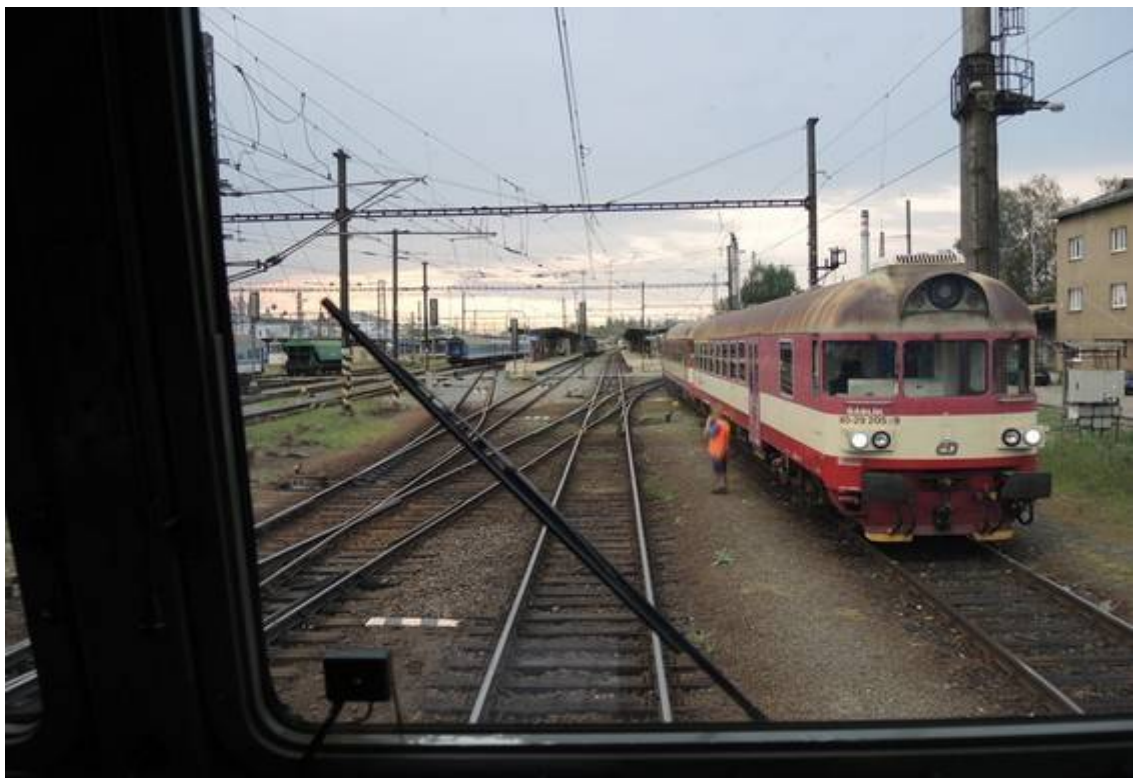
| Direct cause: | <ul style="list-style-type: none"><li>• failure to respect the signal „Shunting forbidden” given by the shunting signal device Se81 (situated at Kolín station) by the supervisor of the shunting operation who was at the head of the shunting operation.</li></ul> |
| Underlying cause: | <ul style="list-style-type: none"><li>• inattention of the supervisor of the shunting operation (who was at the head of the shunting operation), who did not instruct the train driver of the shunting operation to stop in time, so that the shunting operation was not able to stop safely at latest at the end of the shunting operation route, ie. in front of the shunting signal device Se81.</li></ul> |

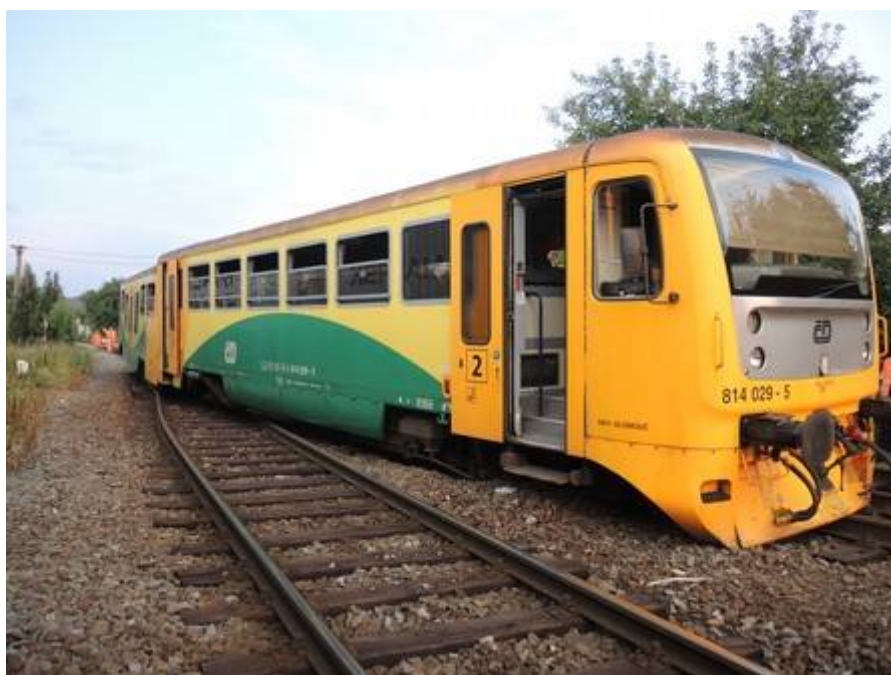
| Direct cause: | <ul style="list-style-type: none"><li>• permission for the train movement over the switch in resetting mode which was not switched to the end position for the priority direction of the train movement.</li></ul> |
| Underlying cause: | <ul style="list-style-type: none"><li>• failure to comply of the technological procedures of the IM for ensure of safety while driving the train in time of disorder of normal position of self-returning switch.</li></ul> |

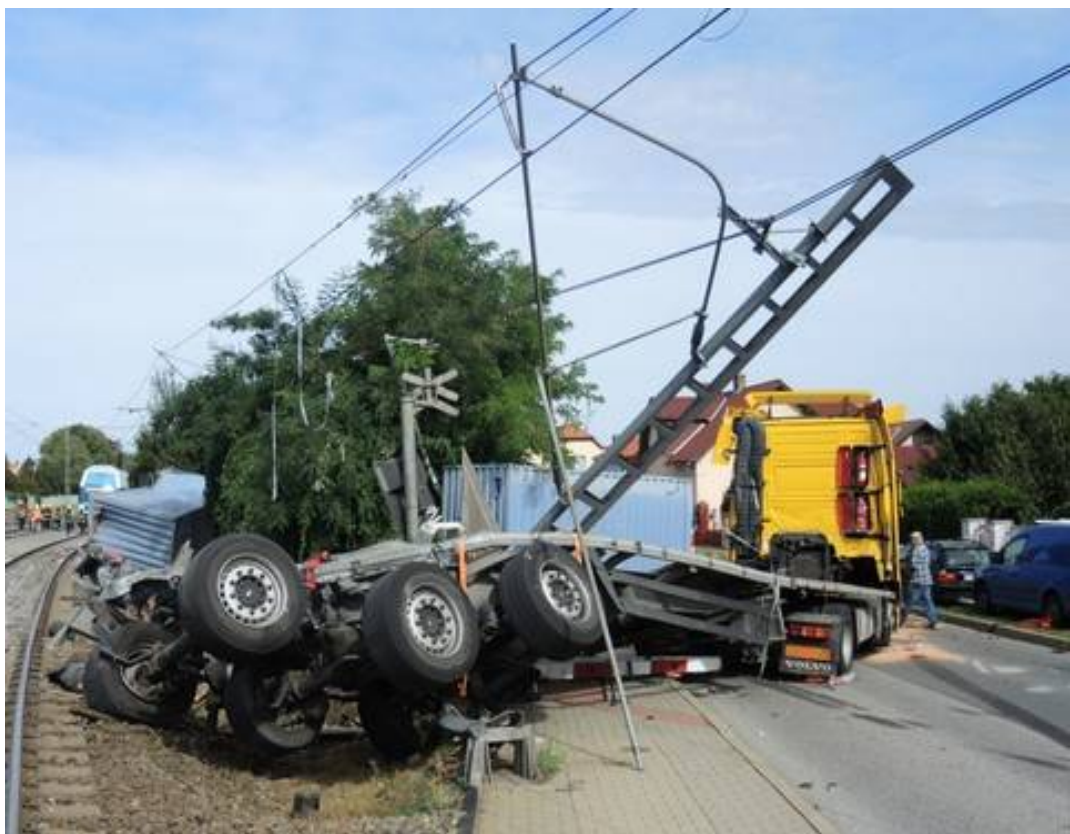
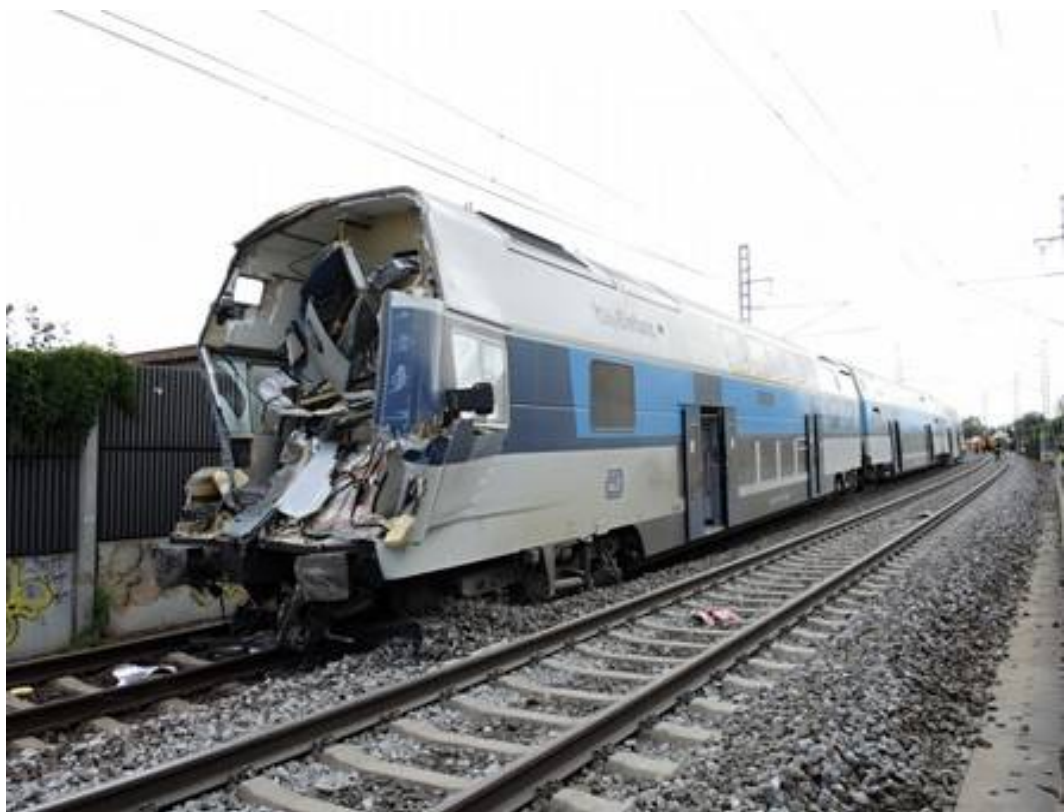
| Direct cause: | <ul style="list-style-type: none"><li>driver's failure to respect the light and acoustic warning and driving across the level crossing at the time when it was forbidden and visual and acoustic warnings were being given.</li></ul> |
| Underlying causes: | <ul style="list-style-type: none"><li>driver's failure to respect of the light and acoustic warning of the level crossing safety installation;</li><li>behavior of the driver in front of the level crossing, the lorry driver wasn't careful enough.</li></ul> |

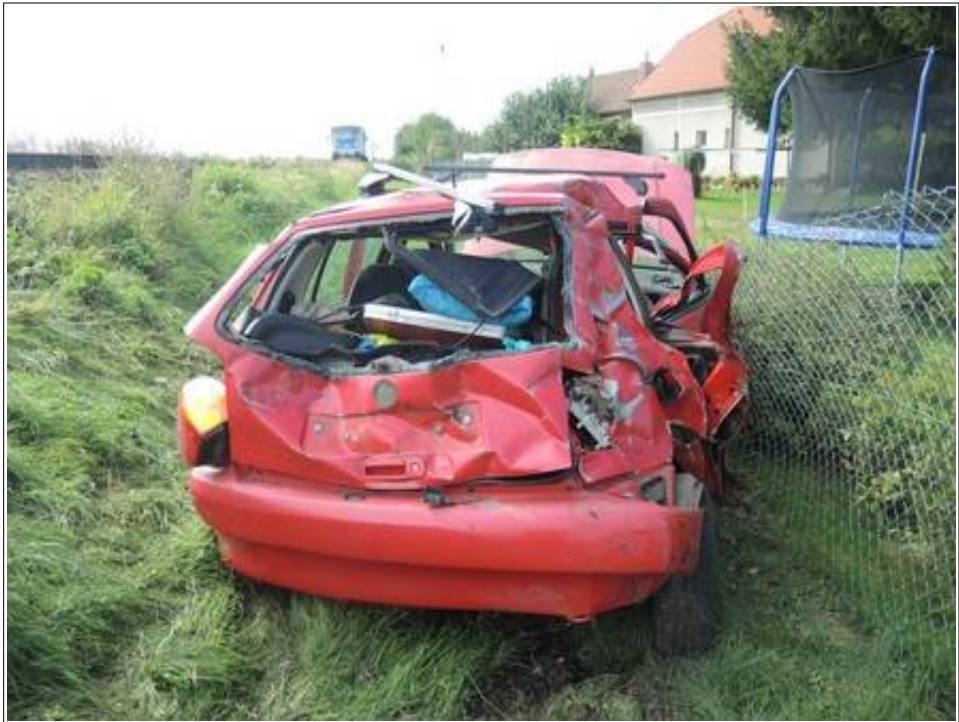
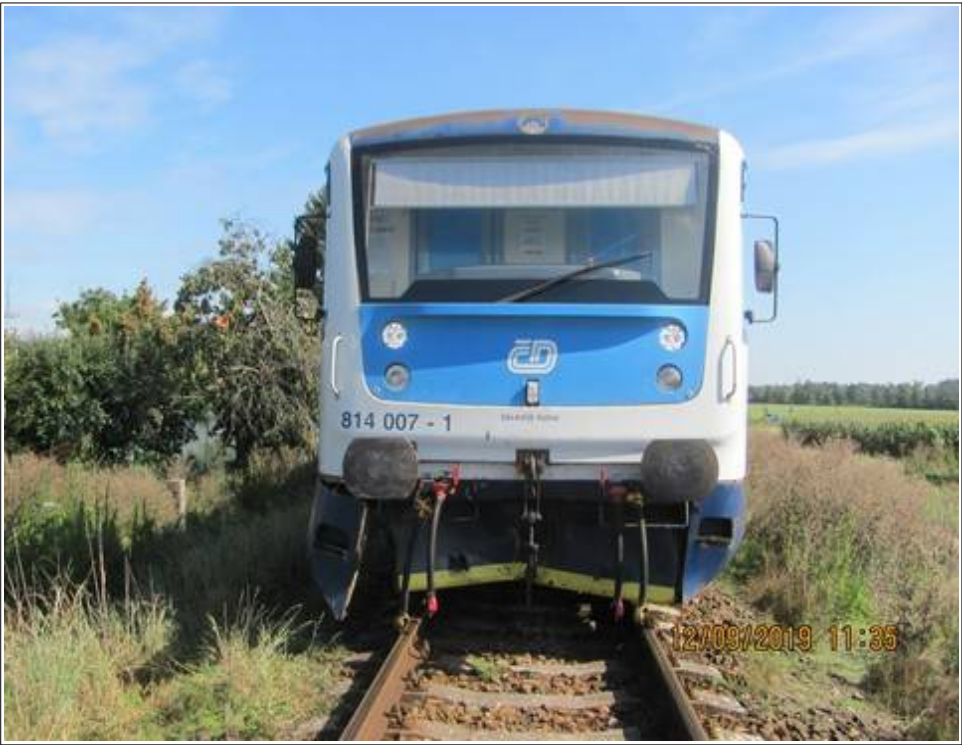
| Direct cause: | <ul style="list-style-type: none"><li>an unauthorized entrance of the car at the level crossing No. P5391 at the time when the train No. 5505 was arriving.</li></ul> |
| Underlying cause: | <ul style="list-style-type: none"><li>driver's behavior in front of the level crossing, the car driver was not careful enough and he did not stop the car in front of the level crossing on command traffic sign "Stop sign" at a place where he had a proper view of the railway line and he did not make sure, whether he can safely proceed over the level crossing.</li></ul> |

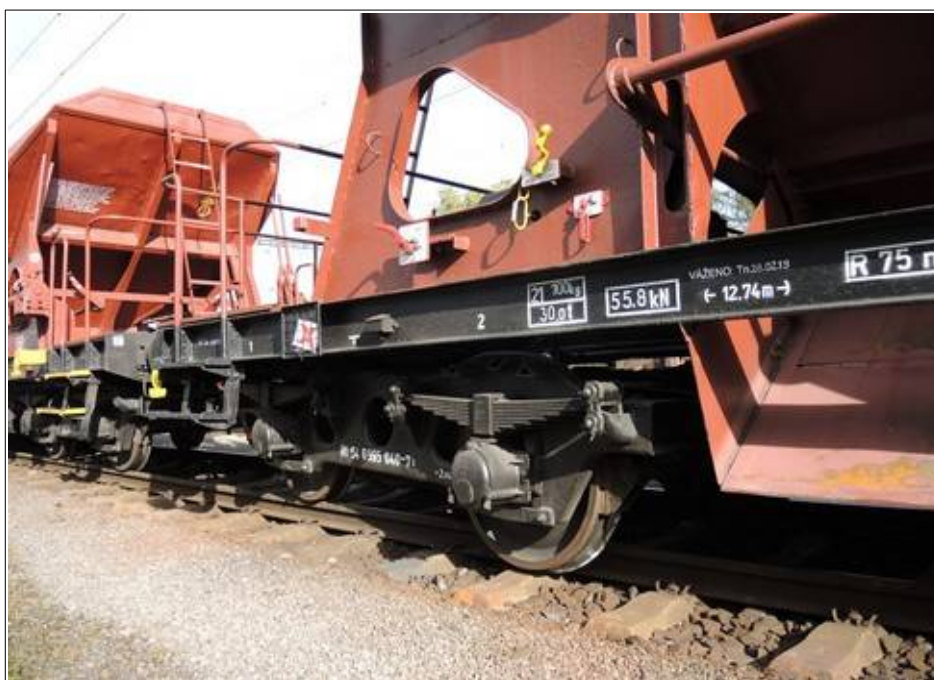
| Direct cause: | <ul style="list-style-type: none"><li>the loss of the vertical wheel effort of the right wheel of the first axle (in the direction of the ride) of the rear bogie of the rolling stock CZ-ČDC 81 54 6995 040-7 series Faccs295.2 caused by the defects in the track geometry parameters of the track in the switch No. 65 and the adjacent part of the track No. 18 at Liberty Ostrava siding.</li></ul> |
| Underlying cause: | <ul style="list-style-type: none"><li>failure to ensure the regular checks and maintenance of the railway at the place of the incident.</li></ul> |

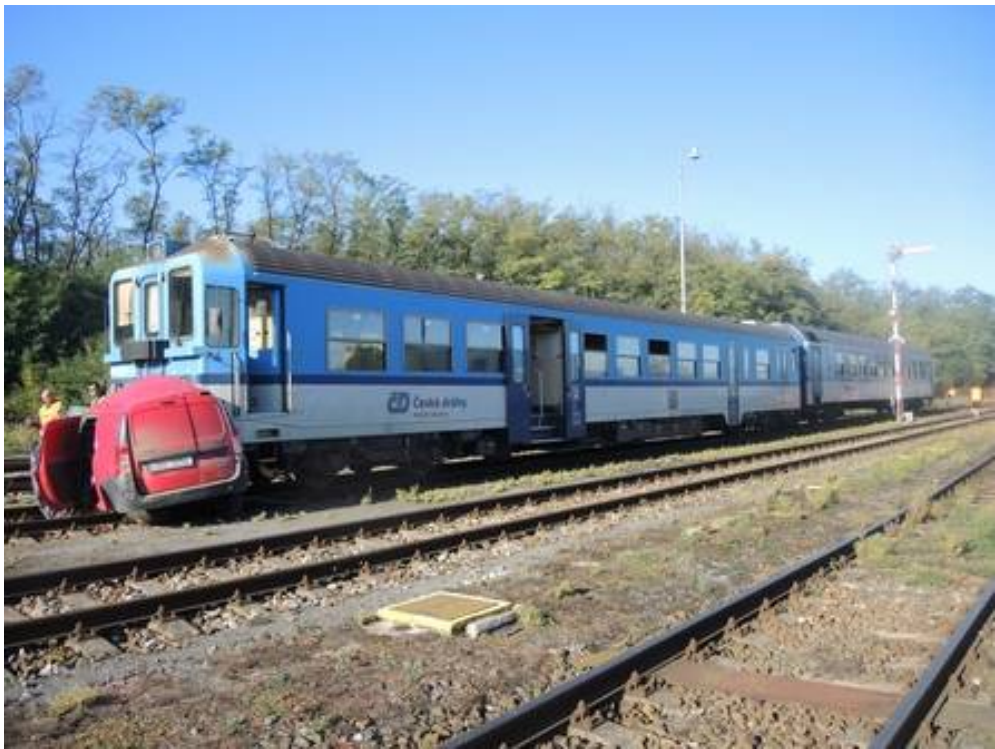
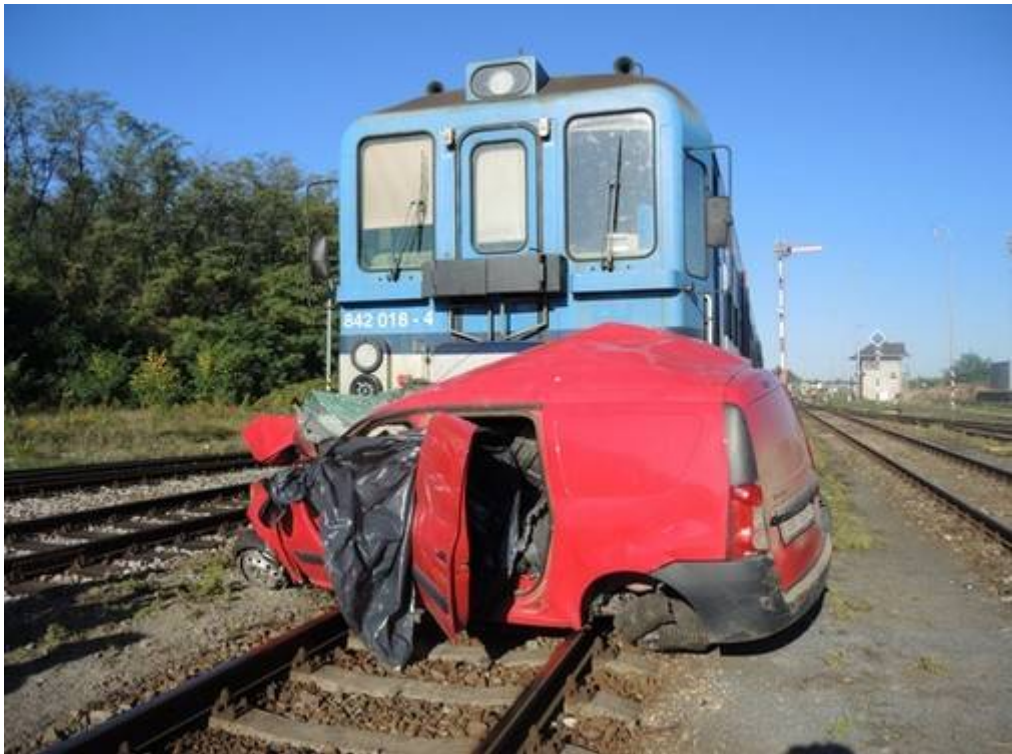
| Direct cause: | <ul style="list-style-type: none"><li>• driver's failure to respect the light and acoustic warning and driving across the level crossing at the time when it was forbidden and the visual and acoustic warnings were being given.</li></ul> |
| Underlying causes: | <ul style="list-style-type: none"><li>• driver's failure to respect the light and acoustic warning of the level crossing safety equipment;</li><li>• driver's behavior in front of the level crossing, the driver was not careful enough.</li></ul> |

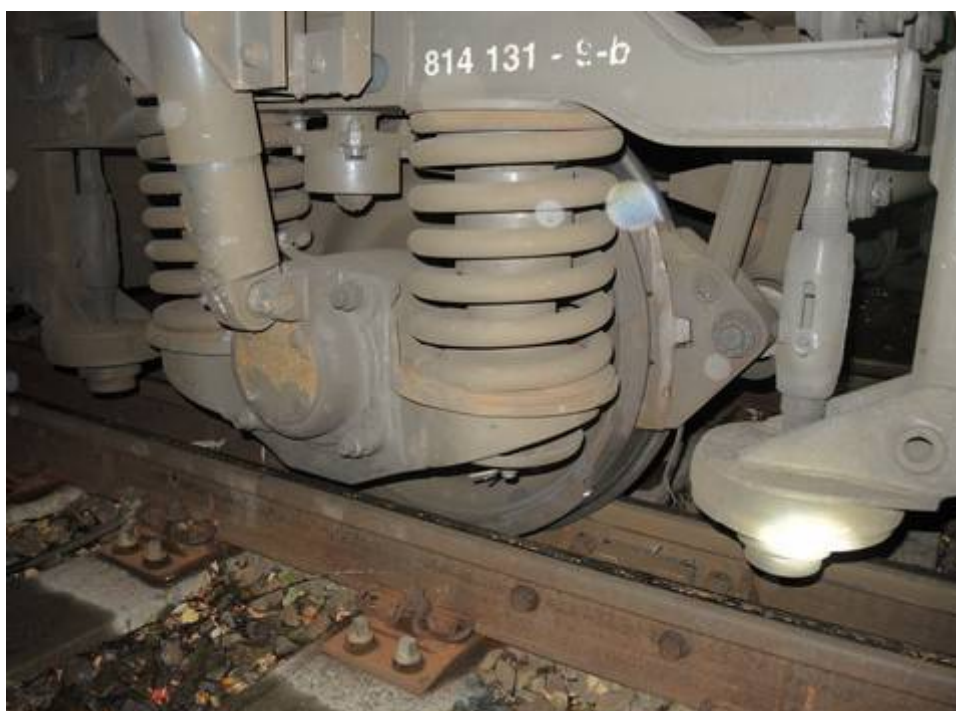
| Direct cause: | <ul style="list-style-type: none"><li>• change of position of the switch No. 1, when the rolling stocks of the train No. 18809 were on the switch.</li></ul> |
| Underlying cause: | <ul style="list-style-type: none"><li>• failure to comply of technological procedures of the IM at cancellation and preparation of the train route.</li></ul> |

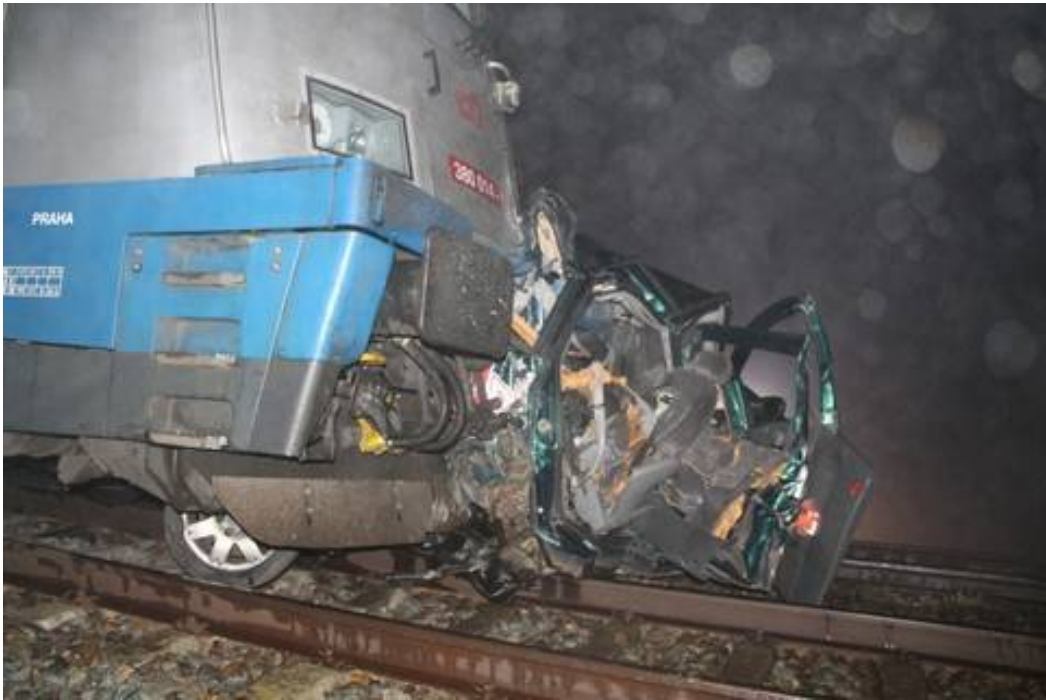
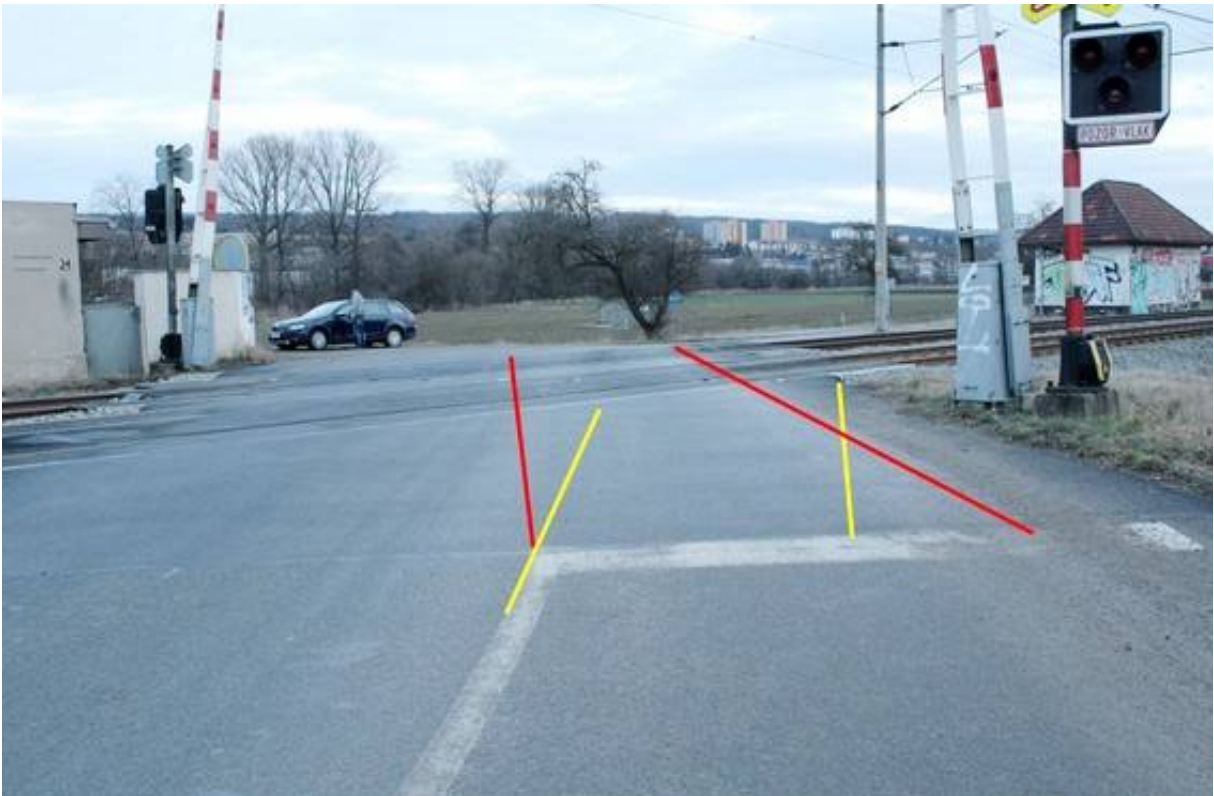
| Direct cause: | <ul style="list-style-type: none"><li>a deadlock of the car in the level crossing area on the right side in driving direction after leaving the level crossing surface.</li></ul> |
| Contributory factor: | <ul style="list-style-type: none"><li>a night time and a heavy falling fog distorted the deteriorated view from the car to the surface of the level crossing.</li></ul> |
| Underlying cause: | <ul style="list-style-type: none"><li>failure to comply with the car driver's obligations to adapt his behavior and his way of driving to the traffic technical road condition, weather conditions and view from the car when participating in road traffic.</li></ul> |

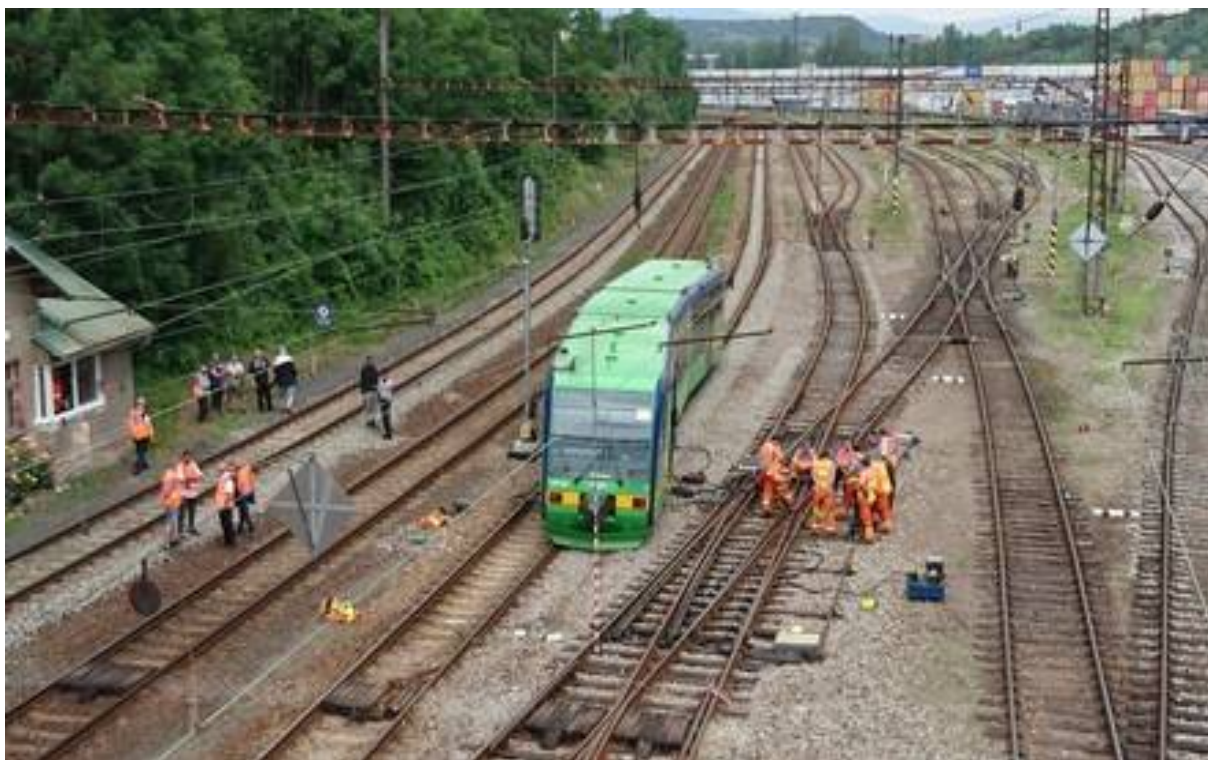
- unauthorized change of position of the switch No. 25a at the time, when the rolling stocks of the train No. 6704 were on the switch, which was preceded by a failure to detect whether the train No. 6704 has arrived whole at the designated track and premature cancellation of train route for this train.

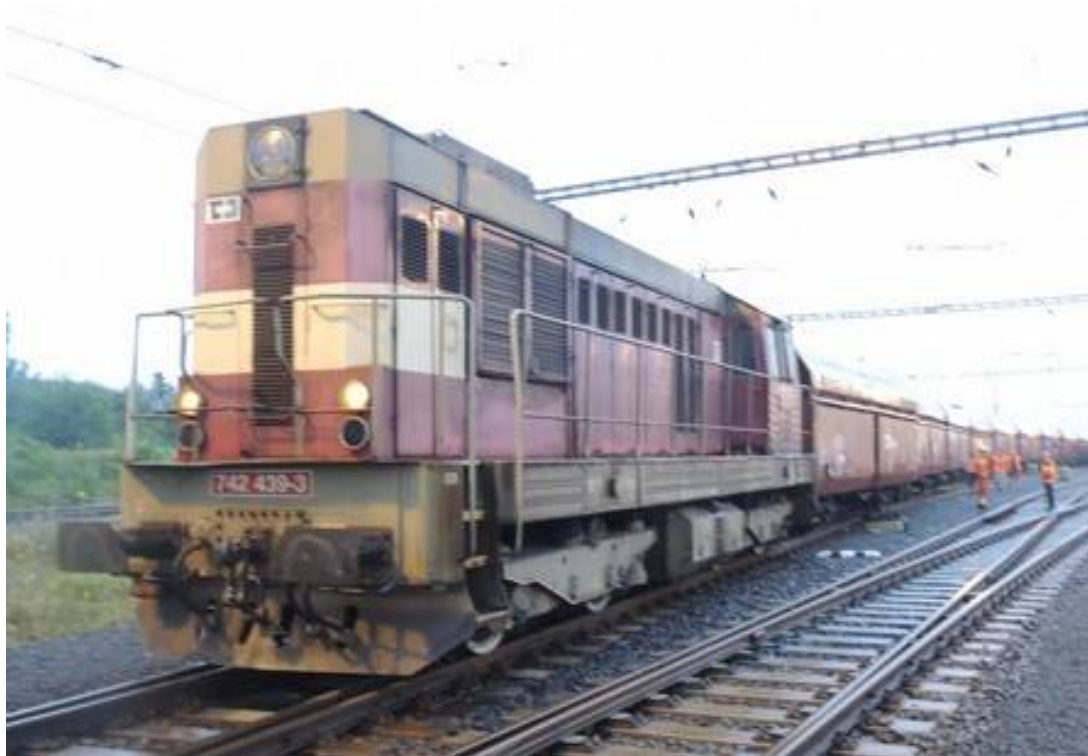
- not remove of device for securing the rolling stock against uncontrolled movement – the rail skate from the rail before the movement of the rolling stocks of the freight train No. 86658.
