State Commission on Railway Accidents Investigation
MINISTRY OF INTERNAL AFFAIRS AND ADMINISTRATION

ANNUAL REPORT 2020

ON ACTIVITIES OF THE
STATE COMMISSION ON RAILWAY ACCIDENTS
INVESTIGATION (PKBWK)

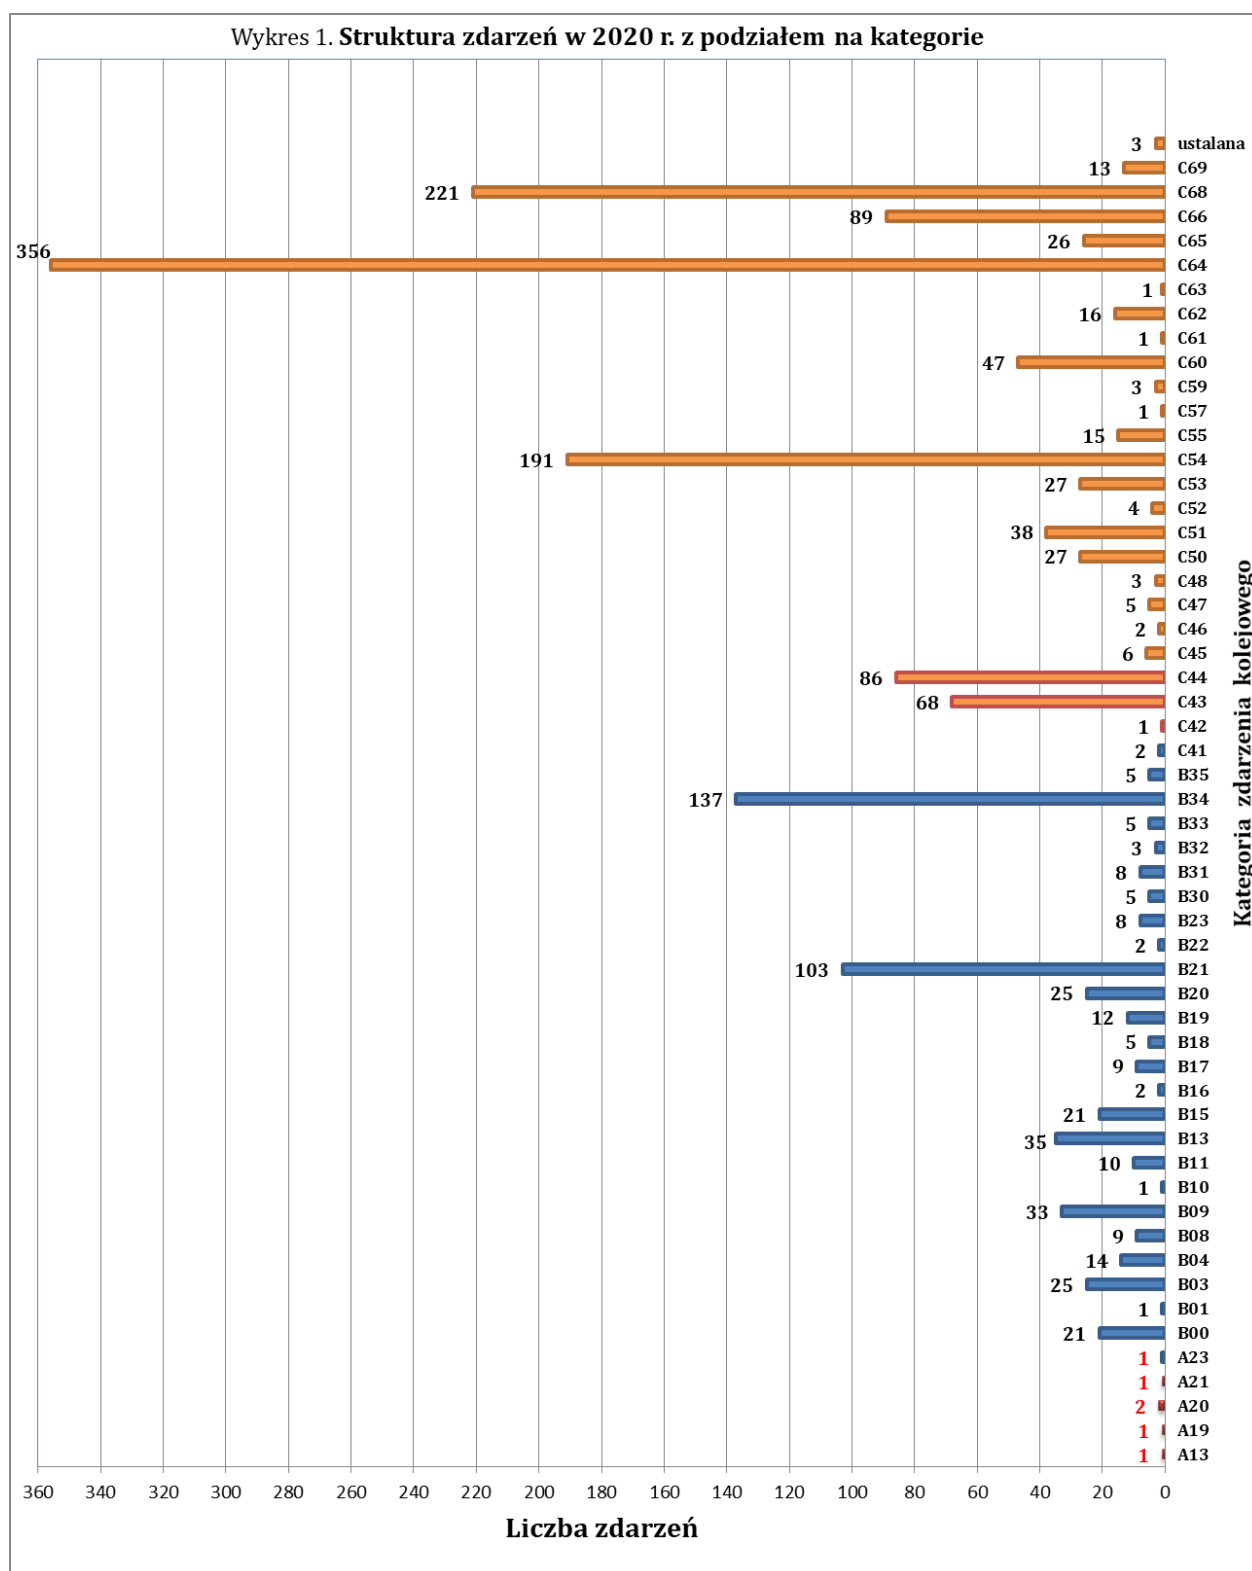
The chart contains 3 railway incidents occurring in 2020 for which a category has not been established until 26 August 2021. - under the heading of category 'established'.

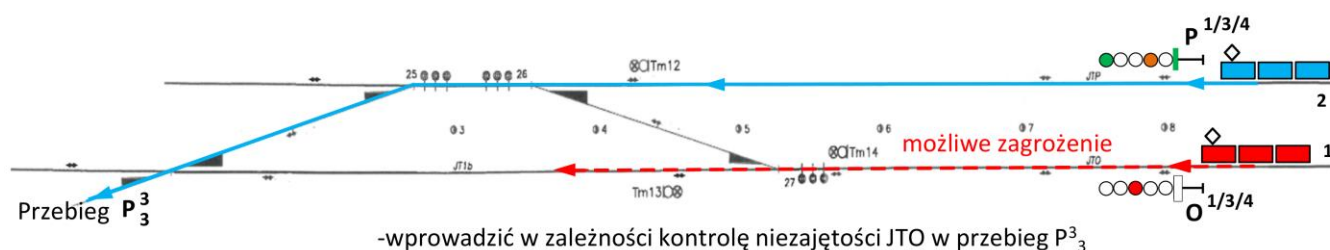
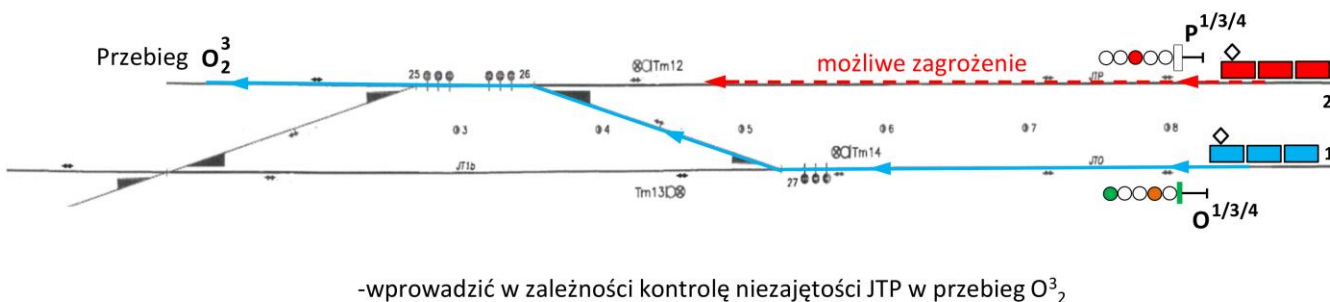
- 6) To increase traffic safety in a signalling circle in case of simultaneous train movement on tracks in the same direction - of the same station and when a train (red) with "stop" signal given on the entry semaphore does not stop to cause earlier change of authorising picture to the "stop" signal, for the train (blue) approaching the entry semaphore on the adjacent track with "free passage" signal it is necessary

In control-command and signalling systems with unoccupied track sections following semaphores on the entry and exit sides of multiple-track routes as part of their mutually conflicting routes, introduce their relation as shown in the examples in the following figures.

This recommendation is addressed to infrastructure managers to eliminate of events such as those which occurred (or similar) at Szymankowo station on 9 March 2020 at 04:15, and the circumstances presented in Report No. PKBWK 01/2021.

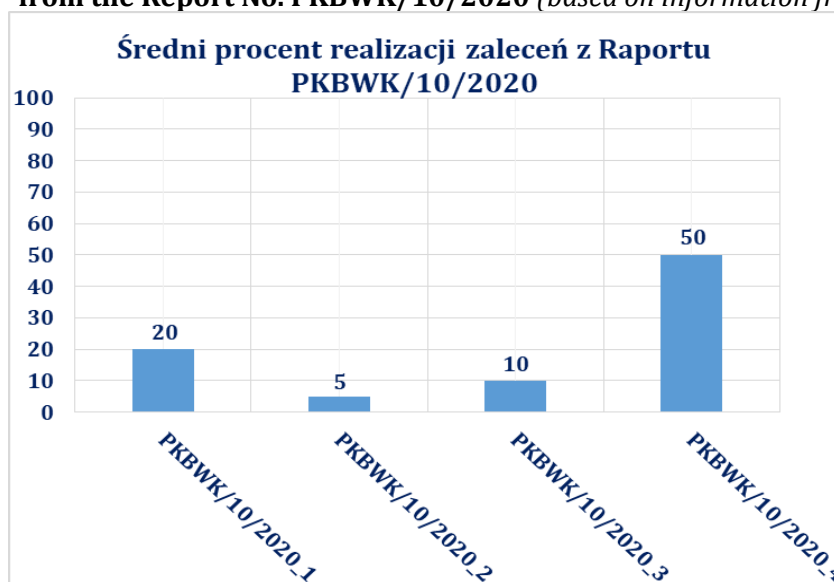
Figure 21: **Average percentage of implementation of recommendations forwarded by the President in Report No. PKBWK/10/2020** (based on information from UTK)

The average percentage of implementation of recommendations was determined by UTK based on declarations of addressees of a given recommendation. Lack of 100% of recommendation results from the schedule of activities undertaken by the entity to fully implement the recommendations of PKBWK.

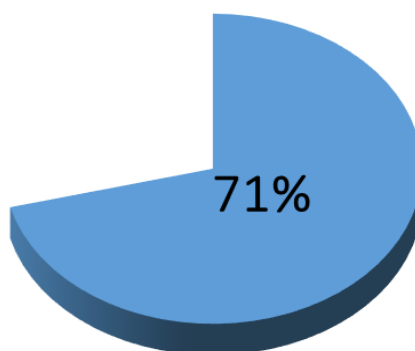
Chart 23: **Average percentage of implementation of recommendations provided by the UTK President - from the Annual Report for 2019** (based on information from UTK)

The average percentage of implementation of recommendations was determined by UTK based on declarations of addressees of a given recommendation. Lack of 100% of recommendation results from the schedule of activities undertaken by the entity to fully implement the recommendations of PKBWK.

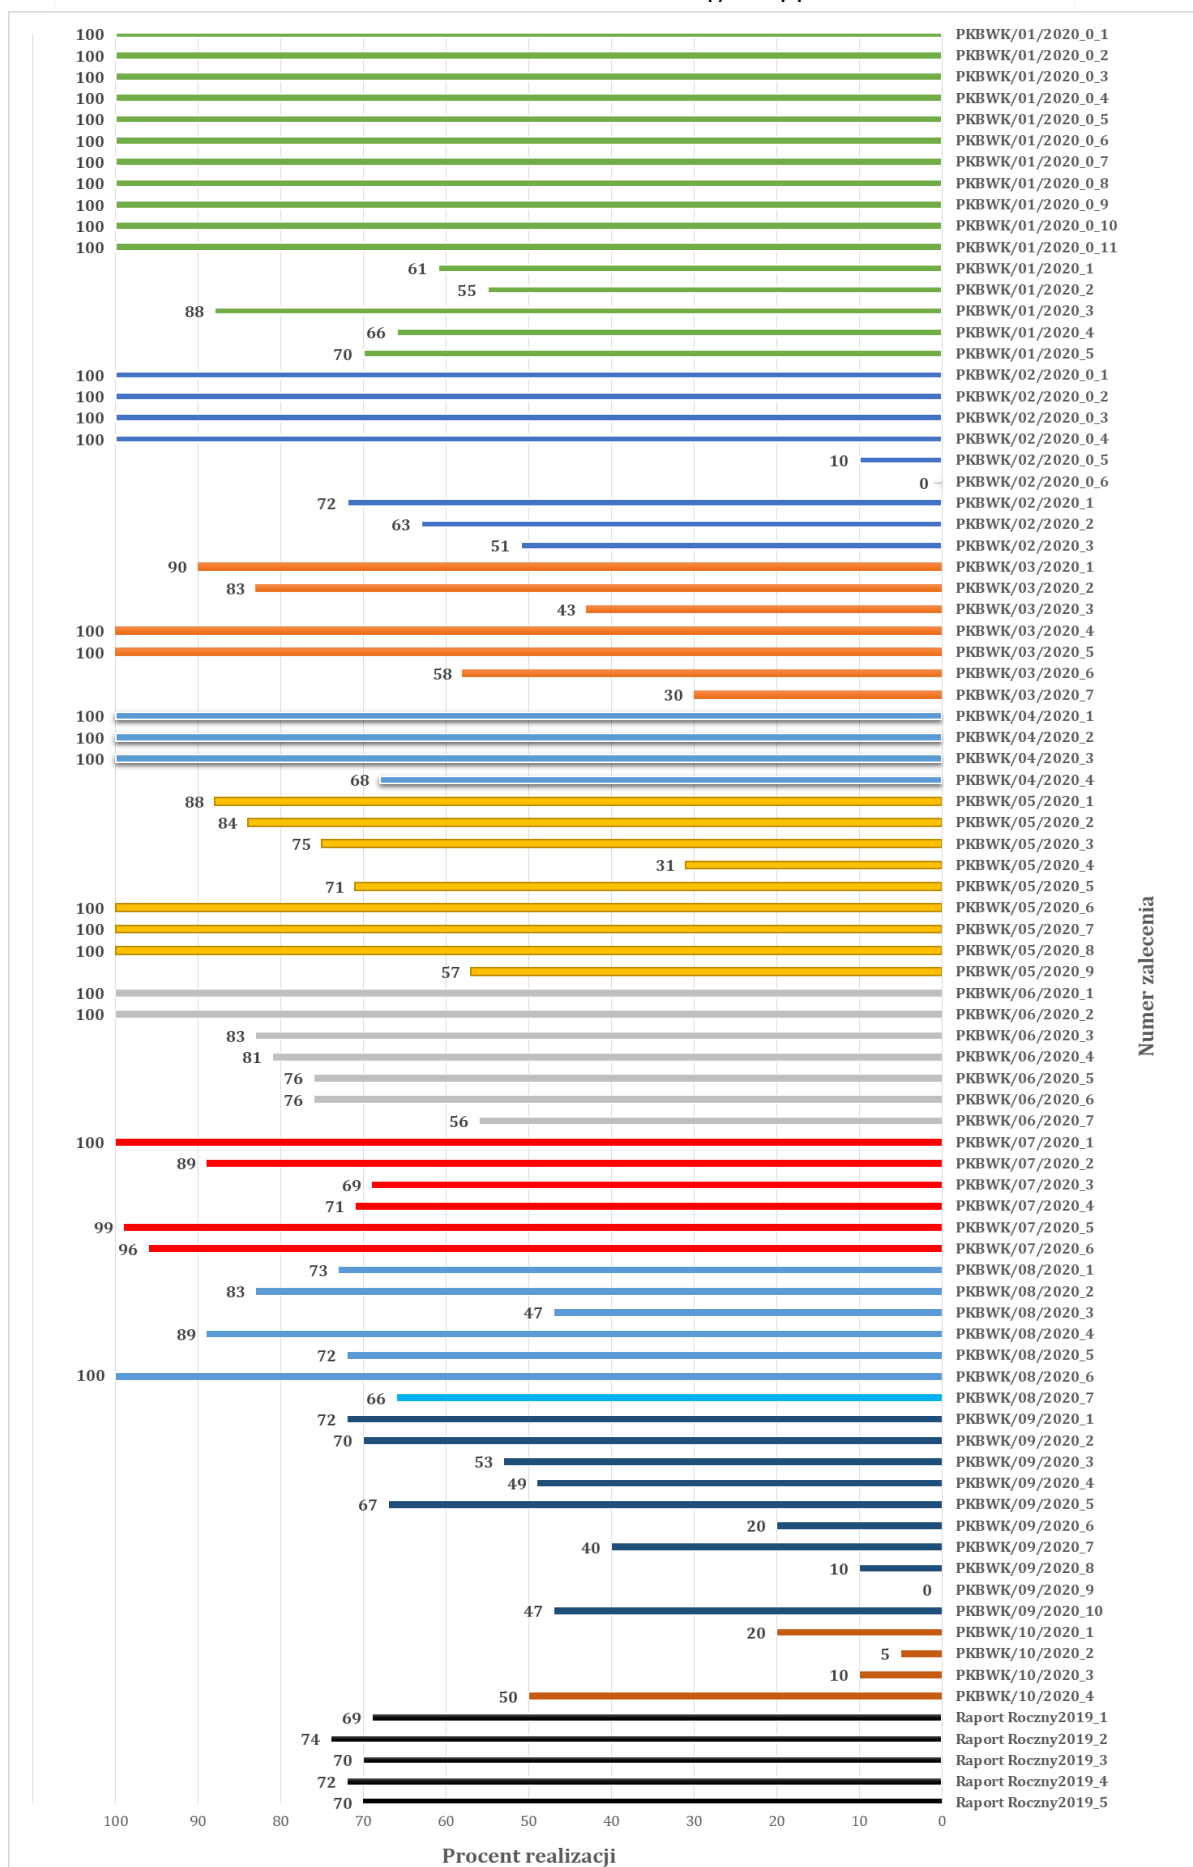
Figure 24: Average percentage of implementation of PKBWK recommendations for 2020 according to Appendix A

The cards include the average percentage of recommendation fulfilment, which was determined based on declarations of addressees of a given recommendation. Lack of 100% implementation of the recommendation results from the schedule of actions taken by the entities to fully implement the recommendations provided to market entities by the President of UTK.

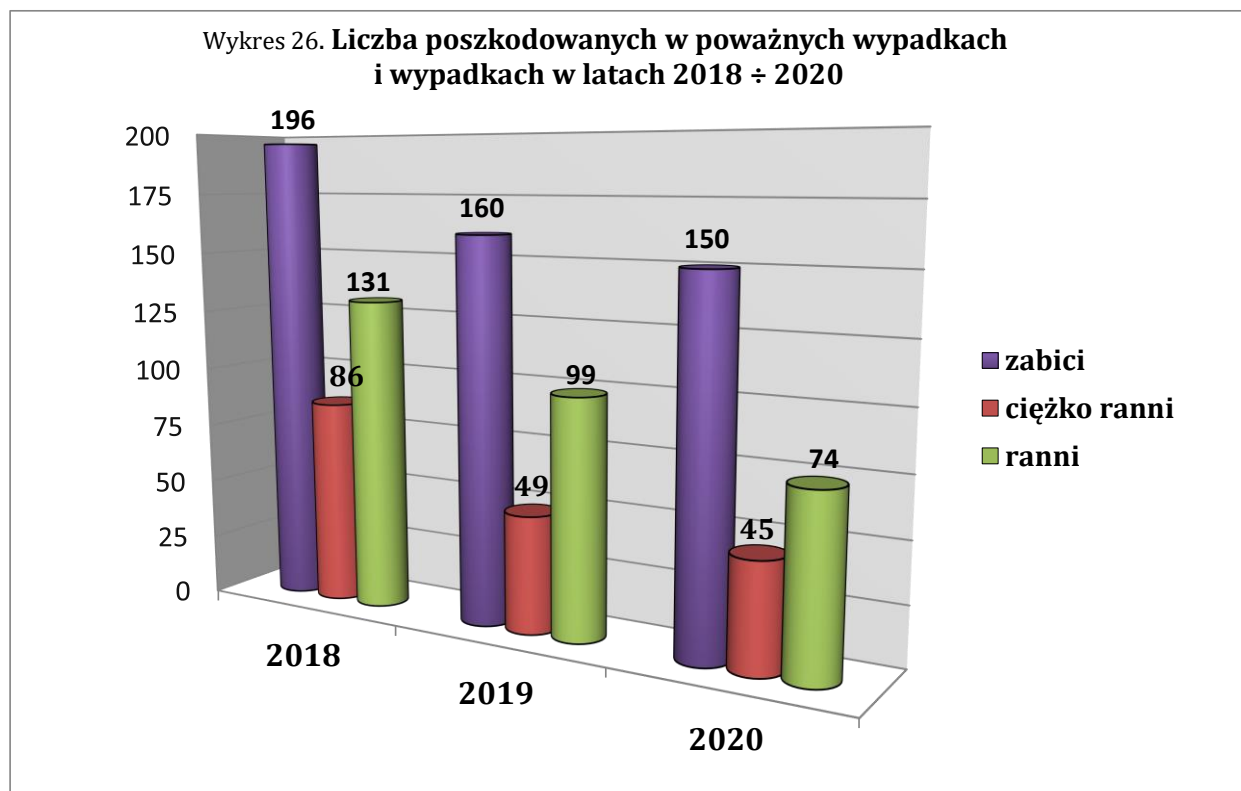
Below the chart illustrates the basic data on the injured (killed, seriously injured and wounded) in 2018 ÷ 2020.

Injured in events occurring in 2020.	Killed	Severely injured	Injured
a) employees including contractor personnel	4	4	9
b) passengers	-	1	17
b) unauthorised persons	98	24	24
c) users of level crossings/road crossings	47	16	24
d) others	1	–	–
Total	150	45	74

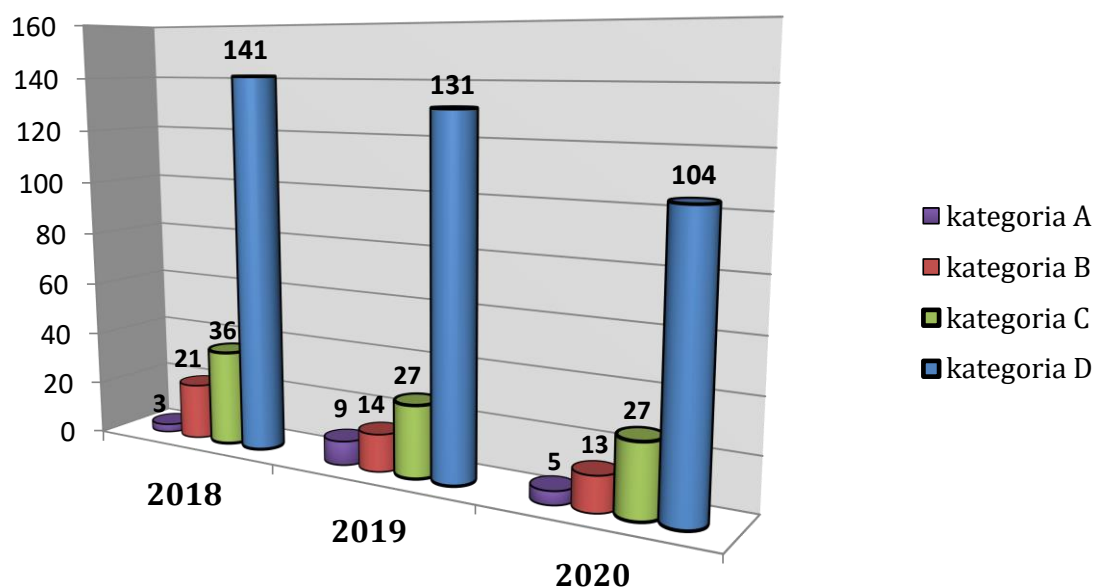
Wykres 27. Poważne wypadki i wypadki na przejazdach kolejowo-drogowych poszczególnych kategorii z udziałem pojazdów drogowych i kolejowych w latach 2018 ÷ 2020

In 2020, compared to 2019, there was a **17.7% decrease** in the total number of accidents at Category A, B, C, D railroad crossings, including:

- at A category railway-road crossings - decrease by 4 accidents,
- at category B railway-road crossings, a decrease of 1 accident,
- At level crossings of category C, the number of incidents (accidents and serious accidents) did not change with respect to the previous year,
- at D category railway-road crossings - decrease by 27 accidents (including users of railway sidings).
