A GUIDE TO UNDERSTANDING HUMAN FACTORS & HUMAN BEHAVIOUR In Safety Management & Accident

In Safety Management & Accident Investigation

This guide has been produced by the staff of the Institute of Naval Medicine and is provided to support procedures for safety management and accident investigation as described by BRd 9147.

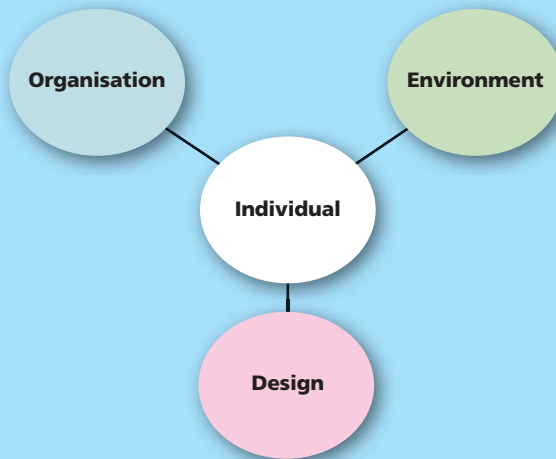
Figure 1 - Where to Look For Human Factors

The diagram below depicts the general scope of Human Factors. It highlights that an individual's behaviour may be influenced by the environment (the physical world), the organisation of their work and the design of machines, equipment, software and workspaces.

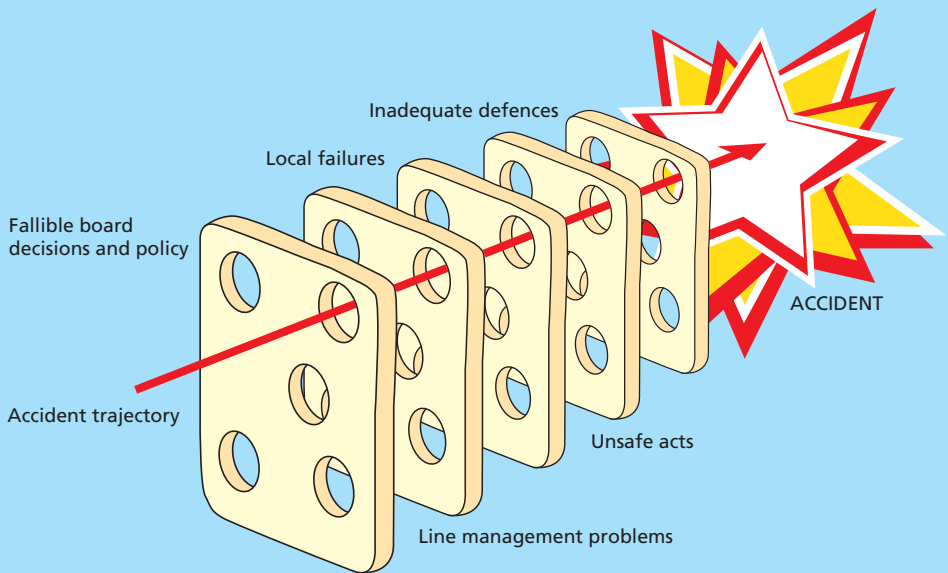
Figure 2 - 'Swiss Cheese' Model of Accidents
 (Redrawn from Reason, J. 1990. Human Error. Cambridge University Press, Cambridge, UK.)

Accidents are usually the end point of a series of events in which the situation becomes increasingly unsafe. Organisations erect multiple barriers to prevent accidents and maximise safety, but none are perfect. By looking beyond the immediate cause, back from the time the accident occurred and outwards, to the wider context, accident investigators can often identify weaknesses at the organisational level from which useful lessons can be learned. Figure 2 illustrates how events can unfold in the form of an accident trajectory (known as the "Swiss Cheese" model).

Appendix C presents case studies to assist with the understanding of Figure 2 and its implications for accident investigation. These case studies illustrate how organisational policies and practices can make it possible for latent failures to exist in the workplace causing accidents to occur when the remaining safety systems fail.

Organisations normally erect multiple barriers to stop accidents from happening. Reason (Figure 2) reminds us that none of these barriers is perfect and that an accident is often the end point of a process in which successive barriers are defeated as events unfold. The focus on organisational factors requires the accident investigator to look beyond the immediate work environment at the time the accident took place and examine how the accident might have 'escaped' through the web of barriers put in place to prevent it from happening. Some key areas of focus include: training and team composition/selection; supervisory style and safety culture; organisational policies and processes, including the composition and function of safety committees and supervisors; risk reporting and reduction and record keeping. Perceptions of safety at work, the extent to which operators perceive the workspace as hazardous and the presence of perverse incentives for unsafe behaviour are also important.

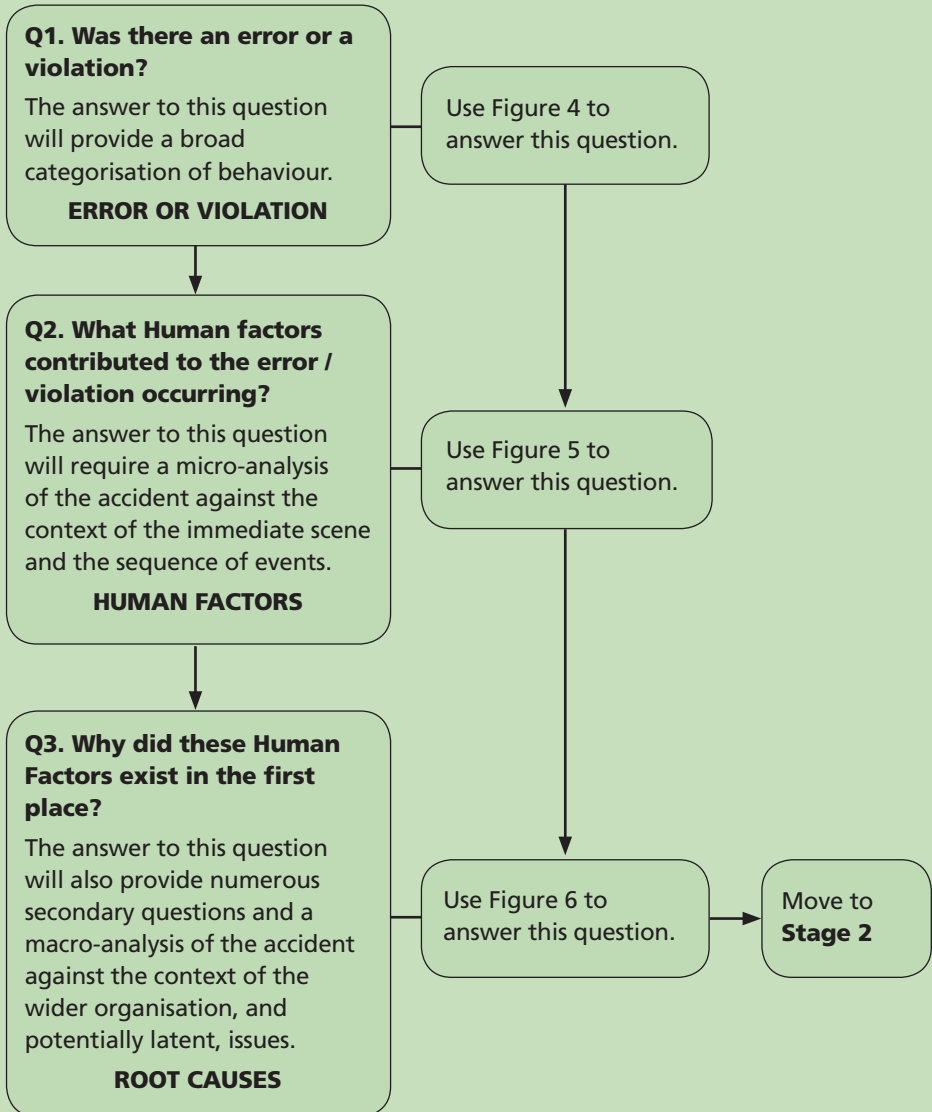
Figure 3 - Identification and Classification of Human Error and Behaviour.

Stage one aims to identify and classify errors/violations, human factors and root causes. This involves answering three questions using Figures 4 to 6 as a guide and should be done in the steps shown below:

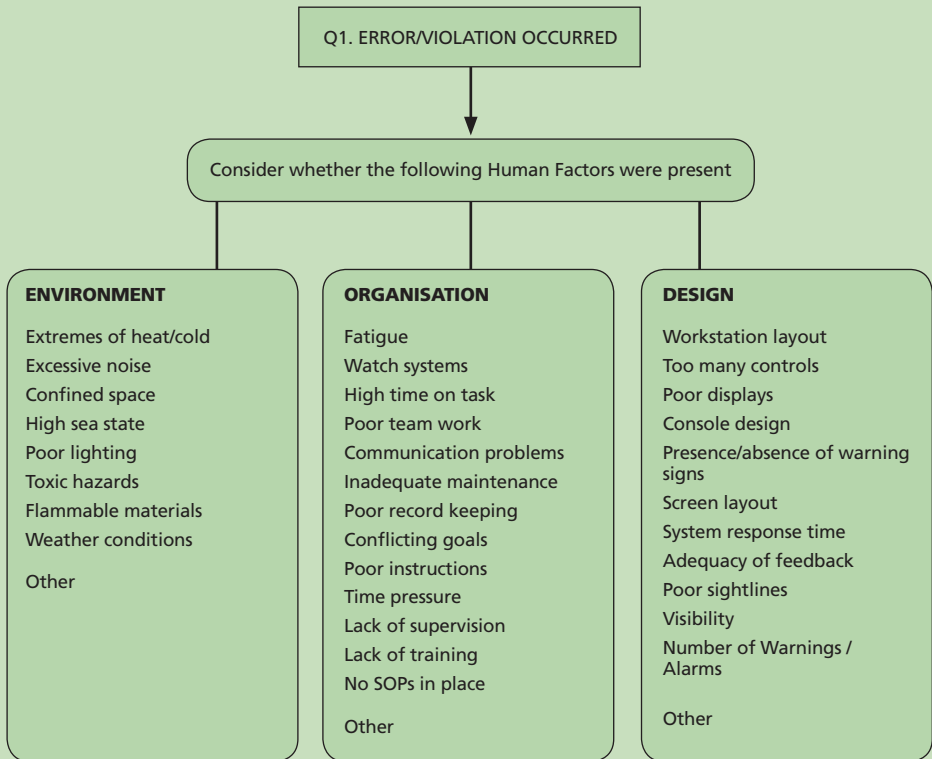
Figure 5 - Flowchart to identify what risk factors were present

To answer this question the following flow chart should be considered:

Many of the Human Factors identified in Figure 5 may have root causes – it is important to consider why these Human Factors existed. Figure 6 (opposite) gives examples of some Human Factors shown in Figure 5 and the root causes that may explain their presence in the workplace at the time the accident took place. In some cases more than one Human Factor may have a single root cause (for example, poor safety culture).

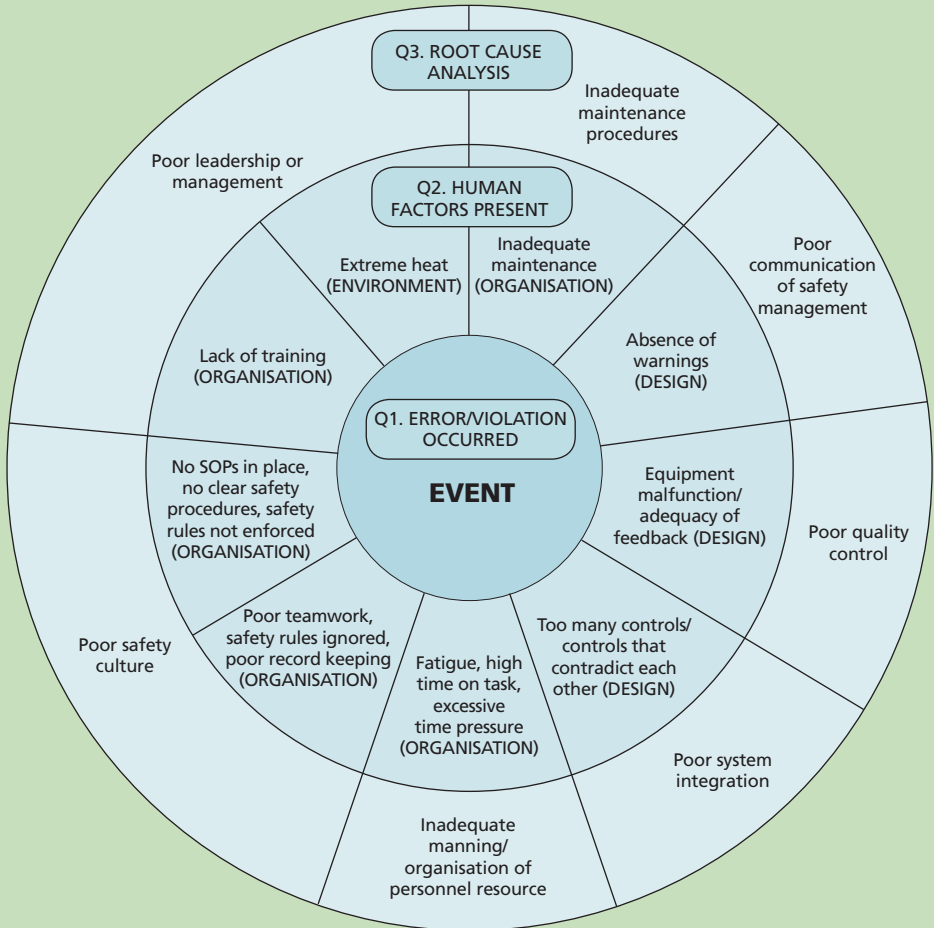
Figure 6 - Analysis of Human Factors and their root causes

If Human Factors (in Environment, Organisation or Design) were present, consider the following root cause analysis (not exhaustive):
