MINISTRY OF TRANSPORTS AND INFRASTRUCTURE
ROMANIAN RAILWAY AUTHORITY - AFER

ROMANIAN RAILWAY INVESTIGATING BODY

INVESTIGATING REPORT

On the railway accident on the 2nd of November 2009 between the railway stations Dealu Ștefăniței – Fiad, km. 28+715

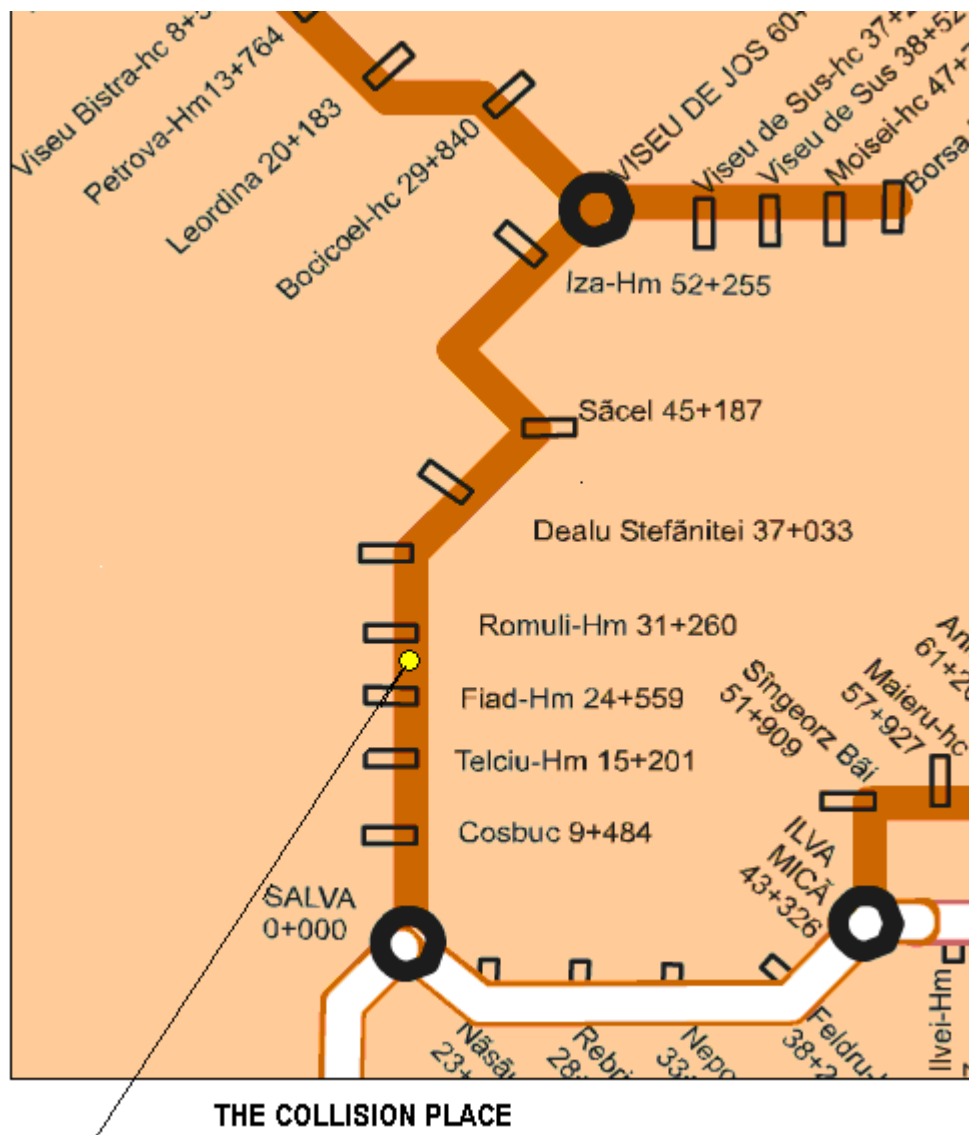
The collision place is in the Railway County Cluj, between the railway stations Dealu Stefanitei – Fiad, km 28+715. The line is sloping (19.2‰) in the running direction of the light locomotive (Dealu Stefanitei – Fiad), straight line on about 250m and in mixed cross section.
