# **Rail Accident Report**

Fatality at Johnson's footpath crossing near Bishop's Stortford, Hertfordshire 28 January 2012

> Report 27/2012 December 2012

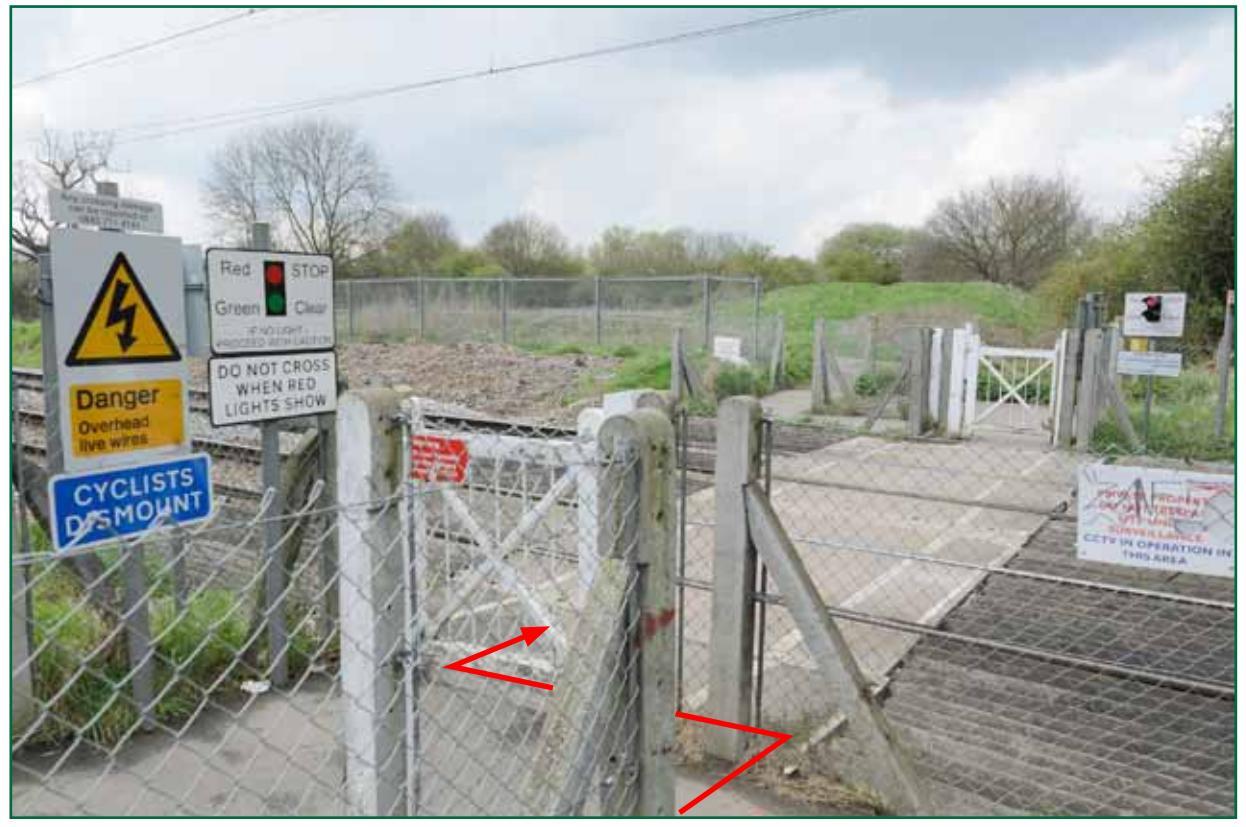
Figure 4: Approach to Johnson's footpath crossing viewed from the east (up) side

15 The crossing was equipped with *miniature stop lights* (MSLs)<sup>3</sup>, located on the opposite side of the railway from approaching pedestrians, audible alarms, self-closing wooden gates and warning signs. The positioning of the MSLs on the far side of the railway corresponded with the guidance published by Her Majesty's Railway Inspectorate<sup>4</sup> when they were installed (refer to paragraph 29). The signs also complied with guidance at the time; additional signs reading 'Do not cross when red lights show' were positioned so that they were visible on the near side of the crossing, see figure 4. The immediate approach to the crossing on each side of the railway involved a doglegged path as indicated at figures 4 and 5.

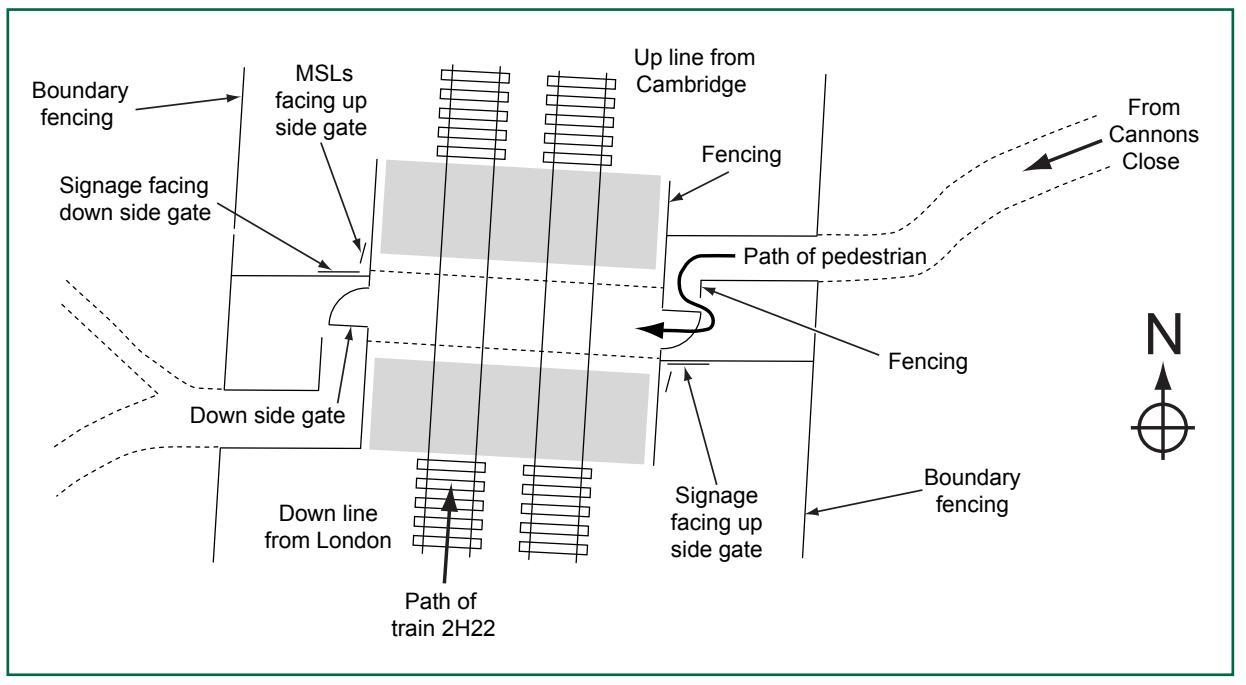
Figure 5: Layout of Johnson's footpath crossing

16 Network Rail determined that the maximum time required for pedestrians to cross safely was 12 – 14 seconds, allowing for vulnerable users<sup>5</sup>. Network Rail's practice is to increase traverse time by 50% if a 'higher than usual' number of vulnerable people is observed using the crossing during visits made to site by its staff to gather data for periodic risk assessments, although what constitutes a 'higher than usual' number is not defined. The MSLs and associated audible alarms provided approximately 25 seconds warning of a train approaching the crossing from either direction at the maximum permitted speed of 70 mph (113 km/h). This equipment was part of the signalling system; Network Rail tested it after the accident, and confirmed to the RAIB that it was found to be working correctly. Recordings made by the signalling data logger at the time of the accident provide supporting evidence of correct system operation.

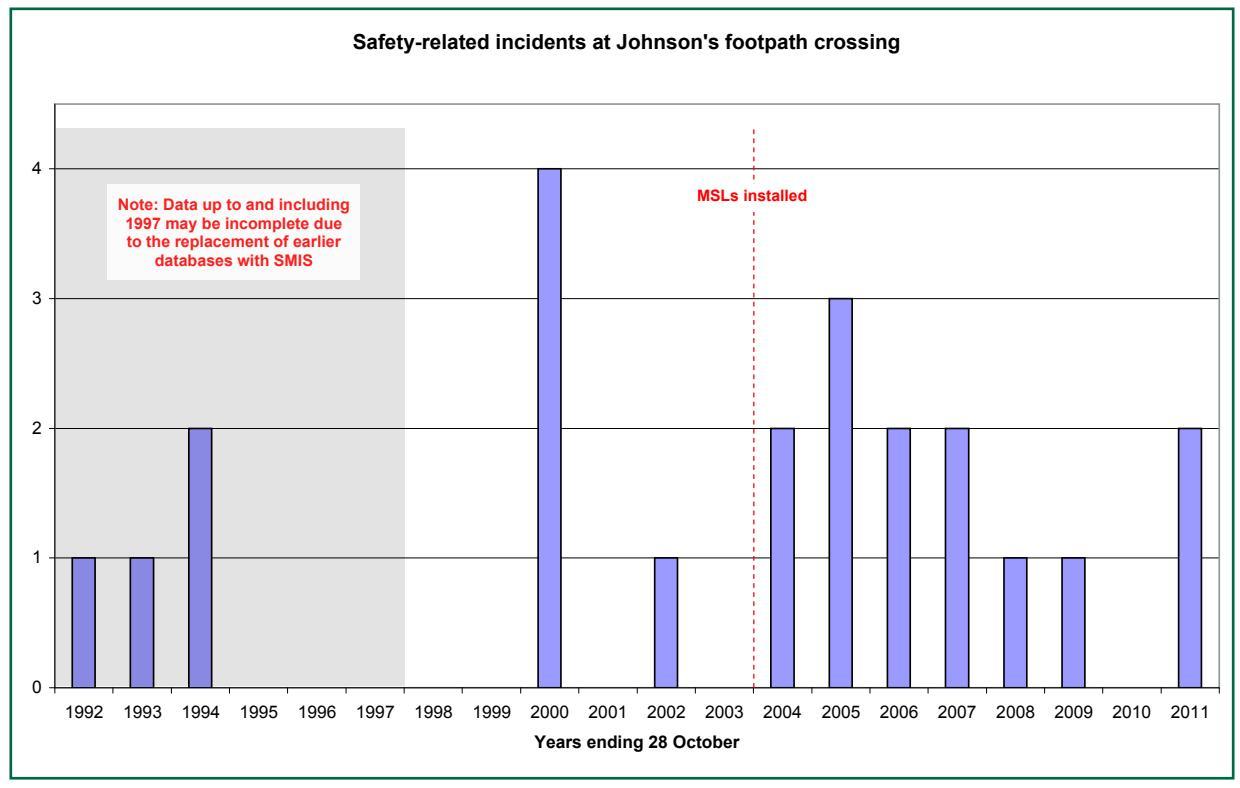
Figure 6: Rate of occurrence of incidents resulting in a near miss or fatality at Johnson's footpath crossing

- 34 The current ALCRM risk scoring of a level crossing (refer to paragraph D5 in appendix D) does not take account of reports of near misses or misuse, although the ORCC is required to consider such factors (paragraph 26; see also paragraph 83). There is documentary evidence that the ORCC considered the history of incidents and near misses at Johnson's footpath crossing, although it is unclear how this was factored into risk assessments for the crossing. In its report on the fatal accident at Halkirk level crossing on 29 September 2009 (RAIB report 16/2010), the RAIB noted that Network Rail's procedures did not give guidance on how the incident history of a level crossing should be used to supplement the information given by the ALCRM, in order to understand the risk and inform decisions on implementing risk reduction measures (refer to paragraph 77).

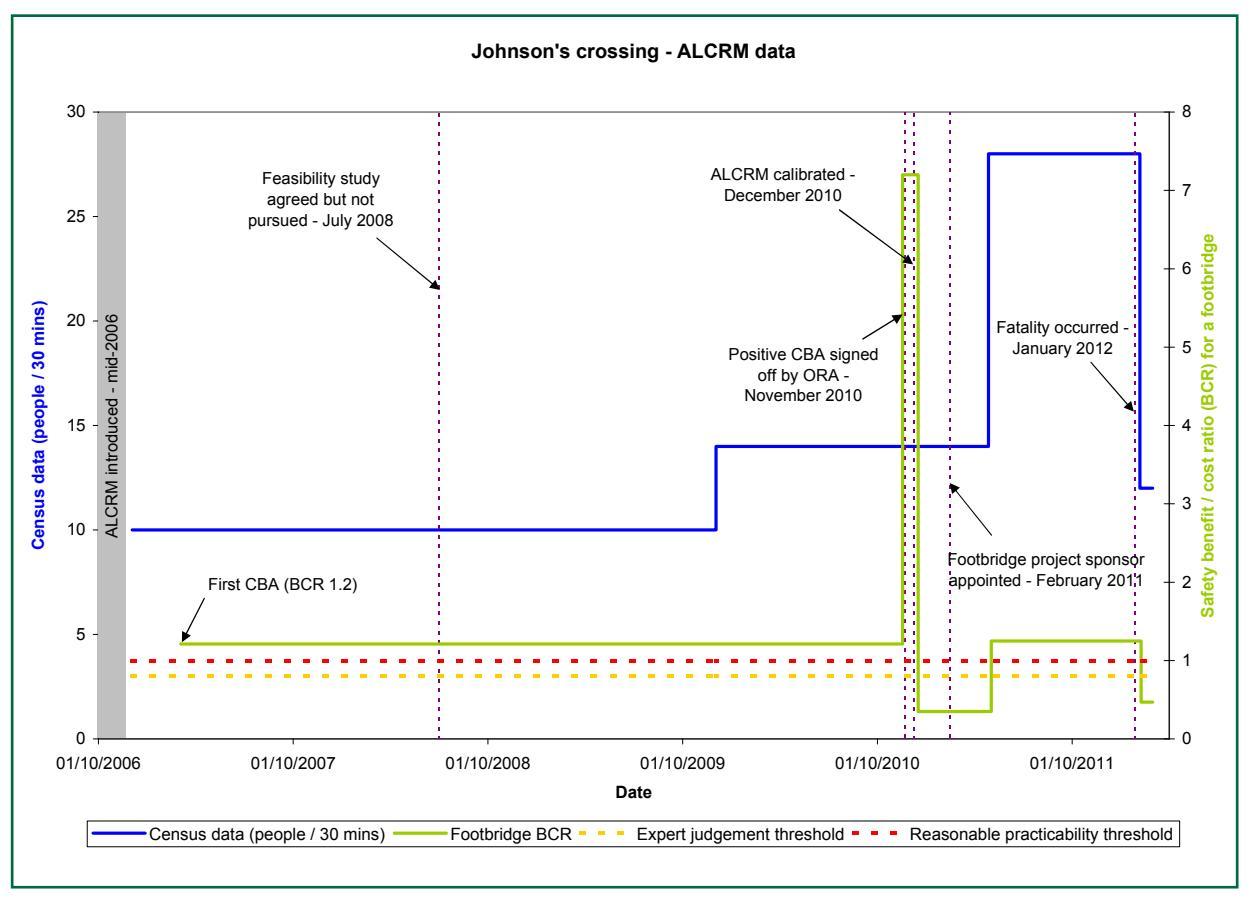
Figure 8: Variations in census data and benefit / cost ratio

66 Since the re-calibration of the ALCRM in December 2010 (refer to appendix D, paragraph D6), the BCR for a footbridge to replace Johnson's footpath crossing has varied between 0.35 and 1.25, table 1 and figure 8, where any figure in excess of 1 represents a positive case for making the investment (paragraph 26). The variations occurred principally because of fluctuations in the census data, although the predicted capital cost of a footbridge was also reduced to reflect Network Rail's modular footbridge design. The number of crossing users recorded during quick censuses at Johnson's footpath crossing varied from 7 to 28 users in a 30 minute period (the RAIB counted the number of users of Johnson's footpath crossing for a total of three and a quarter hours on 12 July 2012; the number observed was equivalent to 16 users per thirty minutes).

- 67 The changes in the BCR were sufficient to cause the result of the cost-benefit analysis for building a footbridge to replace Johnson's footpath crossing to fluctuate between 'the benefits outweigh the costs' (BCR > 1) and 'the benefits do not cover the costs' (BCR < 0.8). It is possible that the train frequency recorded in 2007 was an error (for example counting the trains passing over the crossing in one direction only). In addition, despite the variations in pedestrian usage indicated at table 1, it is unlikely that the usage had in fact changed significantly in this period. The RAIB has been unable to identify any underlying changes, such as housing developments in the area, which would explain such variations. The use of the quick census is not always an effective means of gauging pedestrian crossing usage, particularly where a crossing may see increased usage at weekends, or at other times outside of those prescribed by Network Rail<sup>27</sup>. The RAIB has previously identified issues regarding the effectiveness of Network Rail's level crossing quick census technique in the following investigations<sup>28</sup>:

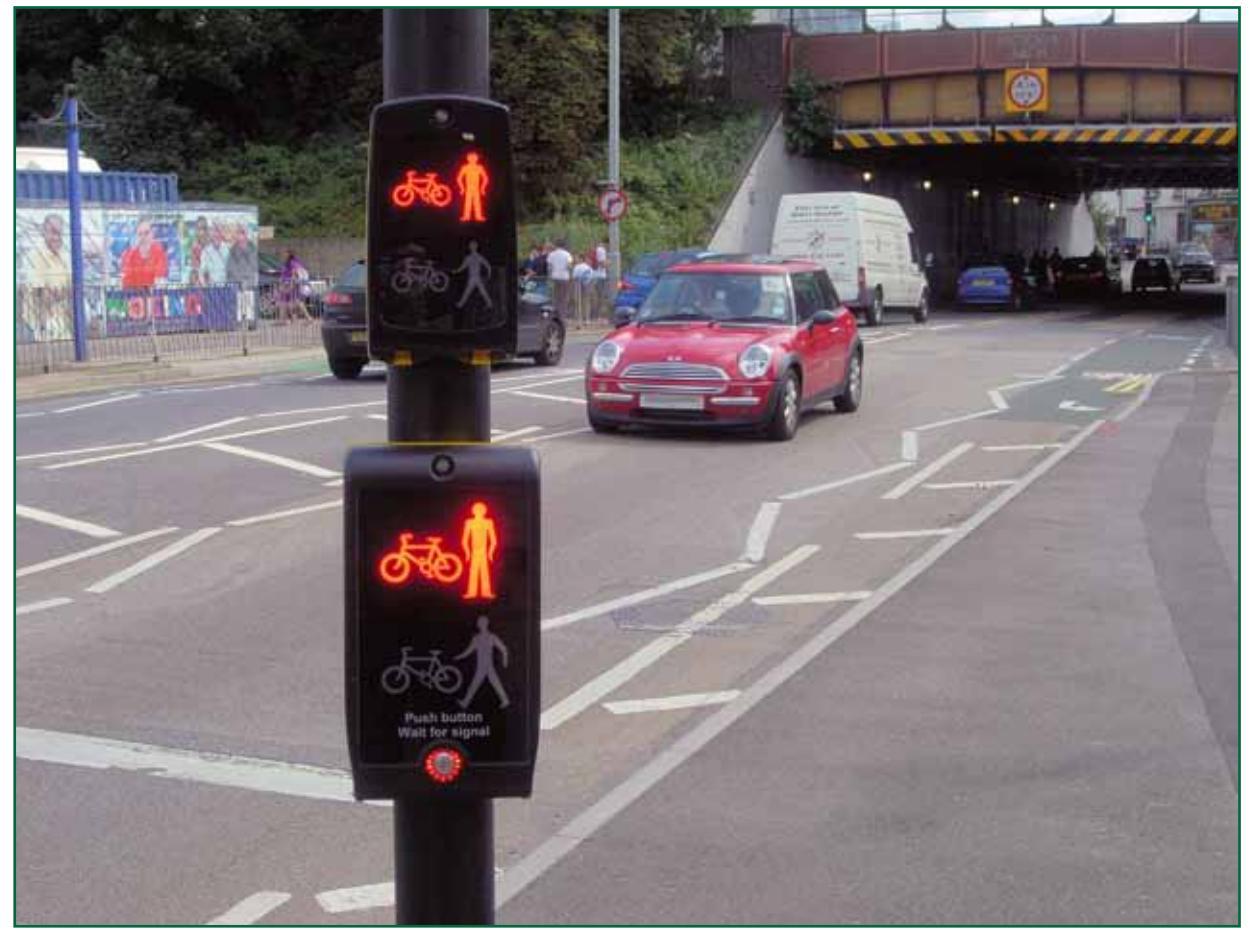
Figure F1: Puffin crossing showing orientation of nearside lights relative to oncoming traffic

Nearside crossing lights (Puffin crossings) are intended to encourage those using the signal demand button to look in the direction of traffic flow.	The ORR has stated that installing MSLs on the nearside of the railway may cause users to be more alert to their surroundings when crossing, not focusing solely on a green lamp ahead. However, the ORR considers that these benefits are probably marginal, and that existing installations in which the MSLs are on the far side of the railway do not need to be modified.
