Speed area's CSG permitted speed (drop) in DMI

**ProRail**

# CR1249 issue with pre-indication

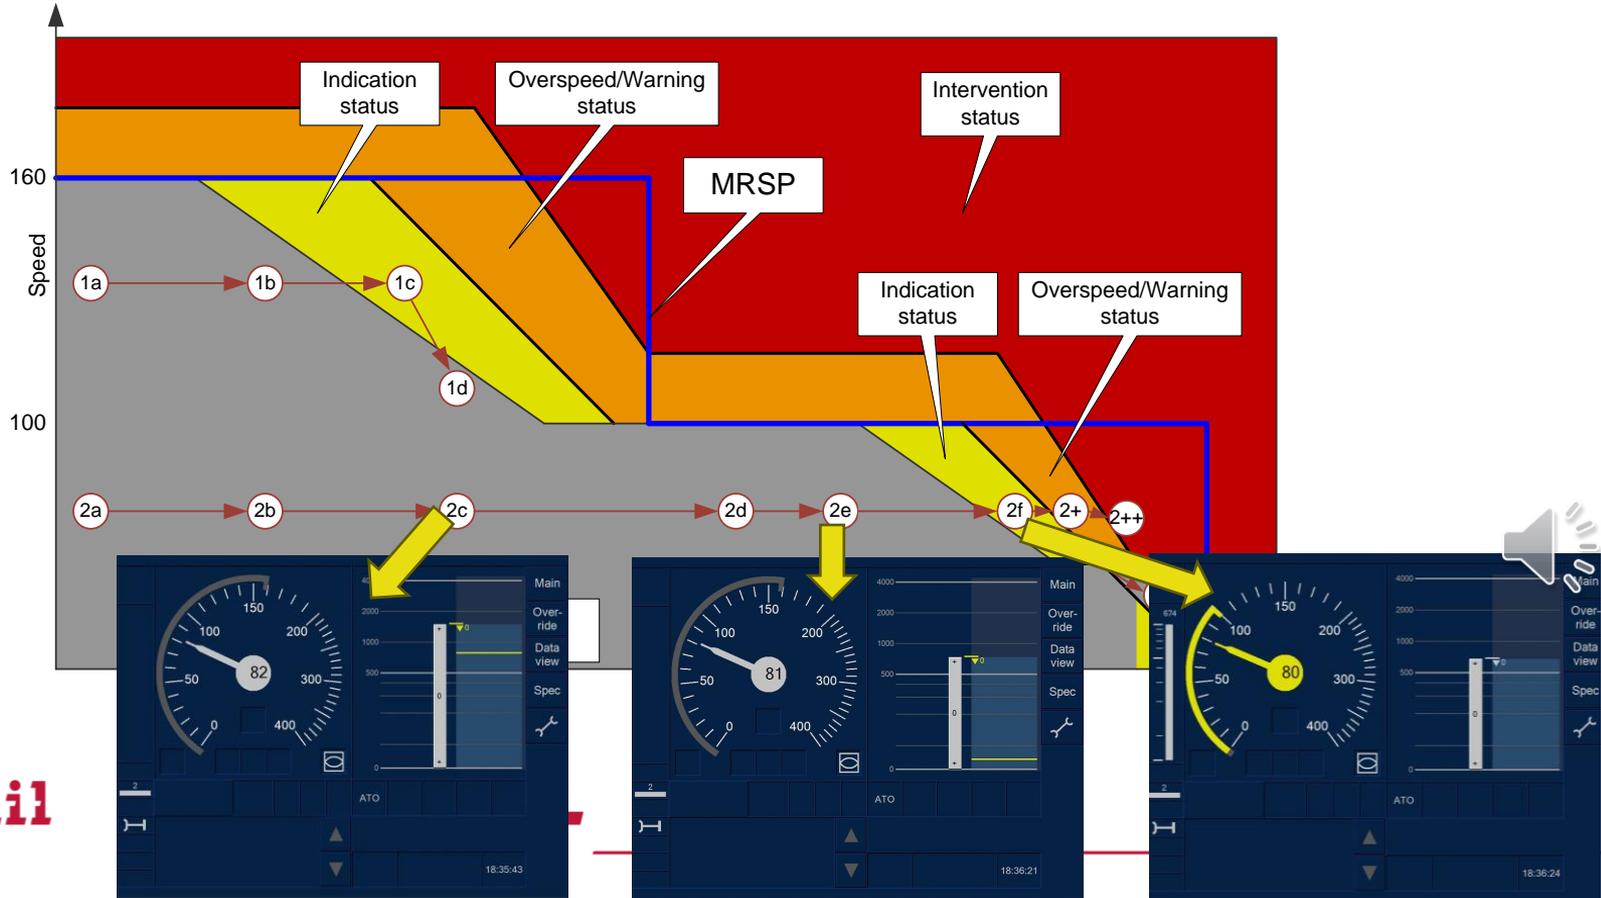
# CR1249 solution (CSM-TSM on indication)

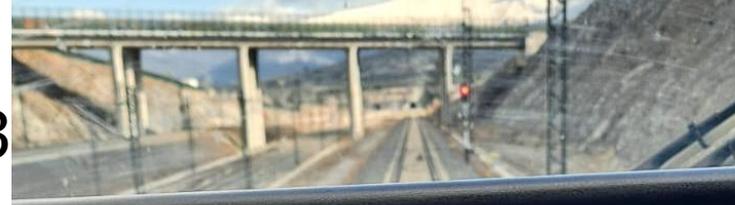
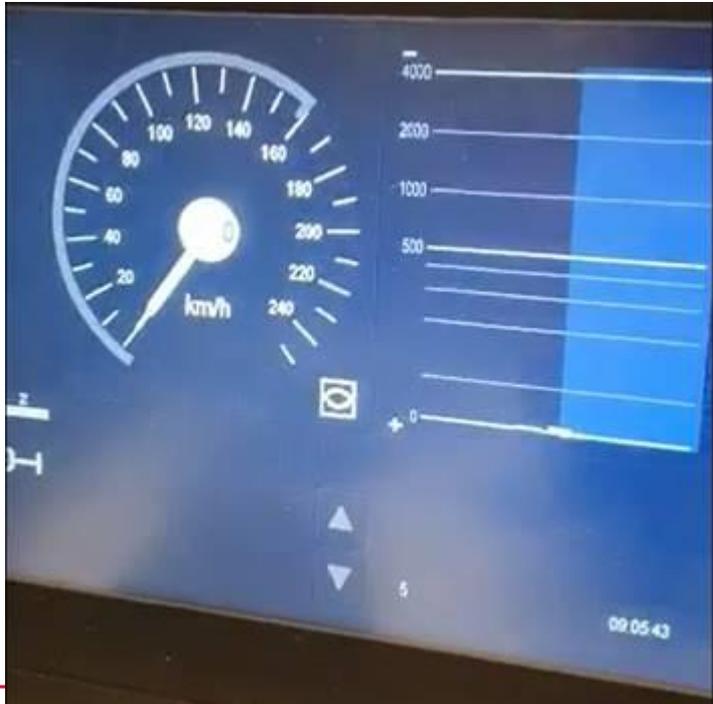
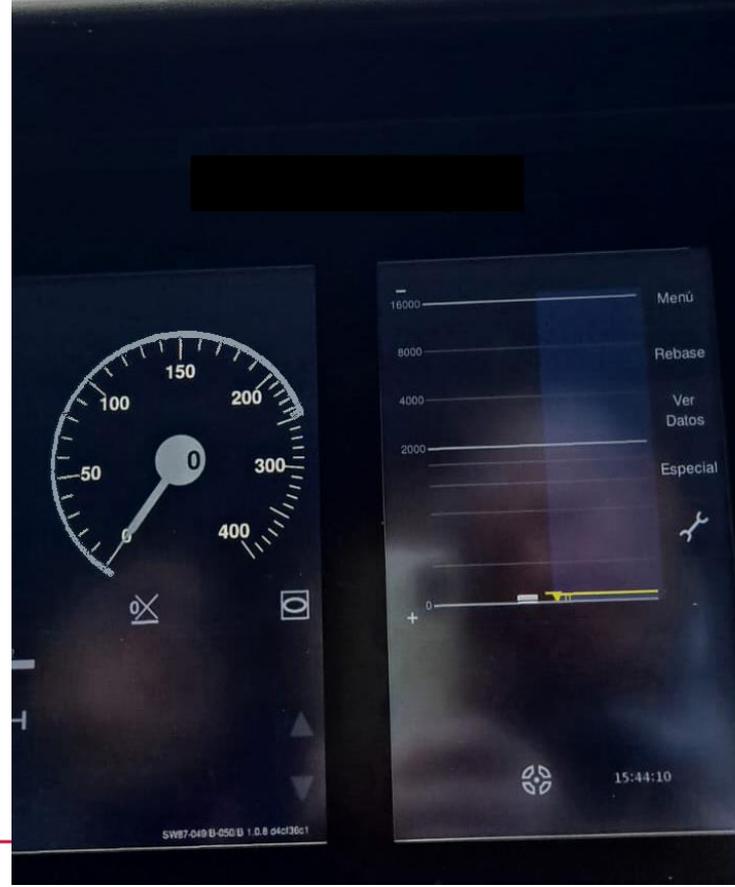
# CR1401 Indication problems in B3 CSM shows MRSP close at EoA
